TRANSPORTATION RESEARCH CENTER

ON-SITE CHILD SAFETY SEAT INVESTIGATION

CASE NUMBER - IN08020
LOCATION - TEXAS
VEHICLE - 2004 GMC ENVOY
CRASH DATE - March 2008

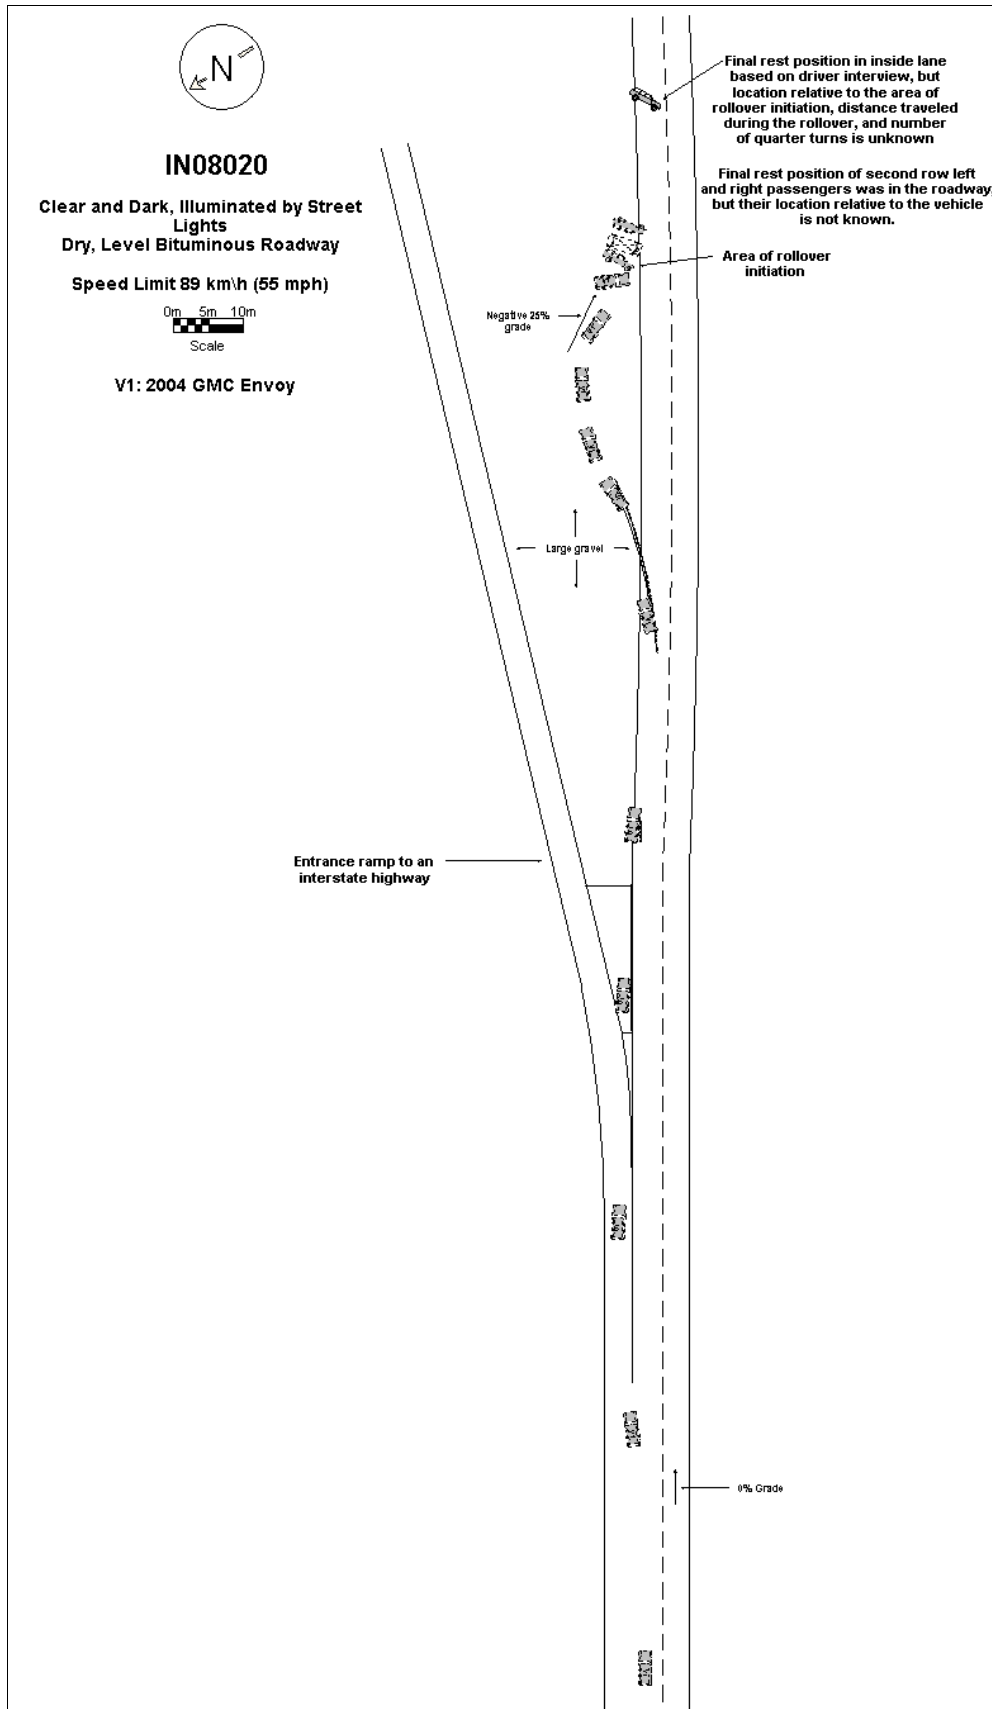
Crash Environment: The trafficway on which the GMC was traveling was a 3-lane, one-way, service road leading to an interstate highway. The roadway had two through lanes and an entrance lane to the interstate highway. The widths of the right lane, left lane, and entrance ramp lane were 3.8 m (12.5 ft), 4.4 m (14.4 ft), and 3.9 m (12.8 ft), respectively. The roadway was bordered by gravel shoulders that were nominally 1 m (3.2 ft) in width. The roadway pavement markings consisted of a white outside edge line, a broken white lane line, solid white entrance ramp lane line, and a yellow inside edge line. There was no posted speed limit sign near the crash site, but the police crash report indicated that the speed limit was 89 km/h (55 mph). At the time of the crash, it was dark but illuminated by street lights, the atmospheric condition was clear, and the roadway was dry, level bituminous. Traffic density was light and the site of the crash was urban commercial. See the Crash Diagram on page 11 of this report.
