On-Site Hybrid Vehicle Investigation
Dynamic Science, Inc. (DSI), Case Number DS08020
2005 Toyota Prius
Washington
June 2008

1. Report No. DS08020		2. Government Accession No.		3. Recipient Catalog No.	
4. Title and Subtitle Hybrid Vehicle Investigation			5. Report Date August 3, 2009

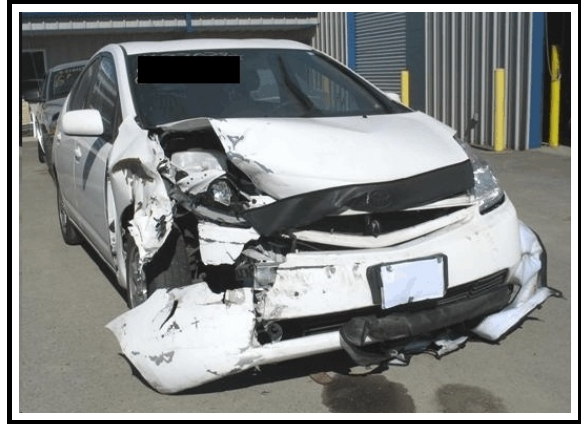
Figure 1. Subject vehicle, 2005 Toyota Prius Hybrid

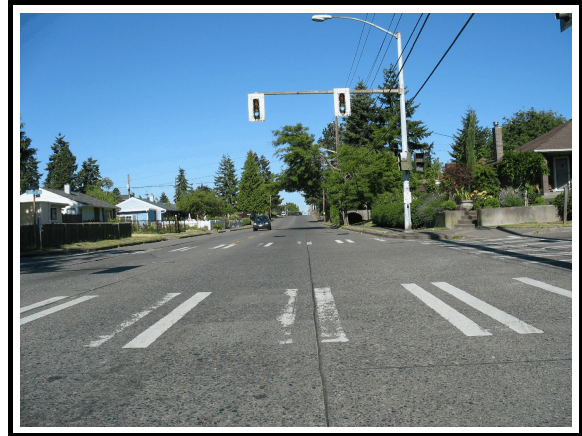
The crash site was a four-leg intersection that comprised an east/west roadway and a north/south roadway. The east/west roadway was undivided and consisted of two lanes for each direction of travel (**Figure 2**). The roadway alignment was straight and the westbound profile maintained a positive 2.2 percent grade as it approached the intersection. The eastbound lanes approaching the intersection were level. The roadway composition was asphalt, and raised concrete curbs bordered the north and south edges. The posted speed limit was 48 km/h (30 mph), and parking was allowed along the south curb.

Figure 2. Subject vehicle's westbound approach to intersection
