## ON-SITE ROLLOVER INVESTIGATION

CASE NUMBER - IN08021

LOCATION - TEXAS

VEHICLE - 2006 MAZDA TRIBUTE DX

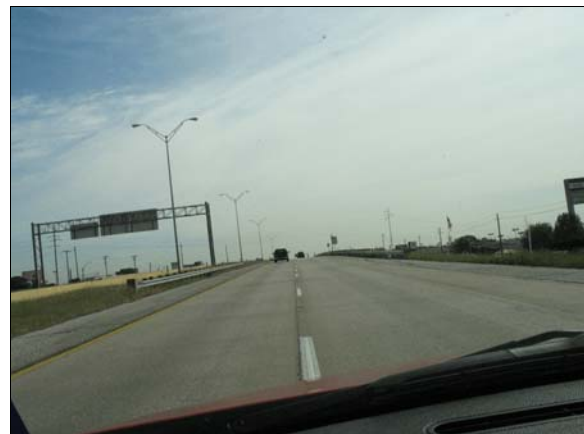
**Pre-Crash:** The Mazda was occupied by a restrained 54-year-old female driver, a restrained 91-year-old female front right passenger, a restrained 3-year-old female second row left passenger, and a restrained 2-year-old female second row right passenger. The driver was traveling northeast in the outside through lane (**Figure 2**). The driver stated in the interview that she had missed an exit, and while looking for the next exit, became distracted when the two children in the back seat called for her. As she looked into

**Figure 2:** Approach of Mazda to area of rollover

the back seat, the vehicle crossed the inside travel lane and departed the left side of the roadway. The driver steered to the right, reentered the roadway and the vehicle began to rotate clockwise. The driver applied the brakes in an attempt to regain control of the vehicle and the crash occurred on the roadway as the vehicle rotated clockwise.
