On Site Tour Bus Crash Investigation - Office of Defects Investigation
Dynamic Science, Inc. (DSI), Case Number DS08028
2001 Prevost Marathon Tour Bus Class A Recreational Vehicle
Nevada
August 2008

1. Report No. DS08028	2. Government Accession No.		3. Recipient Catalog No.	
4. Title and Subtitle On Site Tour Bus Class A Recreational Vehicle Crash Investigation			5. Report Date July 21, 2009

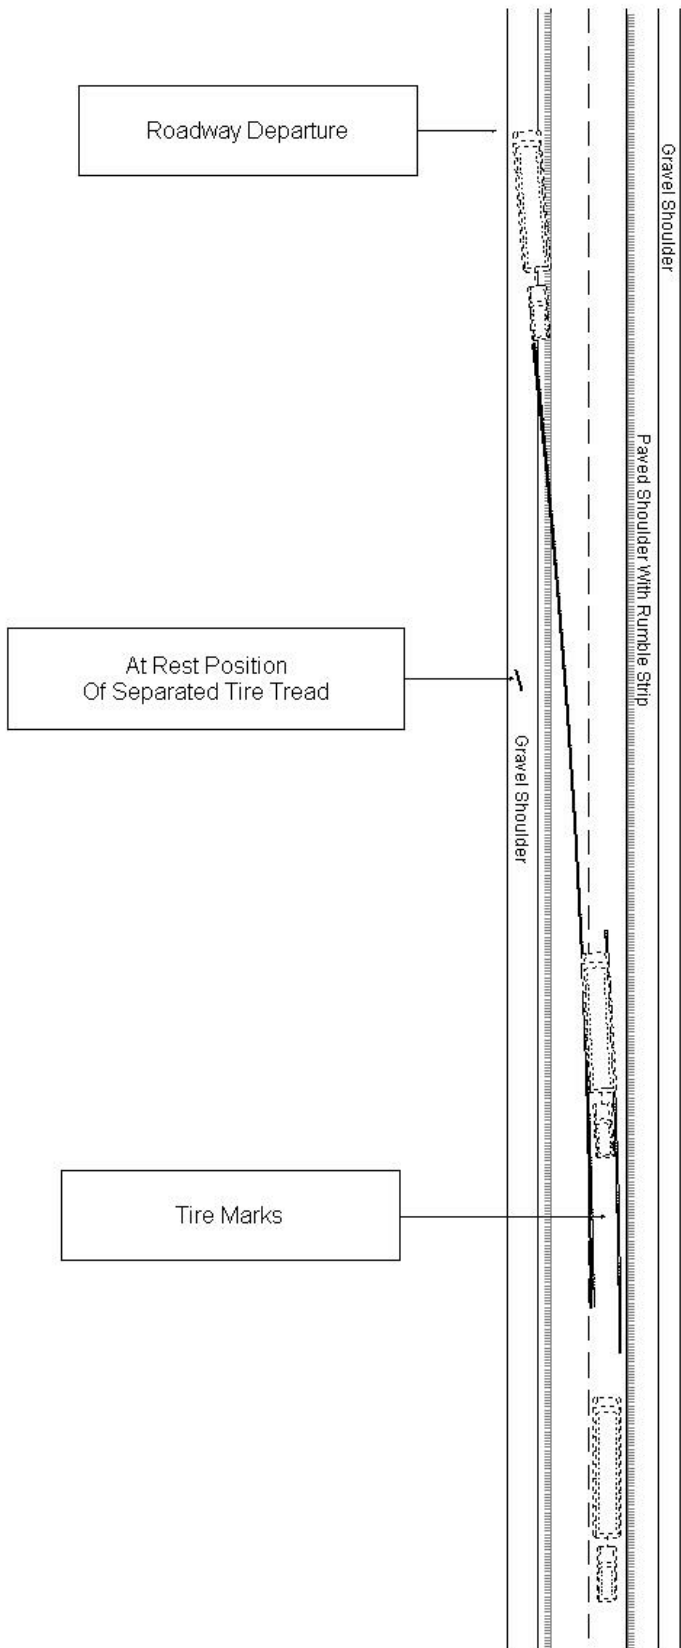
Scene Diagram

DS08028
Nevada
August 2008
Subject Vehicle
2001 Prevost Marathon
Tour Bus
Towing 2008 GMC Yukon
Posted Speed Limit
121 km/h (75 mph)
