**CALSPAN ON-SITE BACK OVER INCIDENT INVESTIGATION**

**SCI CASE NO.: CA08032**

**VEHICLE: 2004 NISSAN ALTIMA**

**CRASH DATE: JULY 2008**

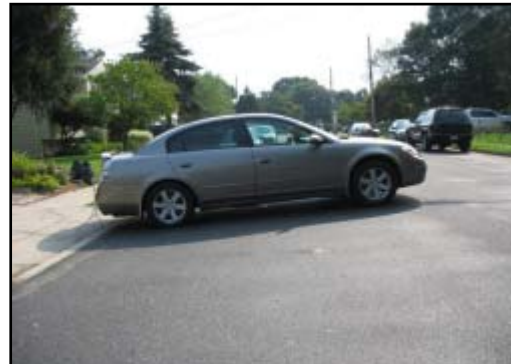
**Figure 1. 2004 Nissan Altima.**

This on-site investigation focused on the sight distances and the circumstances involving a back over incident that resulted in non-fatal injuries to a 3-year-old male. The vehicle in this incident was a 2004 Nissan Altima (**Figure 1**) that was operated by a 28-year-old female driver. The 3-year-old-old male non-motorist is the son of the driver. He was struck by the vehicle's rear bumper as the vehicle was backing into the driveway. The non-motorist was consequently knocked to the ground and was struck by the undercarriage components of the Altima. The non motorist sustained multiple soft tissue injuries to the face and extremities and was hospitalized for five days. It was determined during the on-site investigation, that the non-motorist entered the blind zone during the backing trajectory; therefore, he was not visible to the driver at the time of the incident.

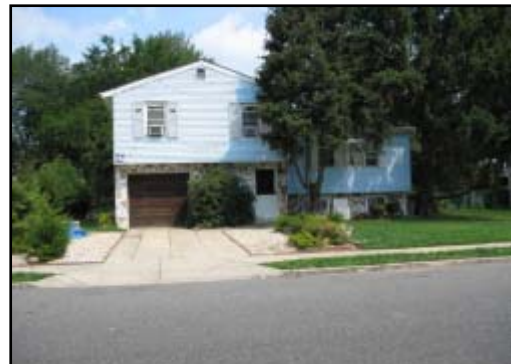
**Figure 2. Overall view of the incident site.**

The residence consisted of a two story home with a single vehicle attached garage (**Figure 2**)

located on the north side of a two-lane east/west road. A concrete surfaced driveway that measured 3.3 meters (10.8 feet) in width and 8.9 meters (29.2 feet) in length extended from the residence to the roadway. The roadway measured 10.3 meters (33.9 feet) wide and was surfaced with asphalt. The driveway was bordered by a red colored decorative concrete border that was 4.6 cm (1.8”) in height. Adjacent to the border was a landscaped area that consisted of decorative stone, shrubs, and small trees. The landscaping did not interfere with the driver’s vision during this backing incident. Due to the crown of the roadway, there was a negative grade of -1.4 percent as the vehicle approached the mouth of the driveway. A positive grade of 1.8 percent was present leading from the mouth of the driveway towards the garage. The Incident Schematic is attached as **Figure 8** of this report.
