ON-SITE ROLLOVER INVESTIGATION

CASE NUMBER - IN08035
LOCATION - ILLINOIS
VEHICLE - 2008 HYUNDAI SANTA FE LIMITED
CRASH DATE - August 2008

June 4, 2009

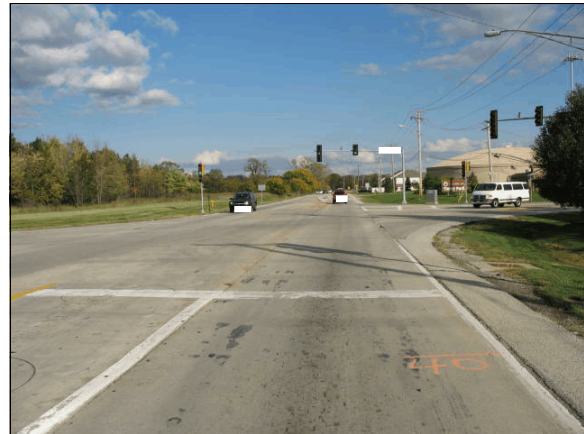
Pre-Crash: The Hyundai was occupied by a restrained 53-year-old female driver and a restrained 31-year-old female front right passenger. The driver stated during the interview that she was traveling east approaching the intersection at approximately 64-72 km/h (40-45 mph) and intended to continue east through the intersection (Figure 2). The Jeep was occupied by a restrained 26-

Figure 2: Approach of the Hyundai eastbound into the intersection

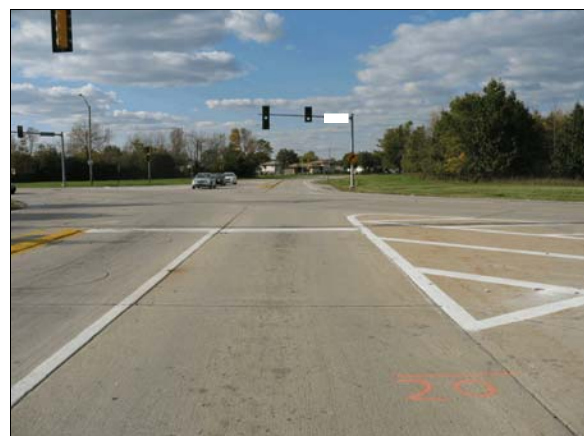
year-old female driver, and she intended to continue northwest through the intersection (Figure 3). The Hyundai's driver did not recall if she attempted any actions to avoid the crash, which occurred within the intersection. A witness told police that the traffic signal was in the red phase for the Hyundai.

Figure 3: Approach of the Jeep northwestbound into the intersection
