# INDIANA UNIVERSITY

## ON-SITE ROLLOVER INVESTIGATION

CASE NUMBER - IN08037  
LOCATION - MICHIGAN  
VEHICLE - 2008 FORD ESCAPE XLT  
CRASH DATE - September 2008

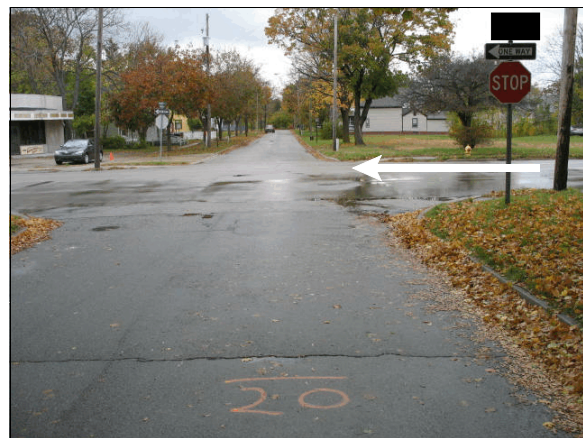
**Pre-Crash:** The Ford was occupied by a restrained 25-year-old female driver and a restrained 47-year-old female front right passenger. The driver was traveling northwest approaching the 4-leg intersection (**Figure 2**). The driver stated during the SCI interview that she was intending to continue northwest. She saw the stop sign but did not stop and continued into the intersection. She took no actions to avoid the

**Figure 2:** The Ford's approach to intersection and the area of impact; arrow shows the approach of the Toyota

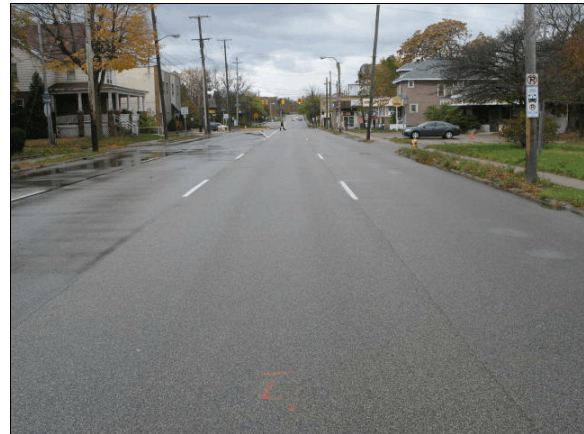
crash. The Toyota's restrained 52-year-old female driver was traveling southwest in the second lane from the right and was approaching the same intersection (Figure 3). The crash occurred within the intersection.

Figure 3: The Toyota's approach to intersection and impact area; arrow shows the approach of the Ford

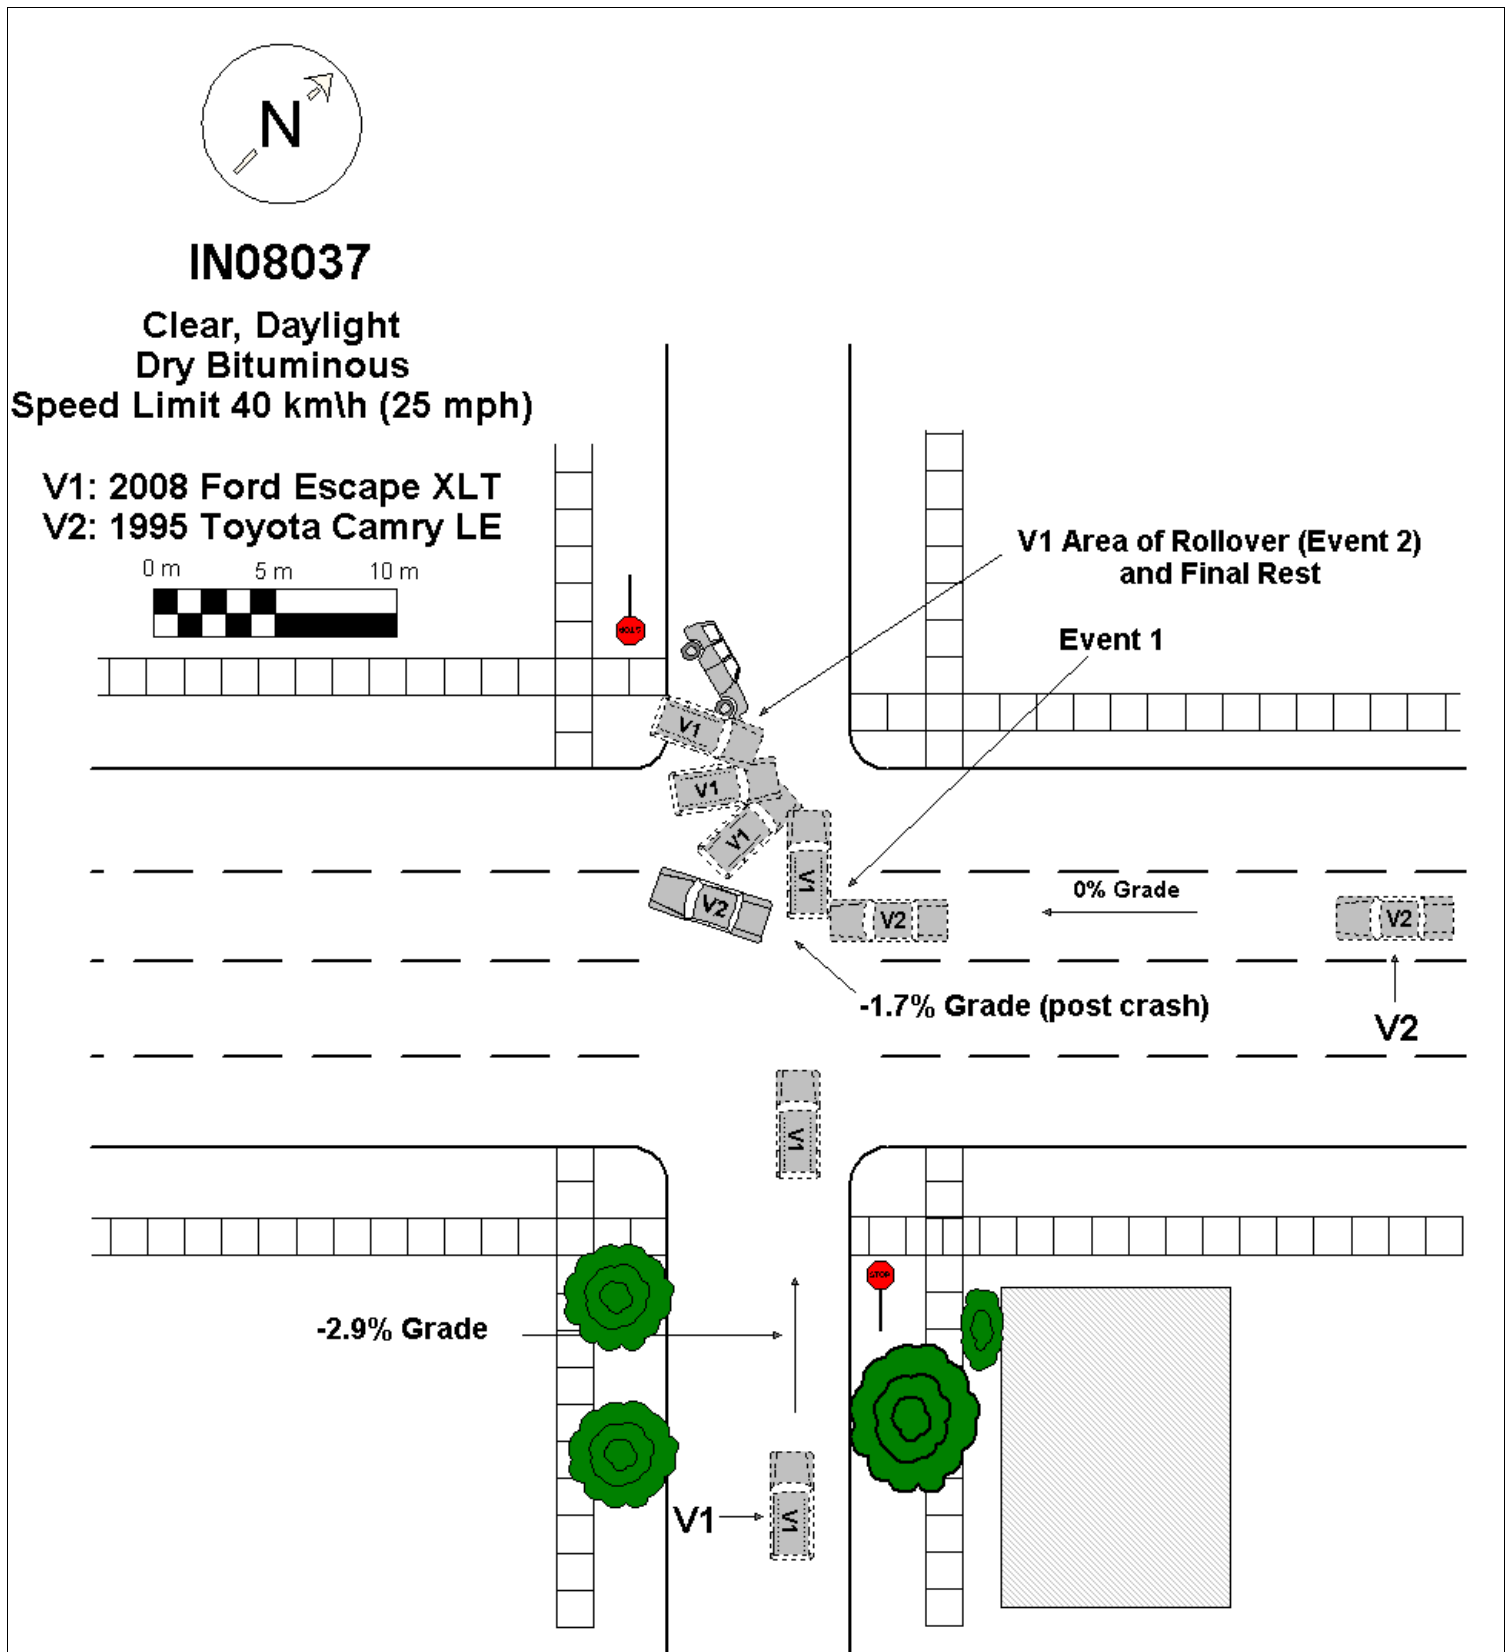
**Crash Environment:** The trafficway on which the Ford was traveling was a 2-lane, undivided, city street, that traversed in a northwest-southeast direction and intersected a 4-lane city street. The trafficway was straight and had one travel lane in each direction. Each travel lane was 3.8 m (12.5 ft) in width. There were no roadway pavement markings and the approach to the intersection was controlled by a stop sign. The Ford had a negative 2.9% grade on the approach to the intersection and a negative 1.7% grade in the area of impact and final rest. The trafficway on which the Toyota was traveling was a 4-lane, undivided, level, one-way, city street, traversing in a southwest direction. Each travel lane was nominally 3.8 m (12.5) in width. The roadway pavement markings consisted of broken white lane lines. At the time of the crash, the light condition was daylight, the atmospheric condition was clear, and the roadway was dry bituminous. The speed limit was 40 km/h (25 mph) for both vehicles. There was light traffic at the time of the crash and the site was urban, residential. See the Crash Diagram on page 8 of this report.
