CALSPAN ON-SITE ROLLOVER CRASH INVESTIGATION
SCI CASE NO.:CA09013

VEHICLE: 2008 CHEVROLET SILVERADO

LOCATION: NORTH CAROLINA

CRASH DATE: JANUARY 2009

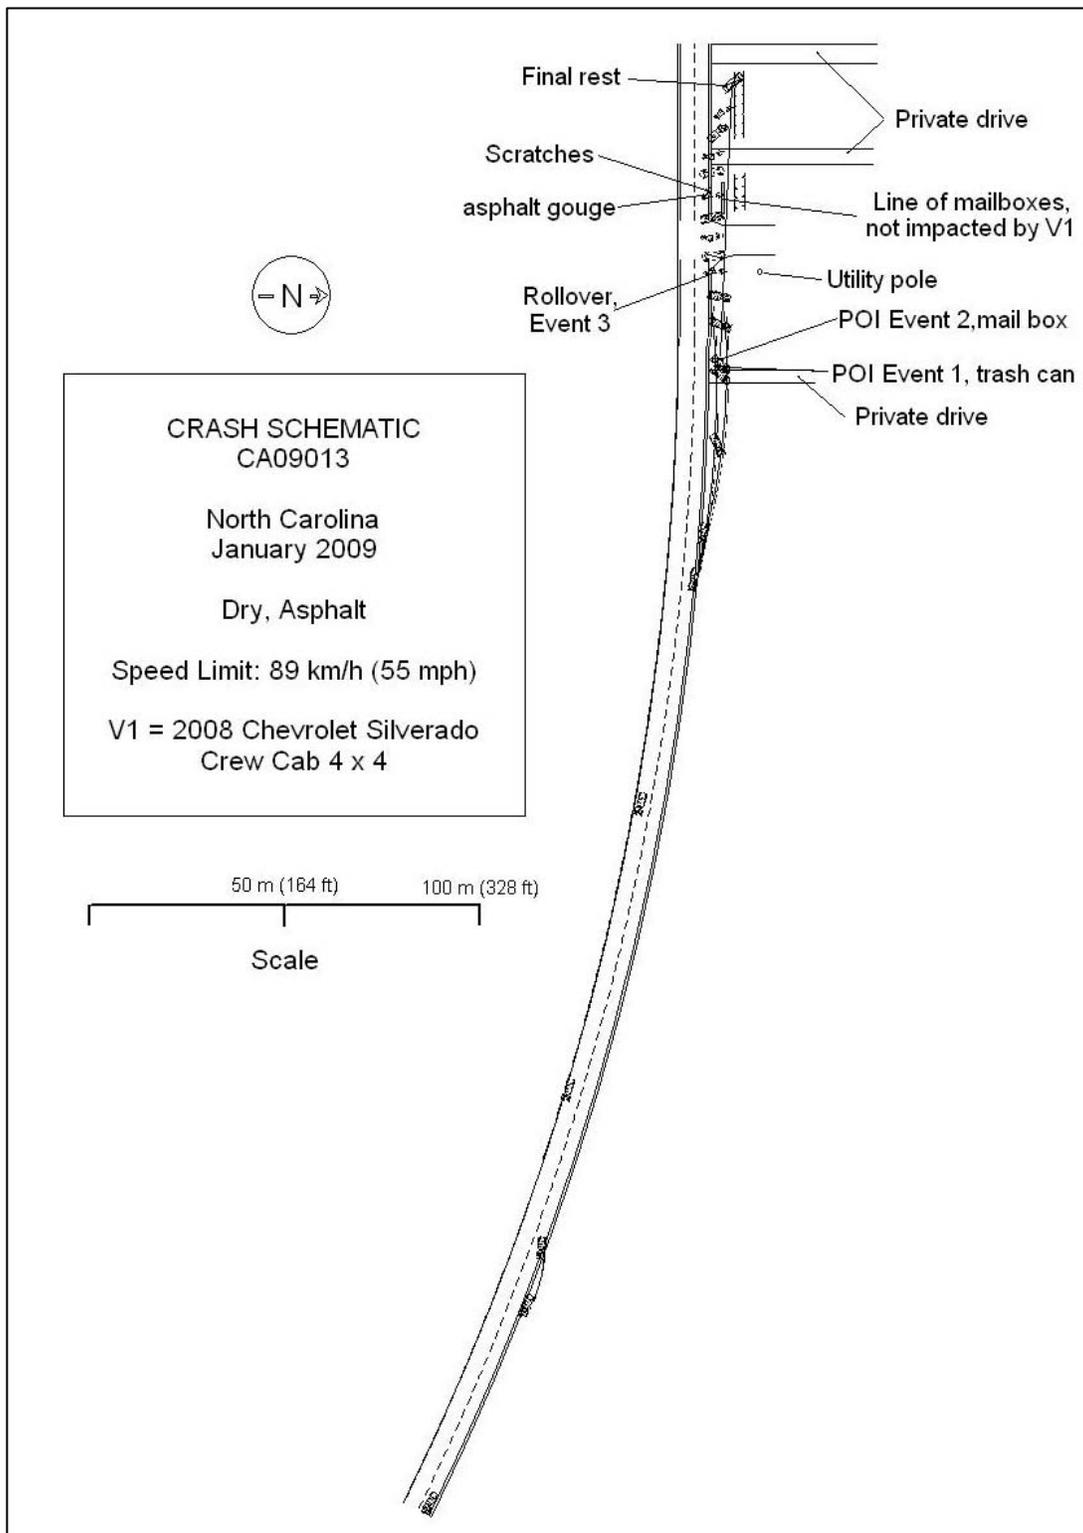
Figure 13: Crash Schematic.

This crash occurred during nighttime hours of January 2009 on the north road side of a four-lane east/west state highway. Lighting conditions were dark, as the rural area was not lighted. The highway consisted of two lanes in each direction. There was a shallow left curve for westbound traffic. The traffic lanes measured 3.7 meters (12.1 feet) in width and were surfaced with asphalt. The east/westbound lanes were separated by a grass median that measured 8.2 meters (26.9 feet) in width. In the westbound direction of travel, the roadway had a positive grade of 1.6 percent and transitioned to a level grade at the mid-point of the curve. The outboard (north) shoulder of the roadway measured 0.7 meters (2.3 feet) in width. The width of the inboard (south) shoulder measured 0.5 meters (1.6 feet). Both shoulders were surfaced with asphalt. The roadside outboard the north shoulder measured approximately 4.5 m (14.8 ft) in width and was sloped away from the pavement for drainage. The slope of the roadside then transitioned into a ditch that was located 7 m (23 ft) north of the road edge. A two-lane road and several private driveways intersected the highway from the north, along the pre-crash trajectory of the Chevrolet. Mailboxes for the respective properties were located 3.1 m (10.2 ft) north of the road edge. The posted speed limit was 89 km/h (55mph). Schematics of the crash site are included at end of this report as **Figures 13 and 14**.

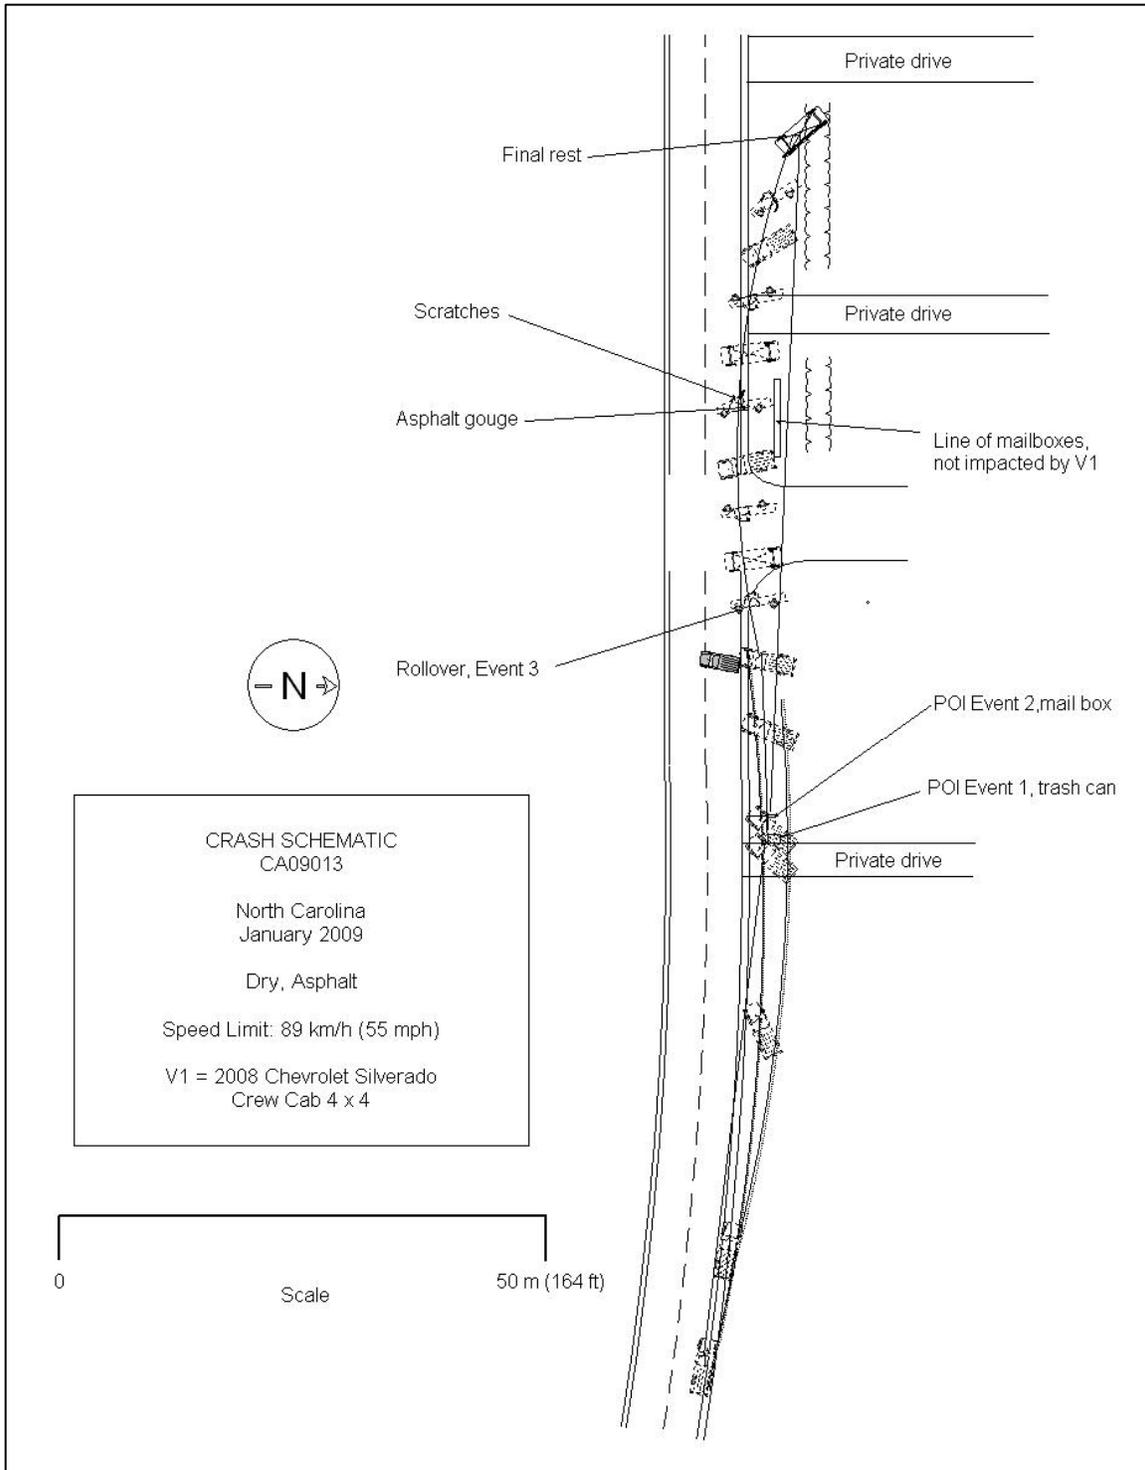
Figure 14: Close-up of rollover sequence.

After the impact with the mailbox, the Chevrolet continued an additional 17.6 m (57.7 ft) and yawed an additional 30 degrees CCW along the road side. The right side tire impressions indicated that the vehicle was on an arcing trajectory heading back toward the road. As the vehicle encountered the pavement edge, the right front wheel rim tripped on an 11 cm (4.3 in) drop off between the asphalt and the dirt/grass roadside. The interaction at the road/rim interface caused the Chevrolet to initiate a right side leading tripped rollover. The location of the edge drop and the start of the rollover are depicted in **Figure 3**.
