Hybrid Vehicle Investigation  
Dynamic Science, Inc. (DSI), Case Number DS09014  
2007 Toyota Prius  
California  
September 2008

1. Report No. DS09014	2. Government Accession No.	3. Recipient Catalog No.	
4. Title and Subtitle  On-Site Hybrid Vehicle Investigation		5. Report Date September 15, 2009

**Dynamic Science, Inc.**  
**Crash Investigation**  
**Case Number: DS09014**

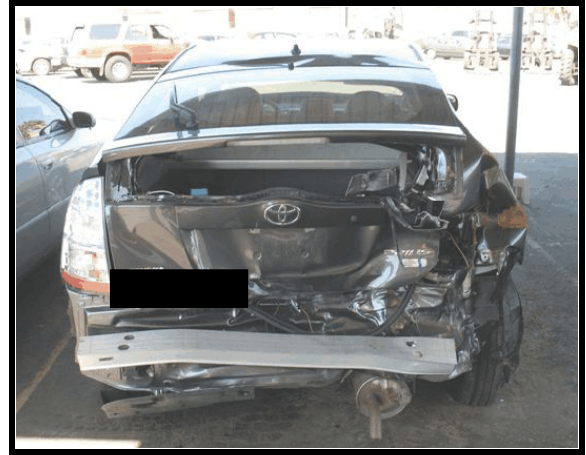
This investigation focused on a 2007 Toyota Prius hybrid vehicle that sustained a back end impact (**Figure 1**). The crash occurred in the southbound lanes of a seven-lane north/south roadway that approached a four-leg intersection. The Toyota was being driven in the second lane from the right by a 52-year-old male. The other vehicle was a 2004 Jeep Wrangler Rubicon that was being driven by a 44-year-old male and occupied by a 42-year-old female front right passenger. The Jeep was traveling behind the Toyota. The driver of the Toyota saw and heard an ambulance in a parking lot to his right. He braked and came to a complete stop at the north limit line of the intersection. The driver of the Jeep braked but did not stop in time and the front end of the Jeep impacted the rear of the Toyota. The drivers of the two vehicles were not injured. The front right passenger of the Jeep complained of pain to her neck and right foot. The Toyota was towed from the scene due to damage and the Jeep was driven from the scene. The Toyota was later declared a total loss by the insurance company.

**Figure 1.** Subject vehicle, 2007 Toyota Prius

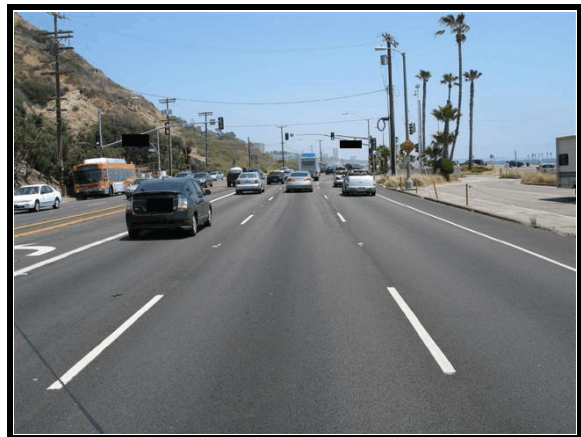
This two-vehicle crash occurred in September 2008 at 0930 hours. The crash occurred in the southbound lanes of a straight seven-lane, divided roadway (**Figure 2**). The roadway approaches a four-leg intersection and was comprised of three southbound travel lanes, a left turn lane, a painted median formed by two sets of double yellow lines, and three northbound travel lanes. The intersection was formed by the north/south roadway, an eastbound roadway, and a westbound entrance into a parking lot. The intersection was controlled by three-phase traffic signals that were green for southbound traffic at the time of the crash. The

**Figure 2.** Southbound approach for Toyota and Jeep

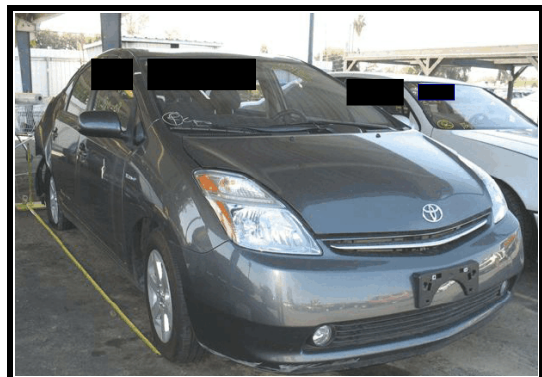
The 2007 Toyota Prius 5-passenger, 4-door hatchback was identified by the Vehicle Identification Number(VIN): JTDKB20U773xxxxxx (**Figure 3**), and was manufactured in May 2007. The Toyota was a gas/electric hybrid vehicle that was equipped with a 1.5-liter, 4-cylinder gasoline engine, an electric drive motor, a continuously variable transmission, front wheel drive, traction control, a regenerative braking system, and a 4-wheel anti-lock brake system. According to the auction facility, the vehicle mileage was 31,970 km (19,866 miles).

**Figure 3.** 2007 Toyota Prius
