On-Site Hybrid Vehicle Investigation  
Dynamic Science, Inc. (DSI), Case Number DS09018  
2007 Toyota Prius  
California  
January 2009

1. Report No. DS09018		2. Government Accession No.		3. Recipient Catalog No.	
4. Title and Subtitle  On-Site Hybrid Vehicle Investigation				5. Report Date April 7, 2010

**Dynamic Science, Inc.  
Crash Investigation  
Case Number: DS09018**

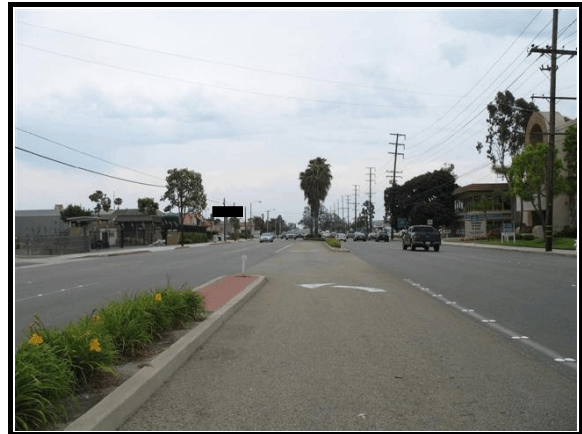
**Figure 3.** West leg of intersection

This three-vehicle crash occurred within a four-leg intersection. At the time of the crash, there were no adverse weather conditions and the asphalt roadway surface was dry. Conditions were dark with streetlights illuminated. The west leg of the intersection was comprised of three eastbound through lanes, a left turn lane, a curbed median, and three westbound travel lanes (**Figure 3**). The east leg of the intersection was comprised of three westbound travel lanes, a left turn lane, a curbed median, and three eastbound travel lanes (**Figure 4**). There were no controls for the east/west roadway and the posted speed limit was 72 km/h (45 mph). The north leg of the intersection was comprised of a southbound travel lane and northbound travel lane. The roadway was controlled by a stop sign and the posted speed limit was 40 km/h (25 mph).
