ON-SITE SIDE IMPACT INFLATABLE OCCUPANT PROTECTION INVESTIGATION

CASE NUMBER - IN09020

VEHICLE - 2008 CADILLAC STS

CRASH DATE - June 2009

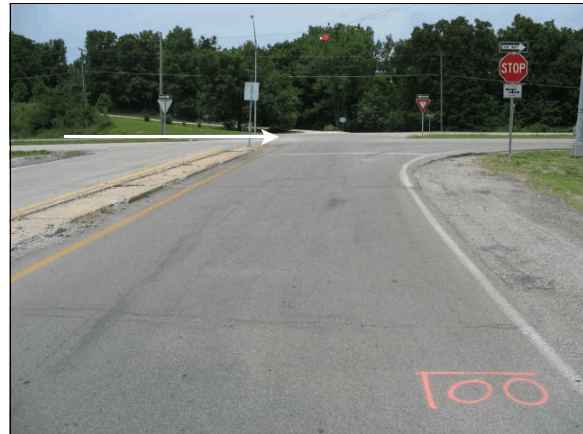
Figure 2: Approach of the Cadillac to the intersection with the U.S. highway; arrow shows approach of the Dodge; number shows feet to the area of impact

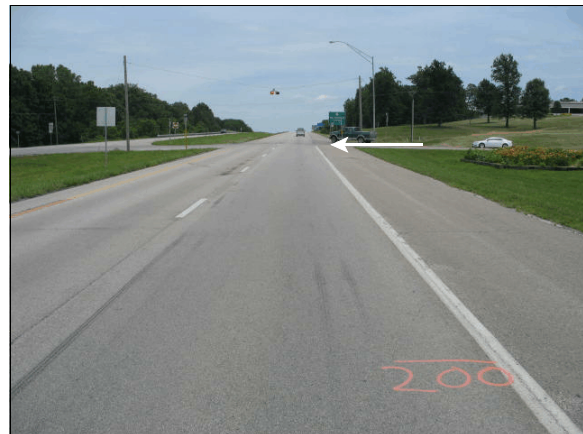
Figure 3: Approach of the Dodge to the intersection; arrow show approach of the Cadillac

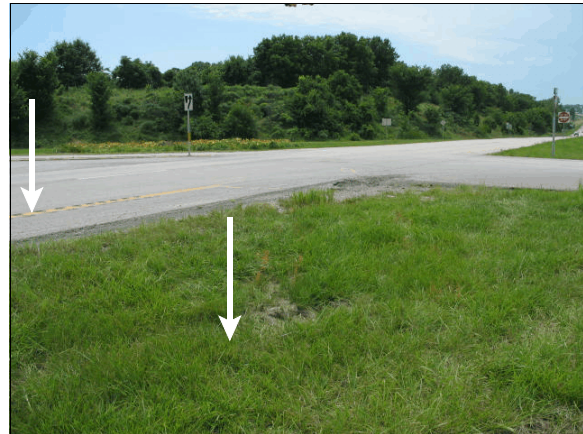
Figure 5: View back to impact area; arrow on left shows area of final rest of the Dodge; arrow on right shows area of final rest of the Cadillac

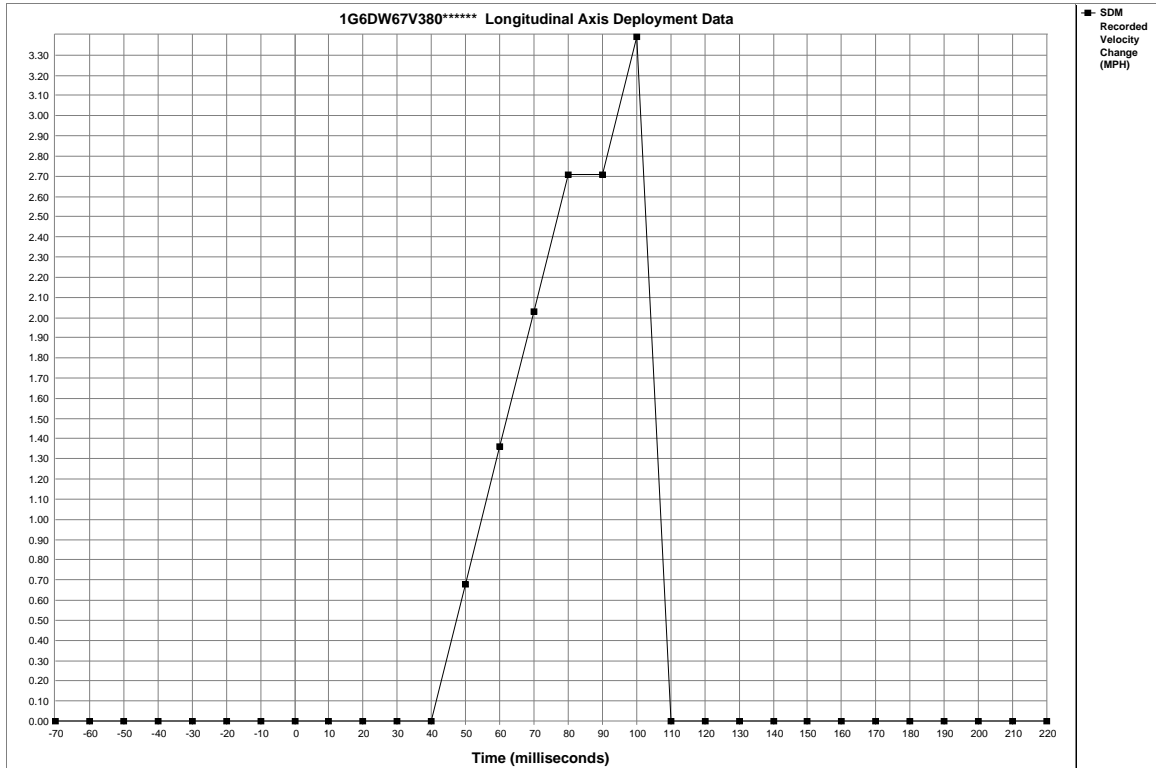
Time (milliseconds)	-70	-60	-50	-40	-30	-20	-10	0	10	20	30	40	50	60	70
SDM Longitudinal Axis Recorded Velocity Change (MPH)	0.00	0.00	0.00	0.00	0.00	0.00	0.00	0.00	0.00	0.00	0.00	0.00	0.68	1.36	2.03
Time (milliseconds)	80	90	100	110	120	130	140	150	160	170	180	190	200	210	220
SDM Longitudinal Axis Recorded Velocity Change (MPH)	2.71	2.71	3.39	0.00	0.00	0.00	0.00	0.00	0.00	0.00	0.00	0.00	0.00	0.00	0.00

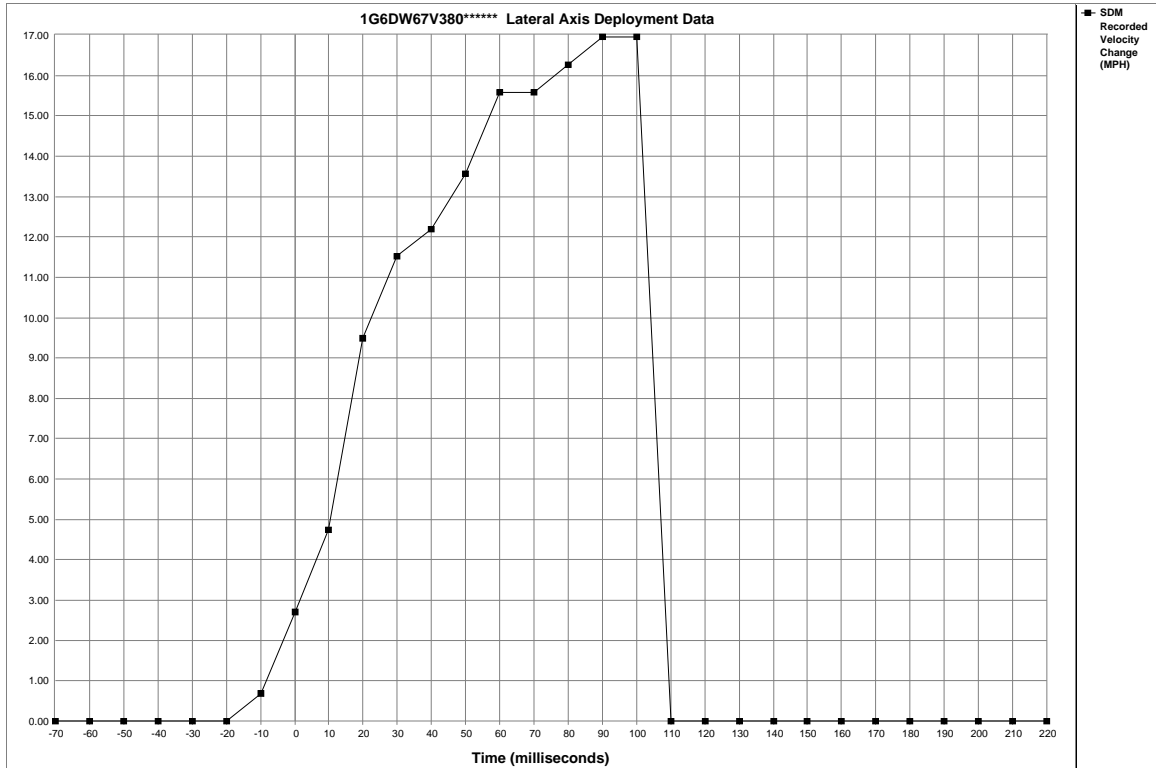
Time (milliseconds)	-70	-60	-50	-40	-30	-20	-10	0	10	20	30	40	50	60	70
SDM Lateral Axis Recorded Velocity Change (MPH)	0.00	0.00	0.00	0.00	0.00	0.00	0.68	2.71	4.74	9.49	11.52	12.20	13.56	15.59	15.59
Time (milliseconds)	80	90	100	110	120	130	140	150	160	170	180	190	200	210	220
SDM Lateral Axis Recorded Velocity Change (MPH)	16.27	16.95	16.95	0.00	0.00	0.00	0.00	0.00	0.00	0.00	0.00	0.00	0.00	0.00	0.00
