CALSPAN ON-SITE CHILD RESTRAINT SYSTEM CRASH INVESTIGATION

SCI CASE NO: CA09023

VEHICLE: 2007 SATURN ION

CRASH DATE: APRIL 2009

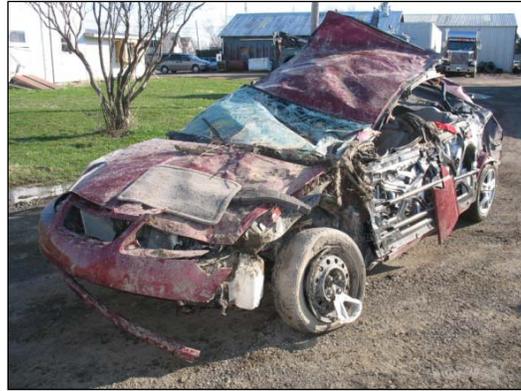
Figure 1: Front left oblique view of the 2007 Saturn ION.

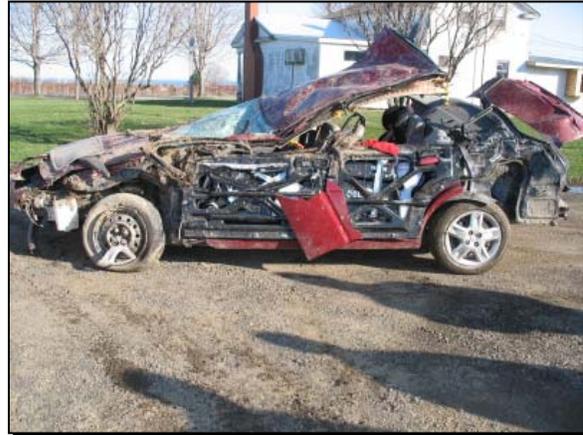
Figure 2: Left side view of the Saturn.

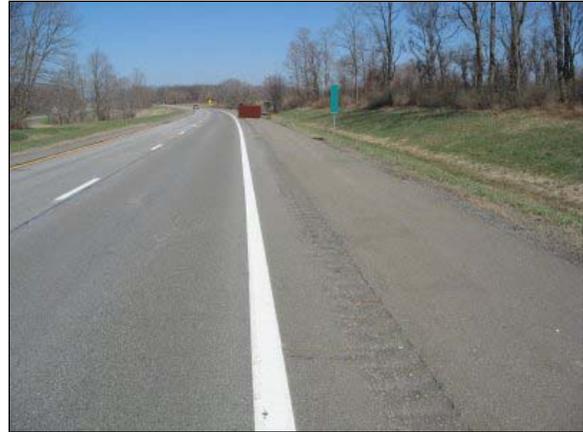
roadway alignment was curved to the left for eastbound traffic. The eastbound travel lanes (**Figure 3**) measured 3.7 m (12.1 ft) in width and were bordered by asphalt shoulders, each of which contained a rumble strip. The south shoulder measured 3.5 m (11.5 ft) in width while the north shoulder was 0.9 m (3.0 ft) wide. The opposing westbound travel lanes were separated by a grassy median populated with trees.

Figure 3: Eastbound travel lanes depicting the Saturn's pre-crash path of travel.

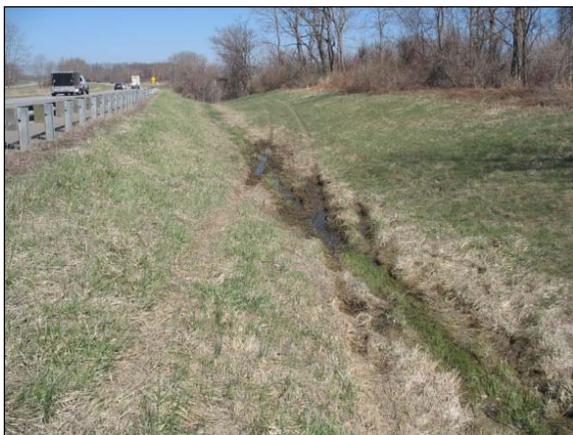
Outboard the south shoulder was a grass embankment that formed a swale. The swale was oriented parallel to the interstate and had a negative slope in the easterly direction. The centerline of the swale was located 6.5 m (21.3 ft) south of the road edge. The Saturn's off-road path of travel was evidenced by tracking/rotating tire marks that initially crossed through swale and then arced back to the left along the embankment (**Figure 4**) toward the centerline of the swale. The swale terminated 135 m (443 ft) from the road departure in a growth of brush and small trees. To the east beyond the end of the swale was a ravine that was approximately 15 m (50 ft) deep. **Figure 5** is a look back view across the ravine toward the end of the swale and the vehicle's off-road trajectory. At the bottom of the ravine was a drainage culvert that passed under the interstate (**Figure 6**). The culvert was protected on three sides by a 1.8 m (6 ft) tall concrete headwall. The center of the culvert was located 150 m (492 ft) east of the road departure point. The terrain east of the culvert, in the area of the vehicle's final rest, had an estimated negative 5 percent grade to the south and contained dispersed patches of small trees and brush. Schematics of the crash site are included as **Figures 21 and 22** of this report.

Figure 4: Off-road trajectory of the Saturn crossing through the swale and along the embankment.

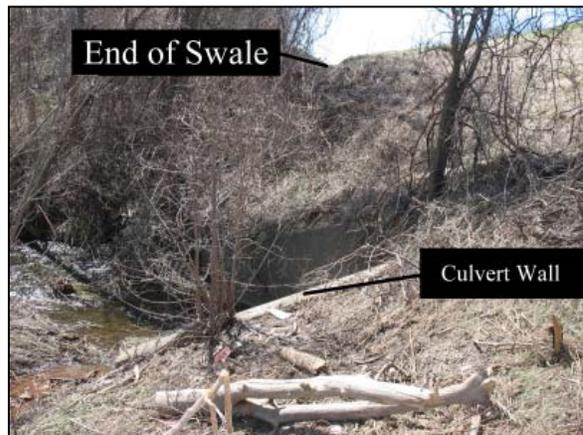
Figure 5: Look back view from the base of the ravine toward the end of the swale and the Saturn's trajectory.

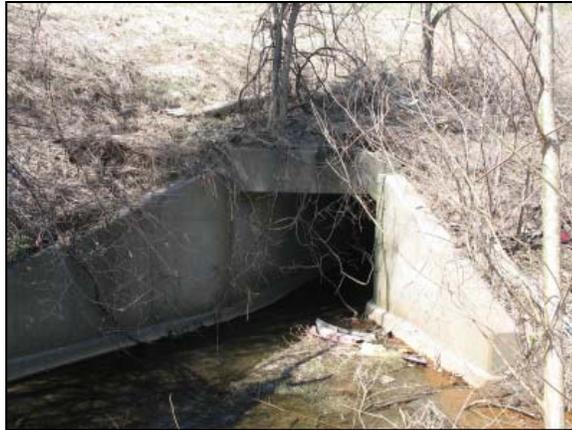
Figure 6: Northward view of the culvert and its headwalls.

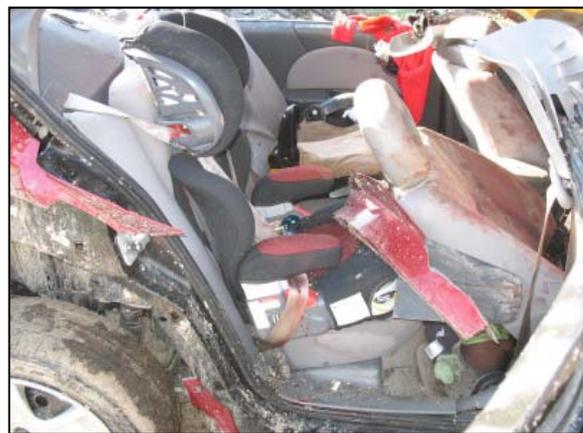
Two child restraint systems were in use at the time of the crash and were still located within the second row of the Saturn at the time of the SCI inspection. **Figure 14** is a right lateral interior view of the vehicle's second row interior. The first CRS was identified as an Eddie Bauer, Auto Booster™ backless booster seat with a labeled model number of "22828 SON". The 6-year-old female passenger, seated within the second row left seat position, occupied this CRS at the time of the crash. The second CRS was identified as a Graco, TurboBooster™ high-back booster seat with a labeled model number of "8693 GLY". The 4-year-old male passenger, seated within the second row right seat position, occupied this CRS at the time of the crash. Both CRS's were removed from the Saturn for further SCI inspection.

Figure 14: Right lateral interior view of the Saturn depicting the position of the CRS's.

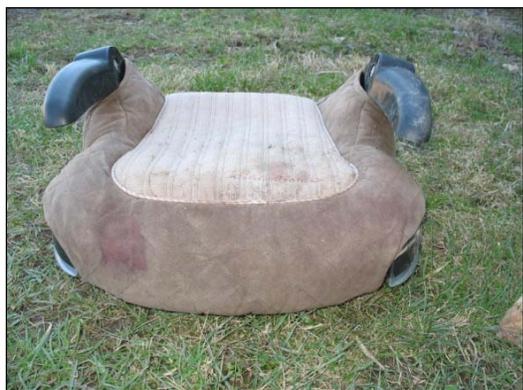
The Eddie Bower backless CRS (**Figure 15**) was manufactured on June 21, 2007 and consisted of a single black plastic shell base with adjustable plastic armrests. The CRS was labeled for use by children over 1 year of age with a height of 109 to 145 cm (43 to 57 in) and weight of 18 to 45 kg (40 to 100 lb) and were to utilize the vehicle's 3-point lap and shoulder belt. The base was covered with a quilted brown and tan fabric cover, which was held in place with two posterior mounted bilateral elastic bands. The seat cover contained dirt and blood stains to its forward aspect. The left plastic armrest was also soiled with dirt and exhibited scuff marks. The CRS appeared to be structurally intact while maintaining its symmetrical shape; however, once the seat cover was removed the left armrest was found to be slightly deformed and separated from the plastic base (**Figure 16**), which indicated that the occupant loaded the CRS during the crash sequence.

Figure 15: Front view of the Eddie Bauer backless CRS used by the 6-year-old female in the second row left position.

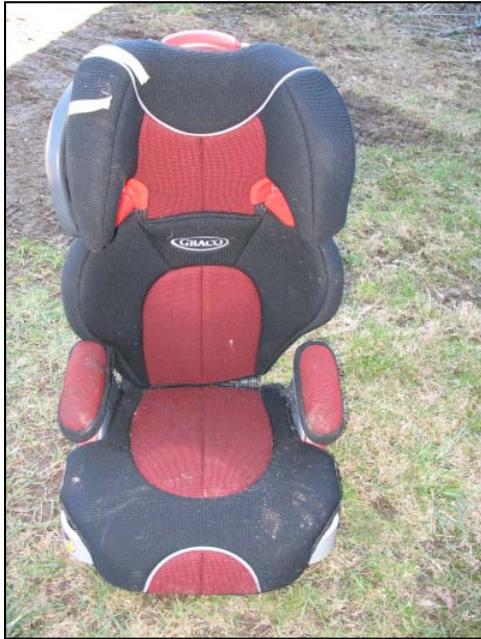
The Graco high-back CRS (**Figure 17**) was manufactured on November 8, 2006. This CRS was designed with a detachable back support and could be used in the high-back or backless mode. The CRS was labeled for use by children from 3 to 10 years of age with the high-back in use and from 4 to 10 years of age without the back support. The child utilized the vehicle's 3-point lap and shoulder belt for restraint. With the high-back in use, the CRS was rated for a child with a height of 97 to 145 cm (38 to 57 in) and a weight of 14 to 45 kg (30 to 100 lb).

The CRS appeared to be structurally undamaged at initial inspection. The seat cover and padded armrests of the CRS contained dirt and blood stains. However, once the fabric coverings were removed the styro-foam insert in the upper aspect of the high-back exhibited bilateral vertical cracks (**Figure 18**), which separated this component into three separate pieces. Additionally, light discolorations in the upper plastic shell were observed, which indicated that the plastic material had been subjected to loading. Further, it was determined that the hinge system connecting the back support to the base was deformed and disjointed from the same impact

forces. A scuff mark to the fabric covering at the outboard wing of the back support was also identified. The damage to the CRS was directly associated to the vertical intrusion of the roof and right side rail during the crash.

Figure 17: Front view of the Graco high-back CRS used by the 4-year-old male in the second row right position.
