On-Site Side Air Bag Investigation
Dynamic Science, Inc. (DSI), Case Number DS09029
2007 Dodge Nitro
Arizona
July 2009

**Dynamic Science, Inc.
Crash Investigation
Case Number: DS09029**

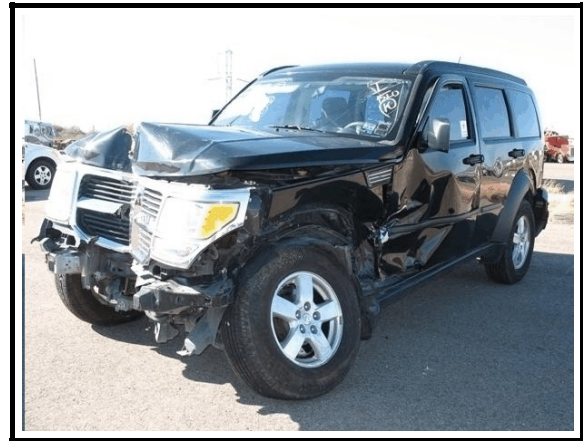
Figure 1. Subject vehicle, 2007 Dodge Nitro

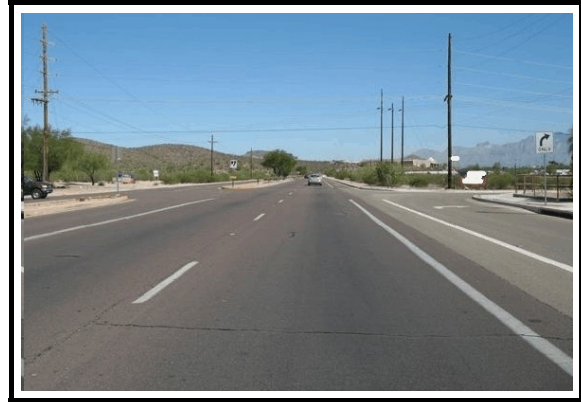
The Dodge was traveling northbound (**Figure 2**) and the Buick was traveling eastbound. The northbound roadway configuration was as follows: a right turn lane measuring 5.0 m (16.5 ft) in width, a bike lane measuring 1.8 m (6.0 ft), two through lanes measuring 3.7 m (12.0 ft) and 4.3 m (14.0 ft), respectively, a left turn lane measuring 3.9 m (12.8 ft), and a raised median strip measuring 3.5 m (11.6 ft).

Figure 2. Subject vehicle northbound approach view
