On-Site Side Air Bag Investigation
Dynamic Science, Inc. (DSI), Case Number DS09032
2007 Honda Accord
Washington
September 2009

1. Report No. DS09032	2. Government Accession No.		3. Recipient Catalog No.	
4. Title and Subtitle On-Site Side Air Bag Investigation		5. Report Date August 27, 2010

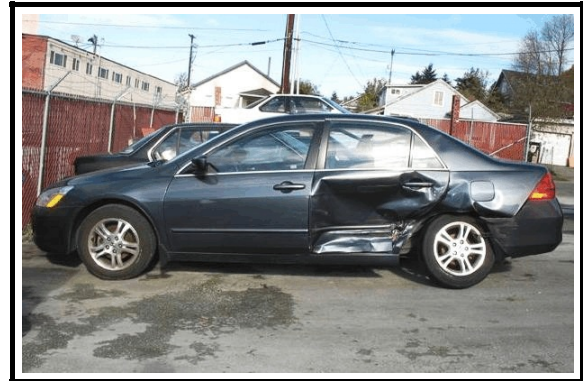
Figure 1. Subject vehicle, 2007 Honda Accord

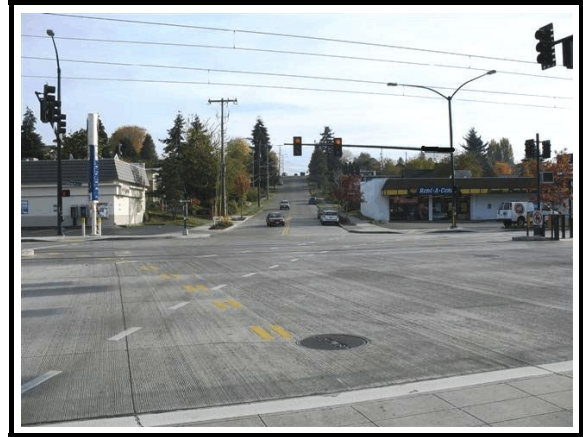
The crash occurred in a four-leg intersection consisting of a divided north/south roadway and an undivided east/west roadway (**Figure 2**). The north/south roadway was configured with two through lanes and one left turn lane for each direction of travel and was divided by two light rail train tracks on a raised center median. All northbound and southbound lanes approaching the intersection measured 3.4 m (11.0 ft) in width. The through lanes were separated by dashed white stripes and

the left turn lanes were separated by solid white stripes. The concrete roadway was straight and level. Outboard of the through lanes were raised concrete curbs and paved sidewalks. Inboard of the left turn lanes was a raised concrete median consisting of a paved surface and two light rail train tracks aligned parallel to the north/south roadway.

The east/west roadway consisted of one lane for each direction of travel separated by solid double yellow stripes. The east leg intersected the northbound roadway at a 110-degree angle. The west leg intersected the southbound roadway at a 100-degree angle.

Figure 2. Crash site, looking east

The intersection was controlled by three-phase traffic signals that utilized leading green arrows for the left turn lanes. Additionally, illuminated signs signaled the approach of trains for the northbound and southbound travel lanes. At the time of the crash the weather was clear, light conditions were daylight, and the roadway was dry. The posted speed limit at this location was 56 km/h (35 mph).
