On-Site Child Restraint System Investigation
Dynamic Science, Inc. (DSI), Case Number DS09036
2002 Nissan Xterra
Oregon
November 2009

| 16. Abstract This on-site child restraint system (CRS) investigation focused on the occupants and Infant Safety Seat (ISS) in a 2002 Nissan Xterra sport utility vehicle that was involved in a side impact crash. The vehicle was being driven by a restrained 21-year-old female. The front right seat of the Nissan was occupied by a restrained 55-year-old female and the second row left seat was occupied by a restrained 28-year-old female. The second row right seat was occupied by a 1-month-old female who was seated in the rear-facing ISS. The other vehicle was a 1979 GMC pickup that was being driven by a 75-year-old male. The crash occurred in the northbound lane of a state highway. The Nissan was traveling southbound and the GMC was traveling northbound. The driver of the Nissan lost control of the vehicle, initiated a counterclockwise rotation, and entered the northbound travel lane. The front of the GMC impacted the right side of the Nissan. The driver of the Nissan sustained moderate injuries and was transported to a local hospital where she was tre

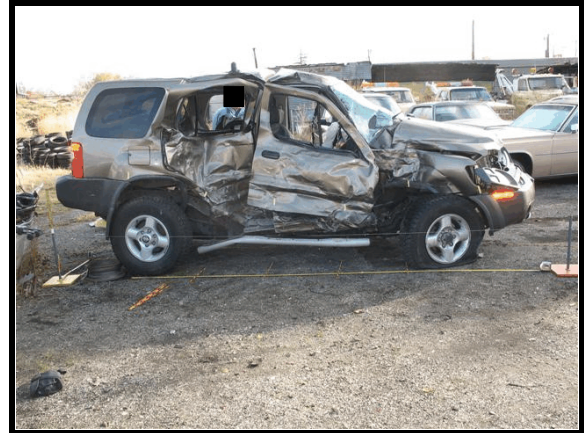
This on-site Child Restraint System (CRS) investigation focused on the occupants and Infant Safety Seat (ISS) in a 2002 Nissan Xterra sport utility vehicle that was involved in a side impact crash (**Figure 1**). The crash occurred in November 2009 at 1000 hours. The vehicle was being driven by a restrained 21-year-old female. The front right seat of the Nissan was occupied by a restrained 55-year-old female and the second row left seat was occupied by a restrained 28-year-old female. The second row right seat was occupied by a 1-month-old female who was seated in the rear-facing ISS. The ISS was anchored to the vehicle using the Lower Anchors and Tethers for Children (LATCH) hardware. The other vehicle was a 1979 GMC Sierra Grande pickup with a slide-in camper that was being driven by a 75-year-old male.

Figure 1. Subject vehicle, 2002 Nissan Xterra

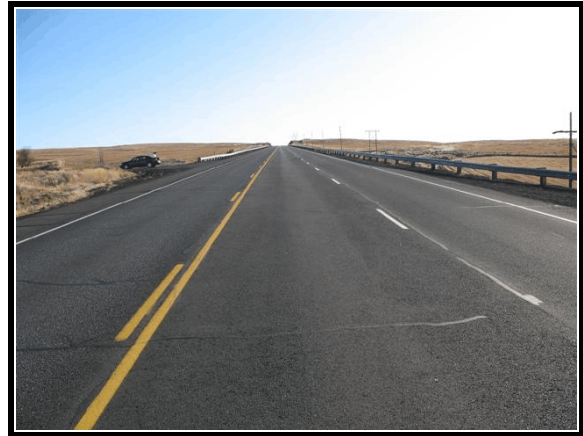
The crash site was a north/south three-lane undivided state highway that was bordered on both sides by paved asphalt shoulders and metal guardrails (**Figure 2**). There were two southbound lanes that

Figure 2. Southbound approach, subject vehicle

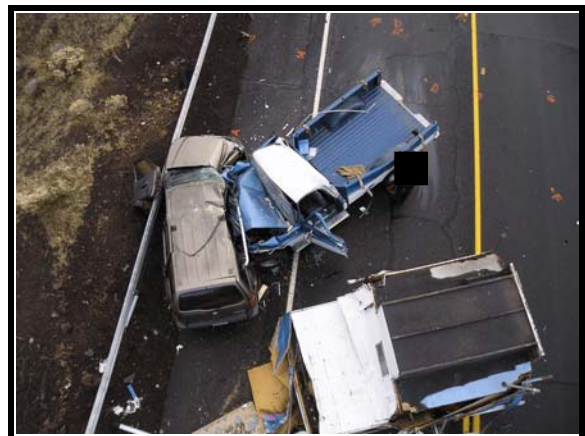
The Nissan came to rest against the guardrail facing south and the GMC came to rest against the Nissan facing northeast (**Figure 3**). The Nissan's right side doors and left front door were jammed shut. The driver of the Nissan sustained moderate injuries and was reported to have been unconscious at the scene. She was extricated by emergency personnel and transported to a local hospital where she arrived with a Glasgow Coma Score (GCS) of 15. She was treated at the hospital and then released.

Figure 3. Final rest (police photo)
