**CALSPAN ON-SITE HYBRID VEHICLE CRASH INVESTIGATION
SCI CASE NO.: CA09048**

VEHICLE: 2006 TOYOTA PRIUS HATCHBACK

LOCATION: NORTH CAROLINA

CRASH DATE: JUNE 2009

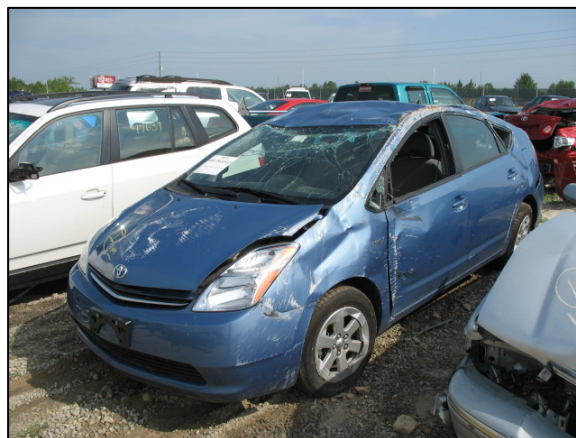
Figure 1: Left front oblique view of the 2006 Toyota Prius.

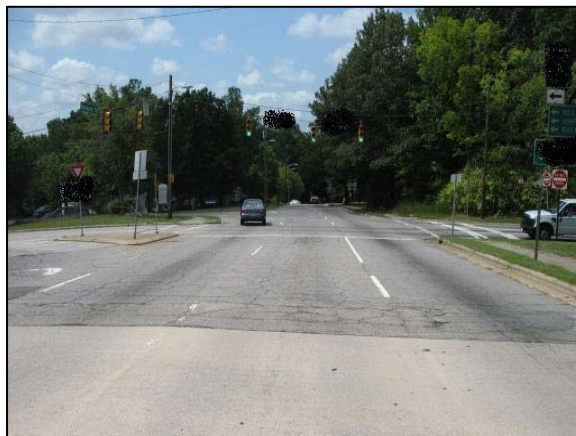
Figure 2: Southbound approach to the intersection.

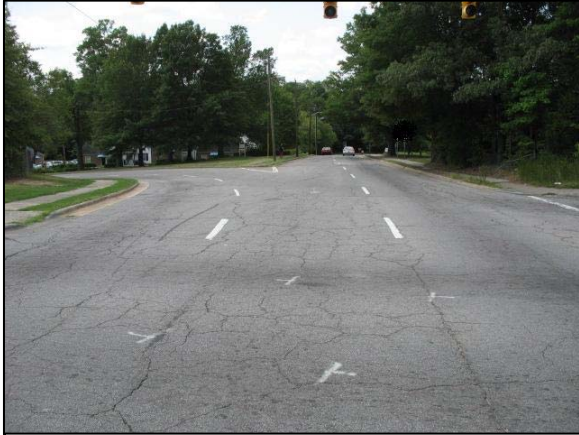
The front of the Chevrolet impacted the rear aspect of the right side of the Toyota (Event 1), within the center of the intersection. The damage to the Toyota began aft of the B-pillar and included the right rear wheel. The direction of force was within the 2 o'clock sector for the Toyota and within the 11 o'clock sector for the Chevrolet. The damage algorithm of the WinSMASH program was used to calculate the crash severity (delta-V) of the crash. The total delta-V for the Toyota Prius was 11 km/h (6.8 mph). The longitudinal and lateral components for the Toyota were -8.4 km/h (-5.2 mph) and -7.1 km/h (-4.4 mph), respectively. The total delta-V for the Chevrolet Malibu was 10 km/h (6.2 mph) with longitudinal and lateral components of -7.7 km/h (-4.8 mph) and +6.4 km/h (+4.0 mph), respectively. The EDR reported delta-V components for the Chevrolet were -6.6 km/h (-4.1 mph) longitudinal and 1.1 km/h (0.7 mph) lateral. **Figure 3** is a view of the initial impact location.

Figure 3: Southbound trajectory view of the area of initial impact.

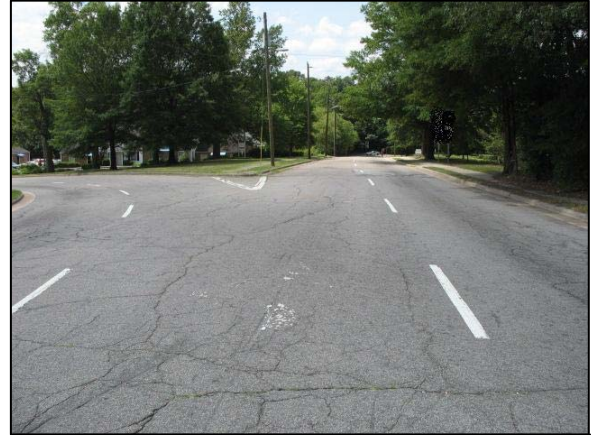
The force of the impact rearward of the Toyota's center of gravity induced a clockwise (CW) rotation to the Toyota within the intersection. The Toyota rotated approximately 80 degrees CW and traveled approximately 14 m (45.9 ft) south of the impact where the left side tires folded under the alloy wheels exposing the rim beads to the asphalt road surface. The rim beads contacted the road surface and tripped the vehicle into a left side leading rollover event (Event 2). The Toyota rolled two-quarter turns to the left over a distance of 6 m (19.7 ft), coming to rest on its roof. The rollover was not interrupted. **Figure 4** is a view of the location of the rollover of the Toyota. The Toyota came to rest on its roof on the roadway facing west. The Chevrolet came to rest at the east curb line, facing south.

Figure 4: Southbound view at the location of the Toyota rollover.

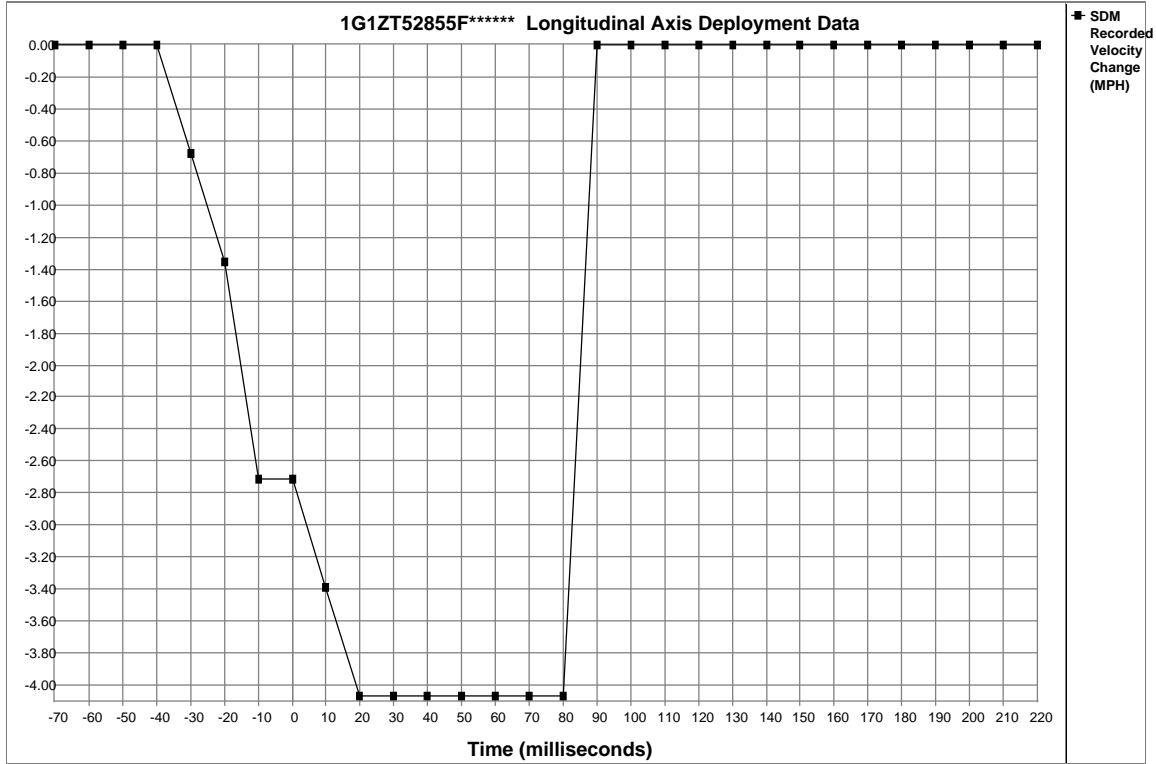
Time (milliseconds)	-70	-60	-50	-40	-30	-20	-10	0	10	20	30	40	50	60	70
SDM Longitudinal Axis Recorded Velocity Change (MPH)	0.00	0.00	0.00	0.00	-0.68	-1.36	-2.71	-2.71	-3.39	-4.07	-4.07	-4.07	-4.07	-4.07	-4.07
Time (milliseconds)	80	90	100	110	120	130	140	150	160	170	180	190	200	210	220
SDM Longitudinal Axis Recorded Velocity Change (MPH)	-4.07	0.00	0.00	0.00	0.00	0.00	0.00	0.00	0.00	0.00	0.00	0.00	0.00	0.00	0.00

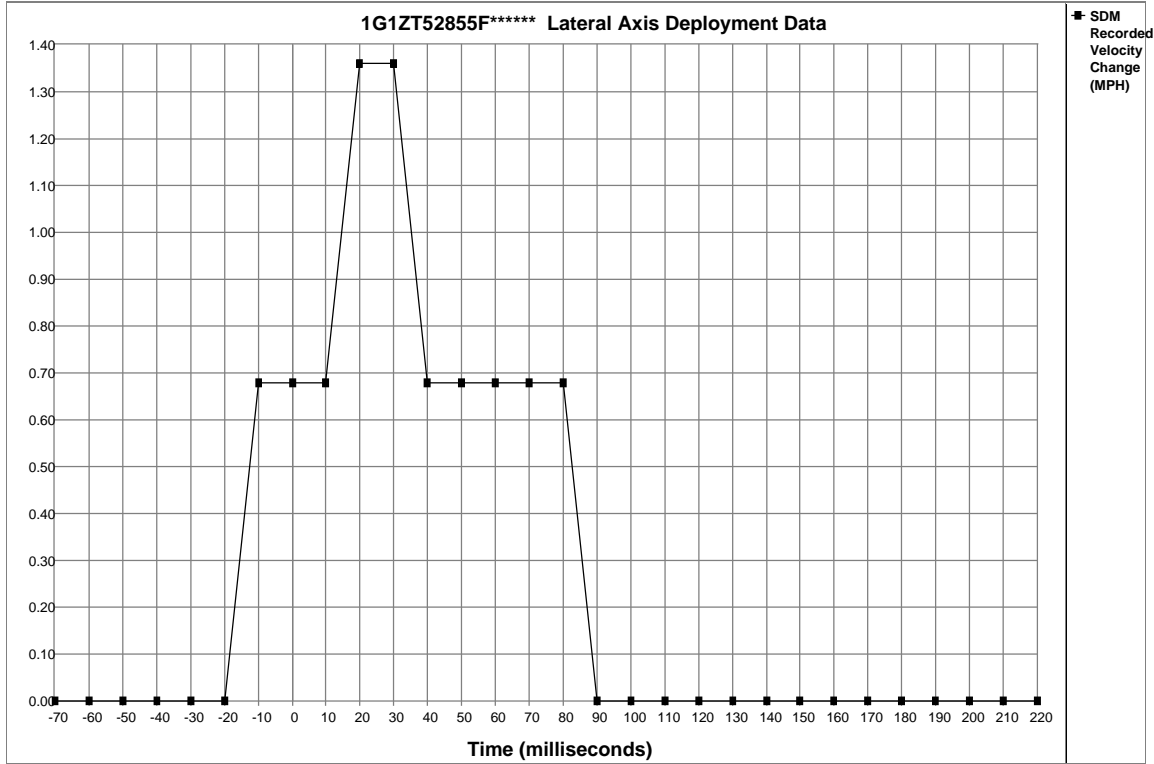
Time (milliseconds)	-70	-60	-50	-40	-30	-20	-10	0	10	20	30	40	50	60	70
SDM Lateral Axis Recorded Velocity Change (MPH)	0.00	0.00	0.00	0.00	0.00	0.00	0.68	0.68	0.68	1.36	1.36	0.68	0.68	0.68	0.68
Time (milliseconds)	80	90	100	110	120	130	140	150	160	170	180	190	200	210	220
SDM Lateral Axis Recorded Velocity Change (MPH)	0.68	0.00	0.00	0.00	0.00	0.00	0.00	0.00	0.00	0.00	0.00	0.00	0.00	0.00	0.00
