**CALSPAN ON-SITE ROLLOVER CRASH INVESTIGATION**  
**SCI CASE NO: CA09065**

**VEHICLE: 2007 DODGE CARAVAN**  
**LOCATION: PENNSYLVANIA**  
**DATE: AUGUST 2009**

1. Report No. CA09065	2. Government Accession No.	3. Recipient's Catalog No.	
4. Title and Subtitle Calspan On-Site Rollover Crash Investigation Vehicle: 2007 Dodge Caravan Location: Pennsylvania		5. Report Date: May 2010

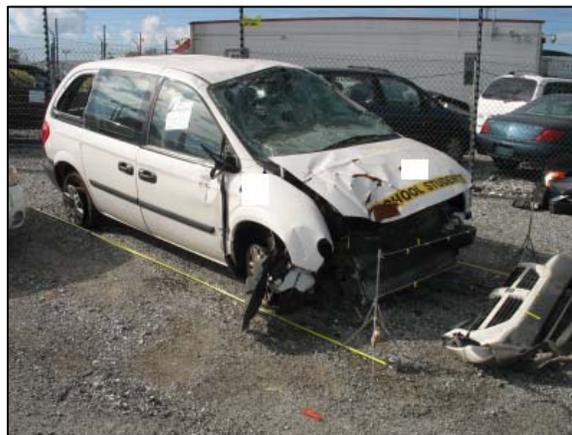
This investigation focused on the roadside departure fixed object/rollover crash of a 2007 Dodge Caravan. **Figure 1** is a front right oblique view of the Dodge. The Dodge was equipped with a Certified Advanced 208-Compliant (CAC) front air bag system and a driver knee air bag. It was not equipped with side impact air bags or Inflatable Curtain air bags. The crash occurred on the south road side of a 2-lane divided east/west state roadway located in a suburban setting. The Dodge was eastbound driven by a 48-year-old female. The police investigation determined the driver was distracted using her cellular telephone immediately prior to the crash. The Dodge drifted to the right where the right wheels struck and mounted the right curb. The vehicle continued forward on the roadside and struck a utility pole with the right aspect of its front plane. The force of the impact resulted in the deployment of the CAC driver air bag and the driver knee air bag. The offset impact initiated a clockwise (CW) rotation of the vehicle. The Dodge then tripped over the left right tire and rolled over 4-quarter turns coming to rest on its wheels straddling the curb. The driver sustained minor soft tissue injuries and was transported by ground ambulance to a local hospital where she was treated and released.

**Figure 1: Front right oblique view of the Dodge.**

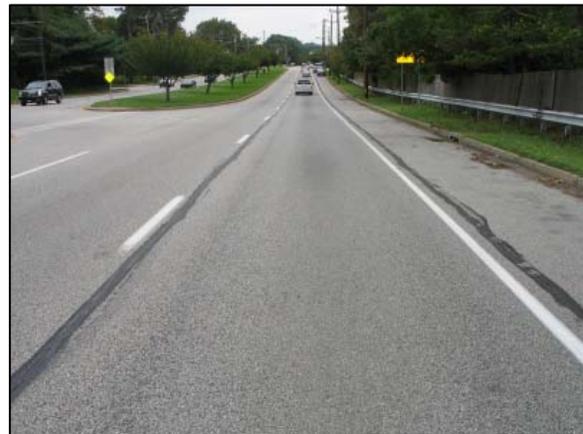
This crash occurred during the daylight hours of August 2009. At the time of the crash, the environmental conditions were reported as clear and dry. The crash site consisted of a 2-lane divided east/west state roadway located in a suburban setting. **Figure 2** is an eastbound trajectory view approaching the point of impact. There was a negative 7 percent (-7%) grade along the Dodge's pre-crash trajectory. The grade at the point of impact and subsequent rollover measured negative 2 percent (-2%). The total width of the eastbound lanes measured 7.0 m (23.0 ft). The width of the south shoulder measured 3.0 m (9.8 ft). The shoulder was bordered by a 15 cm (6 in) barrier curb. A wooden utility pole located along the south roadside was identified in the police report as the

**Figure 2: Eastbound trajectory view 45 m (148 ft) from the point of impact.**

point of impact. The pole had recently been replaced as evidenced by the disturbed earth surrounding the pole. The posted speed limit was 64 km/h (40 mph).

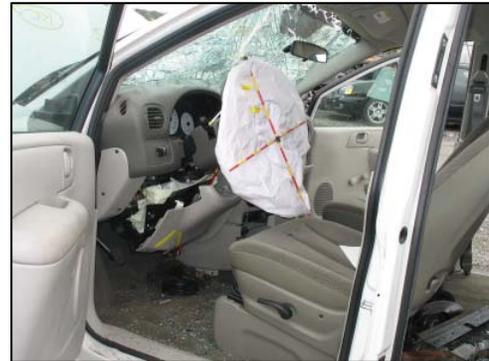
The manual driver seat was located in a full-rear track position as the time of the SCI inspection. It could not be verified if this was the at-crash track position. The total seat track travel measured 22 cm (8.8 in). The seat back angle measured 15 degrees aft of vertical. The adjustable head restraint was in the full-down position. The horizontal distance from the driver air bag module to the seat back measured 65 cm (25.5 in). This distance was measured 41 cm (16.0 in) above the seat bight.

**Figure 6: View of the driver interior.**

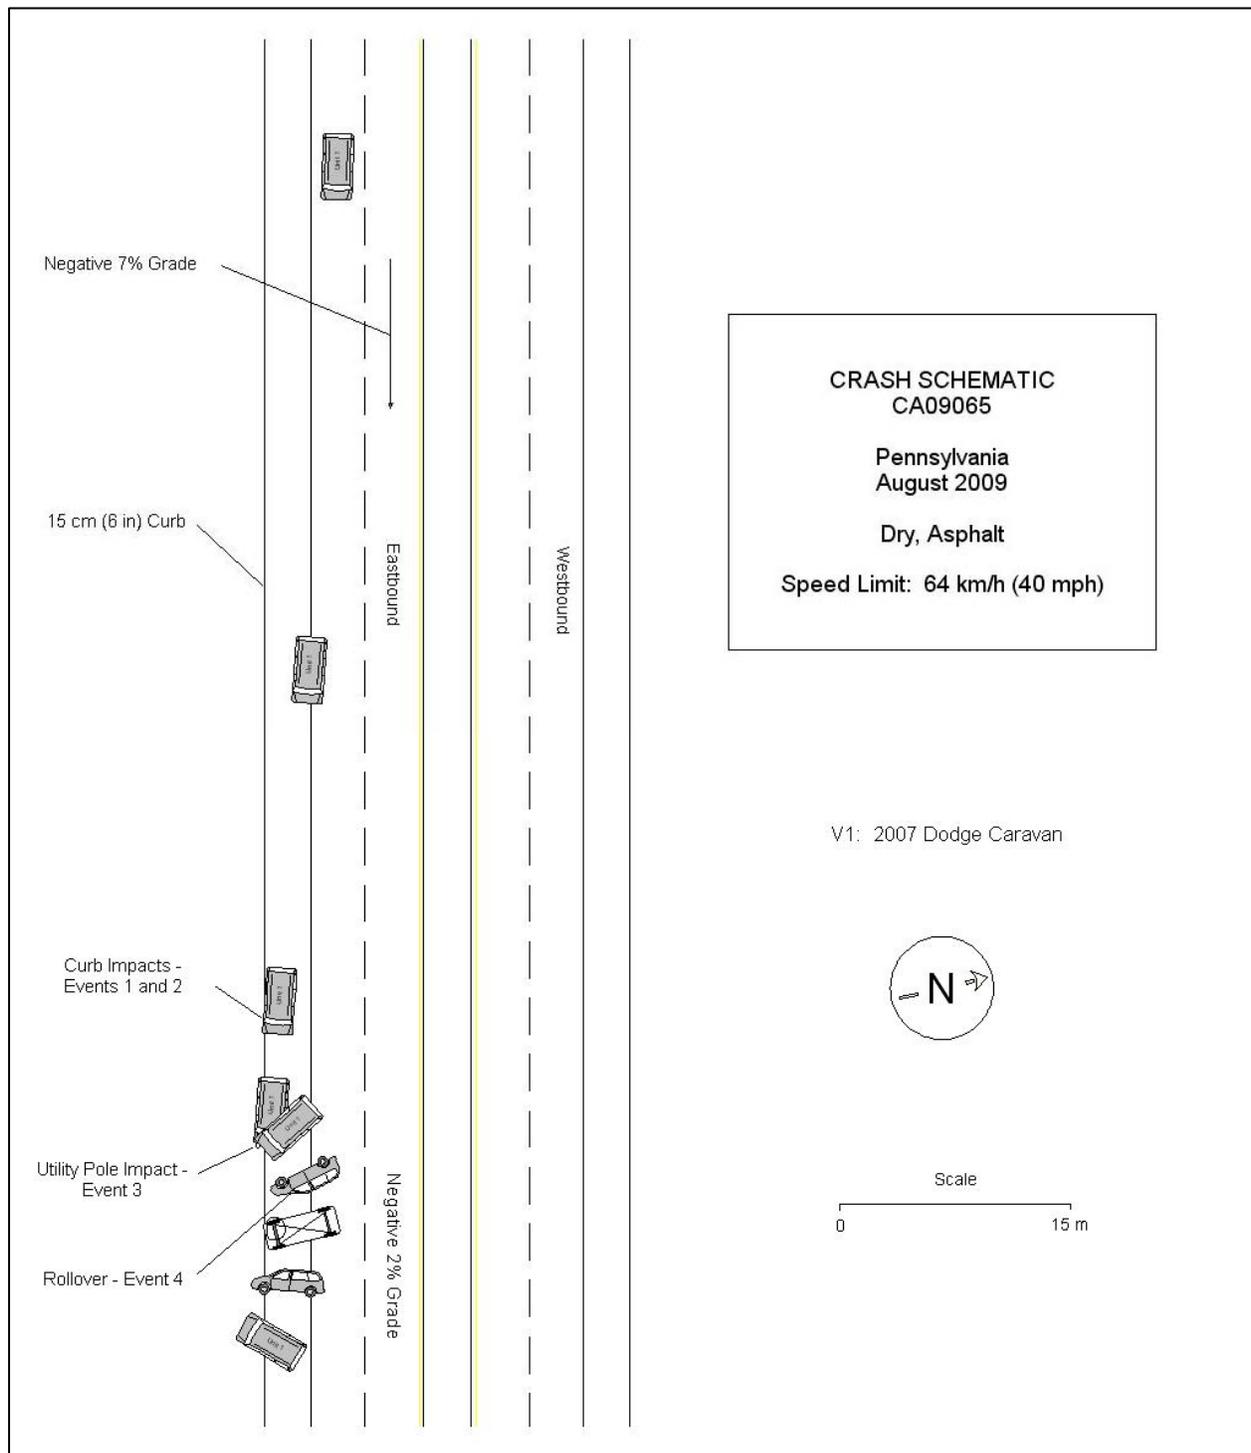
Figure 12: Crash Schematic.

The 48-year-old female was operating the Dodge eastbound in the outboard lane immediately prior to the crash. She was restrained by the vehicle's manual 3-point safety belt. The police investigation determined the driver was distracted by the use of her cellular telephone and allowed the vehicle to drift to the right. The vehicle departed the travel lane and traveled through the right shoulder on a southeast (SE) trajectory. **Figure 12**, located at the end of this report, is a schematic of the crash.
