**CALSPAN ON-SITE CERTIFIED ADVANCED 208-COMPLIANT
VEHICLE CRASH INVESTIGATION
SCI CASE NO.: CA09066**

VEHICLE: 2009 ACURA TSX SEDAN

LOCATION: NORTH CAROLINA

CRASH DATE: AUGUST 2009

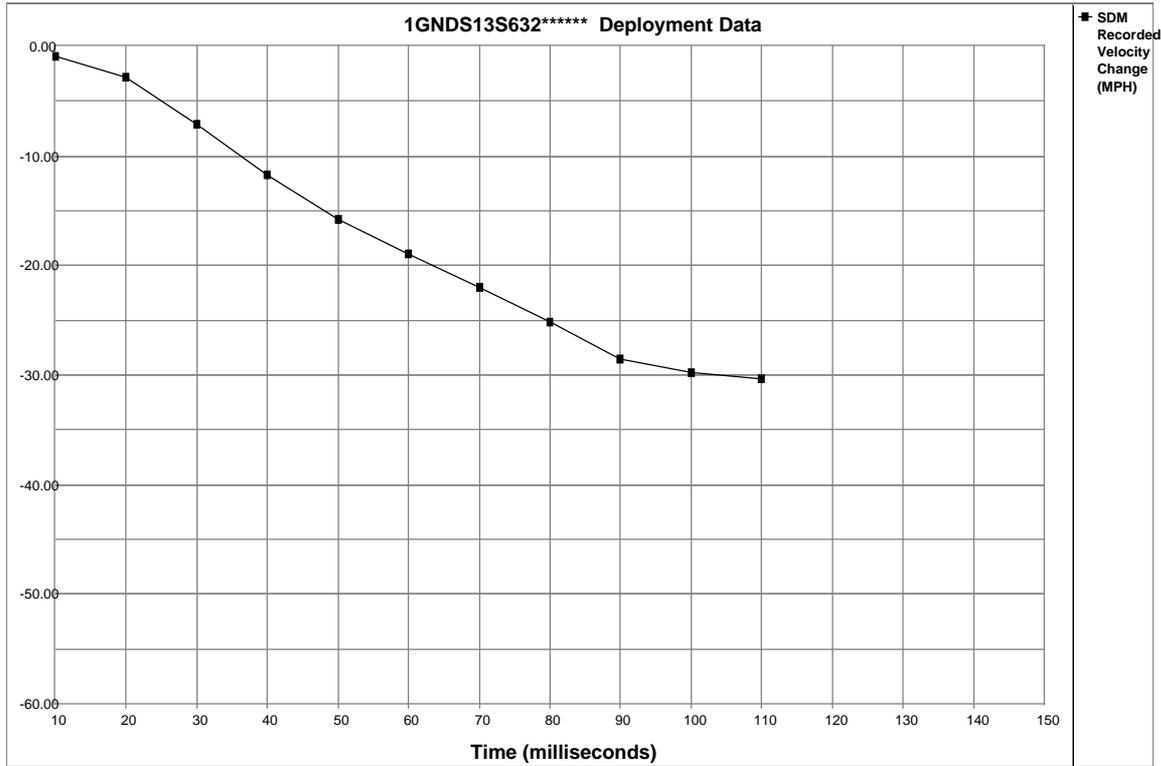
Time (milliseconds)	10	20	30	40	50	60	70	80	90	100	110	120	130	140	150
Recorded Velocity Change (MPH)	-0.93	-2.79	-7.13	-11.78	-15.81	-18.91	-22.01	-25.11	-28.52	-29.76	-30.38	N/A	N/A	N/A	N/A

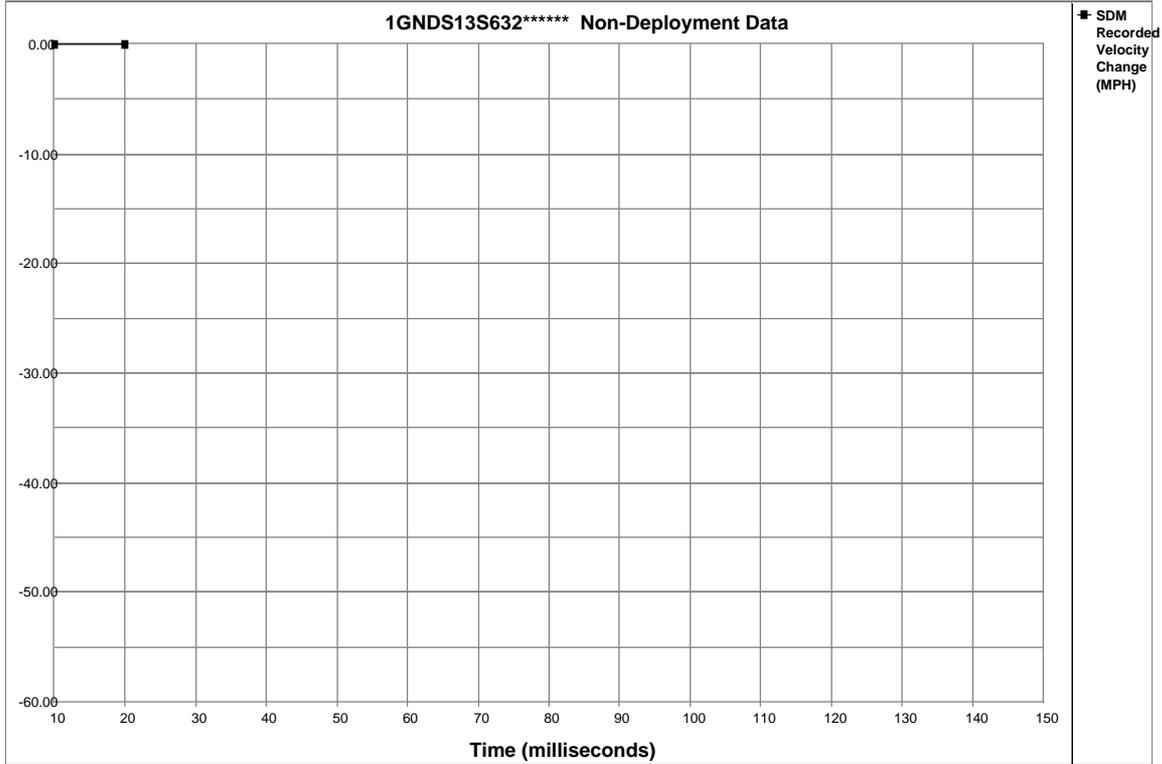
Time (milliseconds)	10	20	30	40	50	60	70	80	90	100	110	120	130	140	150
Recorded Velocity Change (MPH)	0.00	0.00	N/A
