ON-SITE ROLLOVER INVESTIGATION

CASE NUMBER - IN10006

LOCATION - TEXAS

VEHICLE - 2008 NISSAN PATHFINDER LE

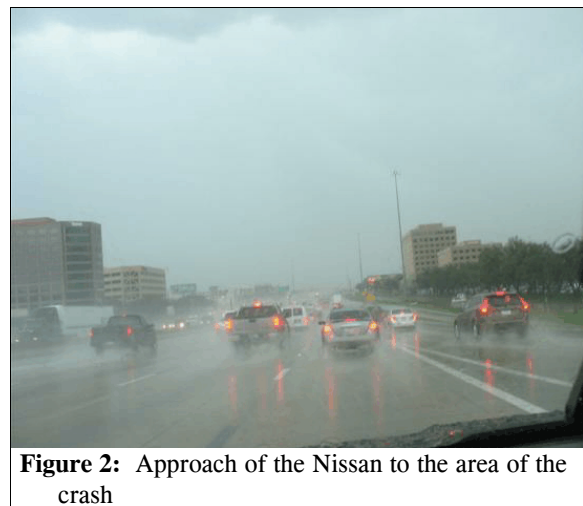
Pre-Crash: The Nissan was occupied by a restrained 50-year-old female driver, a restrained 18-year-old male front passenger, a restrained 52-year-old male second row left passenger, and a restrained 14-year-old male second row right passenger. The driver was traveling east in the first lane from the right (**Figure 2**) and intended to continue straight ahead. The Mitsubishi was traveling east in the on-ramp approaching the acceleration lane (**Figure 3**) and the driver intended to merge into traffic. According to the police crash report, the driver of the Mitsubishi

Figure 2: Approach of the Nissan to the area of the crash

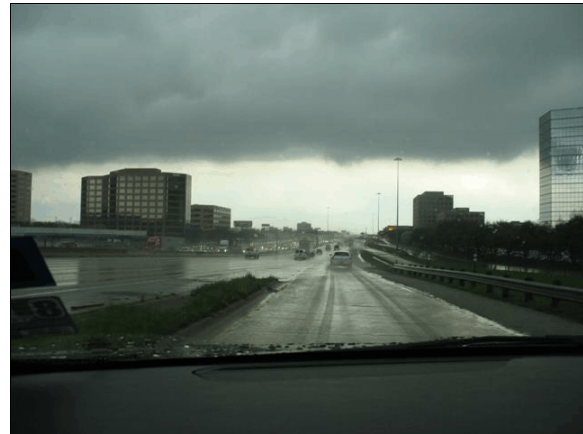
applied hard braking to avoid a vehicle while attempting to merge into eastbound traffic. The braking caused the Mitsubishi to rotate counterclockwise.

Figure 3: Approach of the Mitsubishi to the area of the crash
