On-Site Motor Coach Rollover Investigation
Dynamic Science, Inc. (DSI), Case Number DS10007
1992 Dina Marcopolo Paradiso Motor Coach
Arizona
March 2010

1. Report No. DS10007		2. Government Accession No.		3. Recipient Catalog No.	
4. Title and Subtitle On-Site Motor Coach Rollover Investigation				5. Report Date March 9, 2011

This on-site investigation focused on a 1992 Dina Marcopolo Paradiso motor coach that was involved in a rollover crash. This crash occurred in March 2010 at 0527 hours in a rural area of Arizona. The crash scene was an east/west two-lane divided interstate highway. The bus was being driven by a 67-year-old male and was traveling westbound. There were 22 occupants on board the bus, including the driver. A 1997 Ford F-150 pickup was traveling in front of the Dina. The pickup was traveling slower than the Dina and was impacted by the front end of the bus. The Dina veered to the left onto the median, overcorrected to the right, crossed both westbound travel lanes, departed the roadway on the right side, overturned, and came to rest off the right side of the roadway (**Figure 1**). A total of nine occupants were ejected from the bus. Six of the ejected occupants,

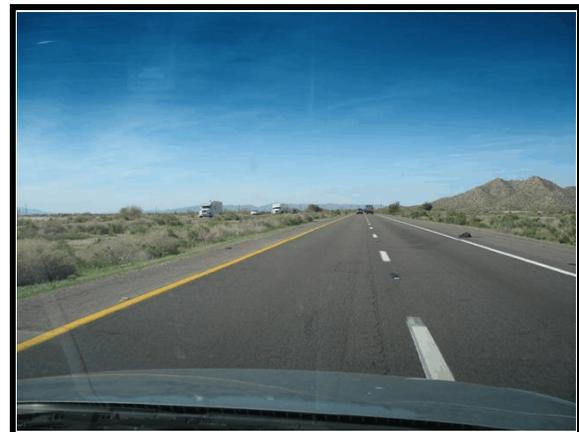
Figure 2. Westbound approach for both vehicles

The crash occurred within the westbound lanes of an east/west interstate highway (**Figure 2**). The highway was configured with two lanes that were separated by dashed white lines. The asphalt roadway was straight, level, and dry at the time of the crash. It was dark and there were no streetlights. The roadway was bordered on the north by a 3.0 m (10.0 ft) asphalt shoulder with a 1.2 m (4.0 ft) rumble strip, and a 21 percent gravel-covered

descending embankment that leveled out after 11.2 m (37.0 ft). Beyond this there was a dirt area which was bordered by a barbed wire right-of-way fence. The roadway was bordered on the south by an asphalt shoulder and depressed dirt median with sparse desert vegetation. A solid yellow line separated the rumble strip shoulder from the inboard travel lane and a solid white line separated the outboard travel lane from the right shoulder. The weather was clear, the winds calm, and the temperature 5 degrees C (41 degrees F) at the nearest reporting station. The posted speed limit was 121 km/h (75 mph).

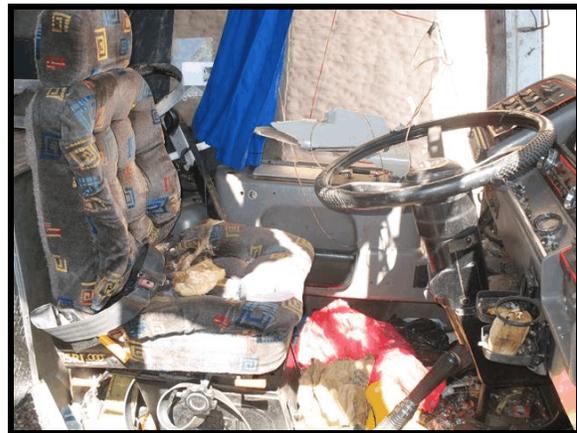
Figure 7. Driver's seat position

The Dina motor coach was configured to carry one driver (**Figure 7**), one front right passenger, and 40 additional passengers (**Figure 8**). Including the front left and right seating positions, there were a total of 11 rows. Each row was configured with left and right 2-seat units. The inboard leg of each seat unit was anchored to a metal strip mounted to the floor and the outboard leg was anchored to a metal strip mounted to the side of the bus.
