ON-SITE HEAVY TRUCK UNDERRIDE INVESTIGATION

CASE NUMBER - IN10015

VEHICLE - 2008 WABASH NATIONAL SEMI-TRAILER

CRASH DATE - March 2010

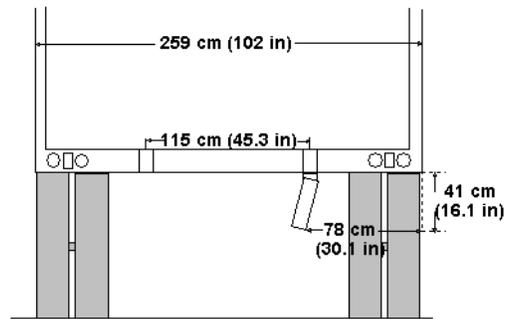
Back View of Semi-Trailer

One identification placard was found on the impact guard but the fire had rendered it unreadable. The impact guard's right vertical support broke at the weld on the horizontal member of the impact guard (**Figures 7 and 8**). The left vertical support broke at the frame rail on the semi-trailer (**Figures 9 and 10**). The schematic on the following page presents the post-crash measurements of the semi-trailer and impact guard.
