CALSPAN ON-SITE MOTORCOACH FIRE INVESTIGATION

SCI CASE NO.: CA10016

VEHICLE: 1995 MCI MODEL 102-DL3

INCIDENT DATE: APRIL 2010

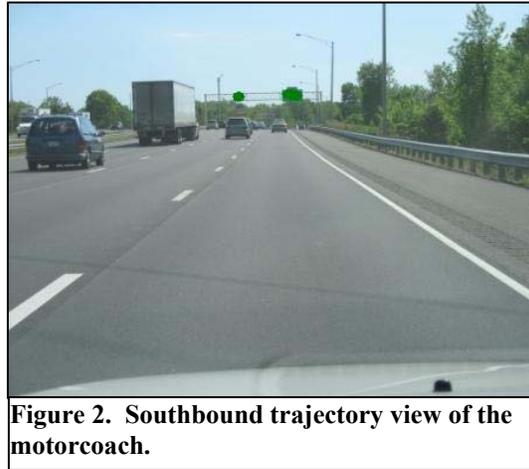
Figure 2. Southbound trajectory view of the motorcoach.

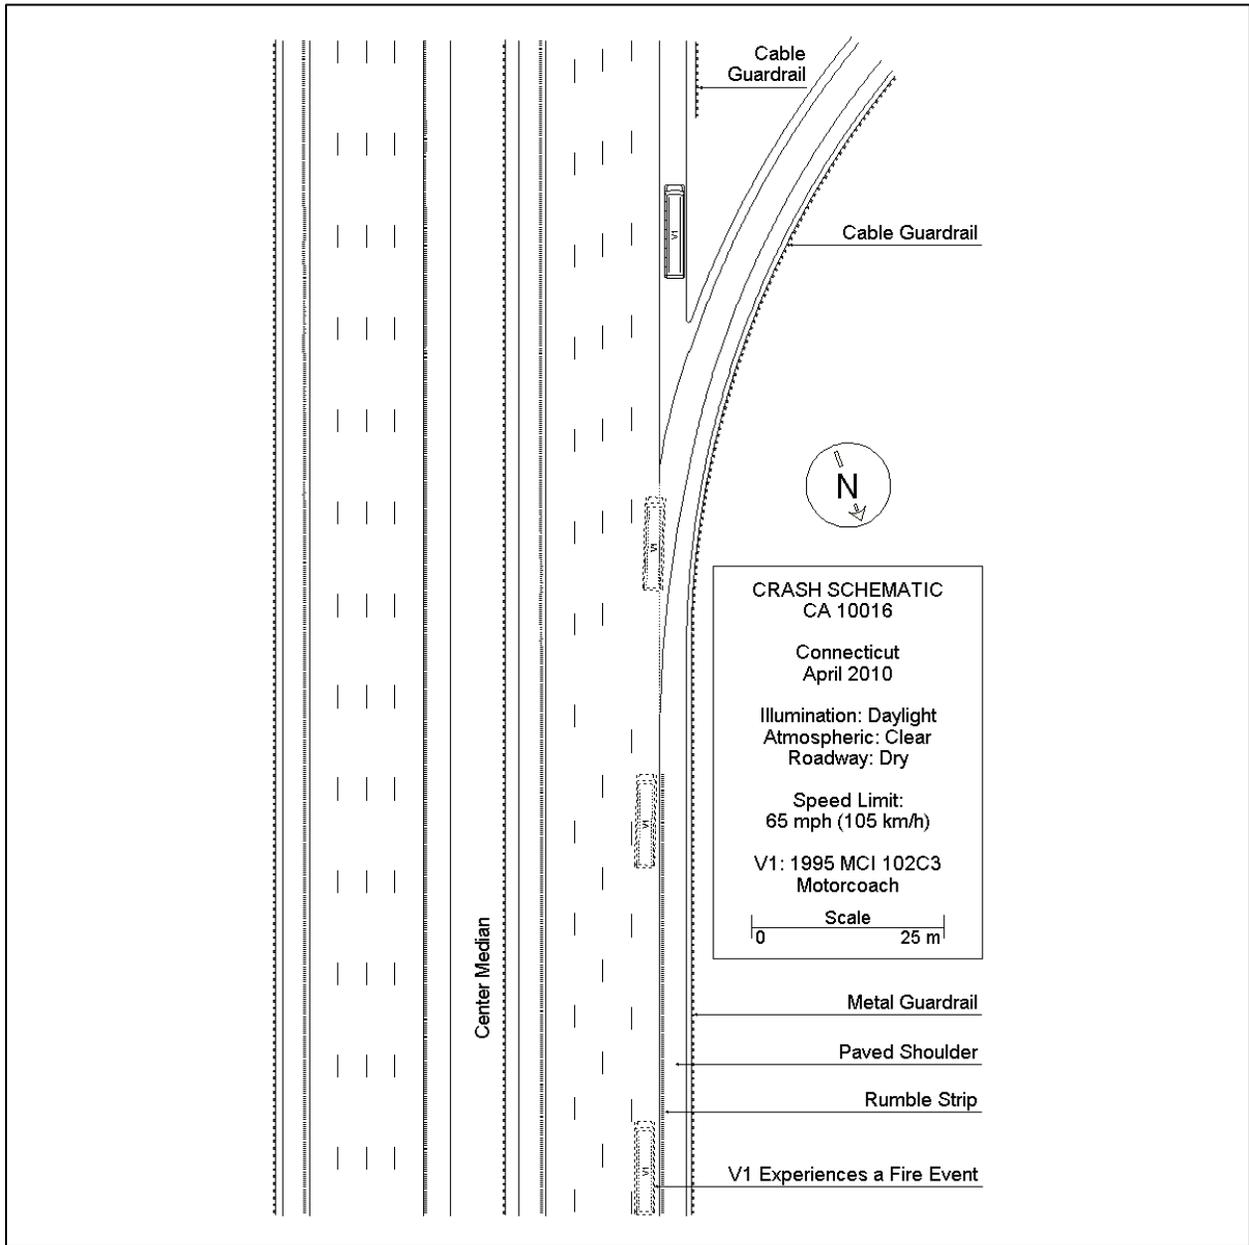
Figure 18. Incident Schematic

A grass median with a W-beam guardrail median barrier physically divided the north and southbound lanes. An off-ramp for southbound traffic was located at the incident site. The area south of the off-ramp adjacent to the travel lanes was surfaced with grass and was unprotected. On the approach to the incident site, the interstate was straight with a positive grade of less than 2 percent. The posted speed limit was 105 km/h (65 mph). **Figure 18** is a schematic of the incident site.
