ON-SITE HYBRID VEHICLE INVESTIGATION

CASE NUMBER - IN10035

VEHICLE - 2002 TOYOTA PRIUS HYBRID

CRASH DATE - October 2010

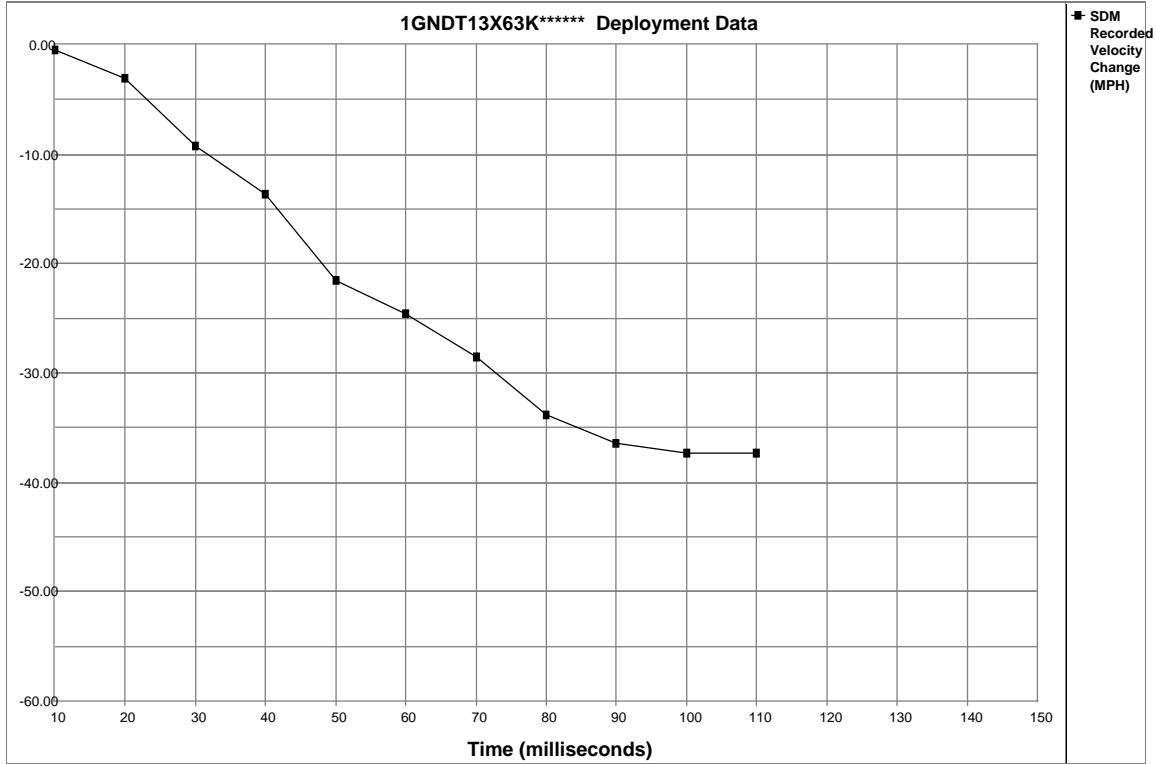
Seconds Before AE	Vehicle Speed (MPH)	Engine Speed (RPM)	Percent Throttle
-5	73	2176	27
-4	73	2176	21
-3	73	2176	21
-2	73	2112	21
-1	66	1984	0

Seconds Before AE	Brake Switch Circuit State
-8	OFF
-7	OFF
-6	OFF
-5	OFF
-4	OFF
-3	OFF
-2	OFF
-1	ON

Time (milliseconds)	10	20	30	40	50	60	70	80	90	100	110	120	130	140	150
SDM Recorded Velocity Change	-0.44	-3.07	-9.21	-13.60	-21.50	-24.57	-28.52	-33.79	-36.42	-37.30	-37.30	N/A	N/A	N/A	N/A

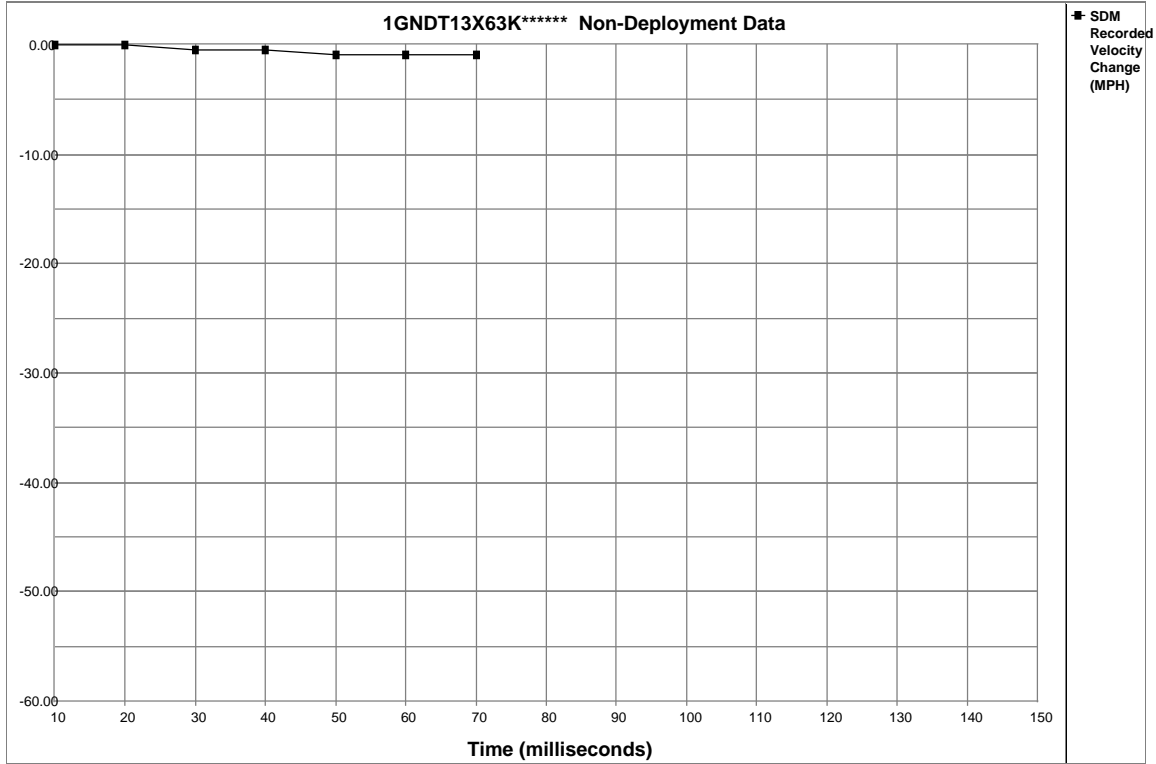
Seconds Before AE	Vehicle Speed (MPH)	Engine Speed (RPM)	Percent Throttle
-5	73	2176	27
-4	73	2176	27
-3	30	2176	21
-2	29	2176	21
-1	28	2112	21

Seconds Before AE	Brake Switch Circuit State
-8	OFF
-7	OFF
-6	OFF
-5	OFF
-4	OFF
-3	OFF
-2	OFF
-1	OFF

Time (milliseconds)	10	20	30	40	50	60	70	80	90	100	110	120	130	140	150
SDM Recorded Velocity Change	0.00	0.00	-0.44	-0.44	-0.88	-0.88	-0.88	N/A	N/A	N/A	N/A	N/A	N/A	N/A	N/A
