**CALSPAN ON-SITE SIDE IMPACT INFLATABLE OCCUPANT
PROTECTION SYSTEM CRASH INVESTIGATION**

SCI CASE NO.: CA11006

VEHICLE: 2010 TOYOTA COROLLA S

CRASH DATE: NOVEMBER 2010

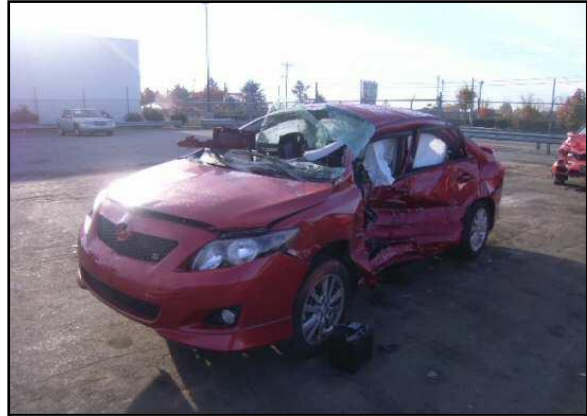
Figure 1: Front left oblique view of the 2010 Toyota Corolla.

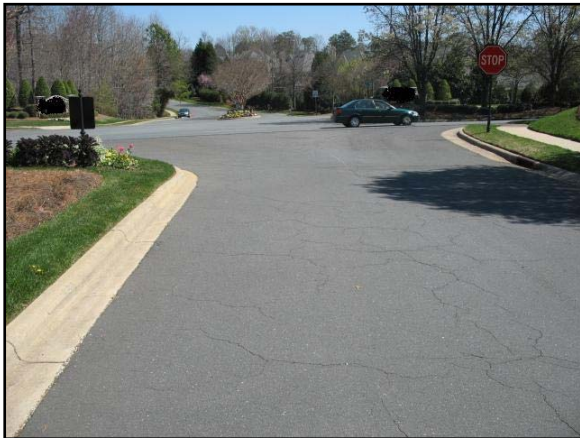
The bituminous residential roadway that the Toyota was traveling on extended east/west and was straight. It had a level grade in the pre-crash area that transitioned to a negative 2 percent grade as it approached the intersection. The eastbound travel lanes measured 8 m (26.2 ft) in width and were separated into two lanes by a faint painted line as it neared the intersection. The center median measured 4.9 m (16.1 ft) in width and ended 13.1 m (43 ft) west of the intersection. The eastbound approach to the intersection was controlled by a stop sign. An eastbound trajectory view of the Toyota's travel path is depicted in **Figure 2**.

Figure 2: Eastbound trajectory view of the Toyota on the approach to the intersection.

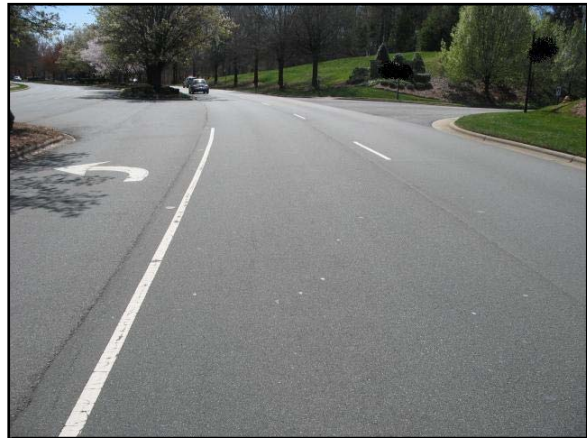
The bituminous main roadway on which the Ford was traveling extended north/south, had a negative 1 percent grade, and followed a shallow left curve. The radius of curvature measured 410 m (1345 ft). In the southbound direction of travel, the right lane was 4.1 m (13.5 ft) in width, the center lane was 3.7 m (12.1 ft) in width, and the designated left turn lane approaching the intersection was 4 m (13.1 ft) in width. The median was landscaped with trees and bushes and measured 5.7 m (18.7 ft) in width. **Figure 3** depicts the southbound approach of the Ford to the intersection. A Scene Diagram is included at the end of this report.

Figure 3: Southbound trajectory view of the Ford on the approach to the intersection.

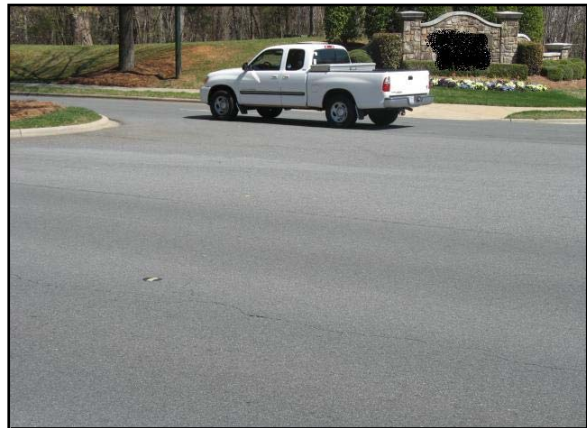
The front plane of the Ford impacted the left plane of the Toyota (Event 1) within the intersection (**Figure 4**). The vehicle-to-vehicle impact began slightly forward of the Toyota's left front axle, reaching maximum engagement at the passenger compartment area of the Toyota. The direction of force was within the 10 o'clock sector for the Toyota and the 12 o'clock sector for the Ford. The force of the impact actuated the Toyota's front left retractor pretensioner and deployed the driver's frontal air bag, the driver's seat-mounted side impact air bag, and both IC air bags.

Figure 4: Northeast trajectory view of the Toyota at the Event 1 point of impact (POI).
