ON-SITE AIR BAG INVESTIGATION

CASE NUMBER - IN97-024
LOCATION - ALABAMA
VEHICLE - 1995 FORD CONTOUR GL
CRASH DATE - August 1997

1. Report No. IN97-024		2. Government Accession No.		3. Recipient's Catalog No.	
4. Title and Subtitle On-Site Air Bag Fatality Investigation Vehicle - 1995 Ford Contour GL Location - Alabama			5. Report Date: October 19, 2000

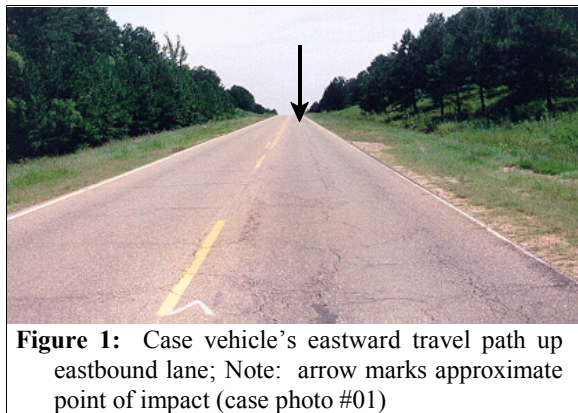
The case vehicle was following the Jeep Cherokee and both vehicles were traveling east in the eastbound lane up (i.e., a 3.2% grade, positive to the east) a two-lane, undivided, state highway (**Figure 1**) and intended to continue in their eastward direction of travel. The Chevrolet S-10 was traveling west in the westbound lane down (i.e., a 3.2% grade, negative to the west) the

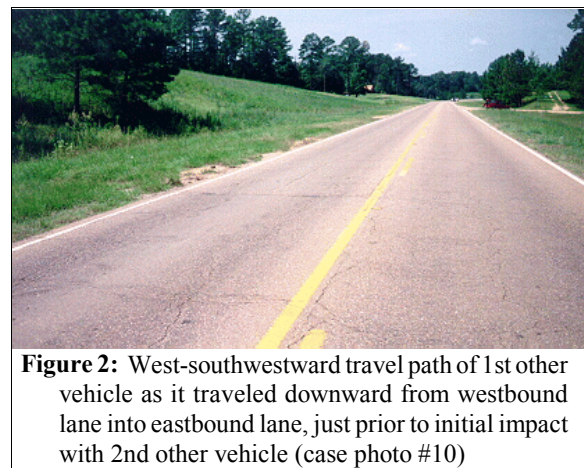
same, two-lane roadway (**Figure 2**) and intended to continue its westward travel direction. The Chevrolet S-10 entered the eastbound lane. The investigating police officer indicated that the driver of the Jeep Cherokee steered towards the right edge line, attempting to avoid the crash. The officer indicated further that after the first impact he observed no scene evidence indicating that the drivers of the case vehicle or the Chevrolet S-10 attempted any avoidance maneuvers; however, the case vehicle's driver indicated that she steered to the left, attempting to avoid the impending crash. Pre-impact travel speed estimates of 80 km.p.h. (50 m.p.h.) were reported by the drivers of the case vehicle and the Jeep Cherokee. The driver of the Chevrolet S-10 reportedly could recall nothing of the crash sequence; in addition, his speedometer was not operable. Both impacts occurred in the eastbound lane of the roadway (see **CRASH DIAGRAM** below).
