REDESIGNED AIR BAG REPORT

CASE NUMBER - IN97-066

VEHICLE - 1998 PONTIAC GRAND AM SE

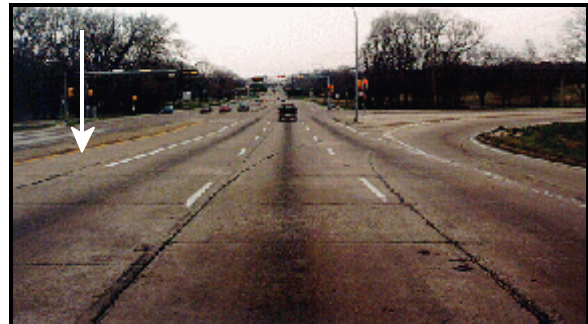
Figure 1: Case vehicle was traveling east in the inside through lane (arrow) of the eastbound roadway and was approaching a controlled four-leg intersection (case photo #01)

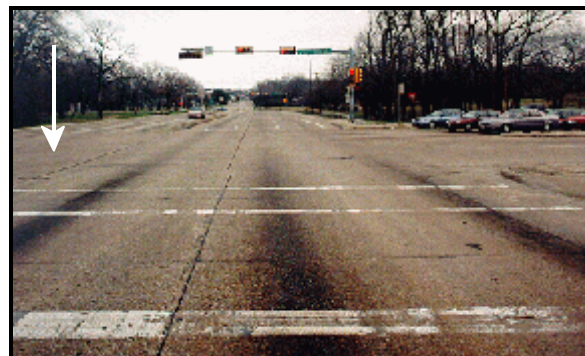
Figure 2: Case vehicle's travel path in inside through lane (left arrow) just prior to impact; Note: right arrow identifies subsequent impact with traffic signal pole (case photo #02)

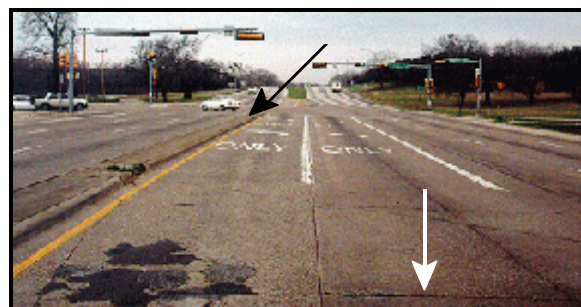
Figure 3: Vehicle #2's travel path, similar to white car above, began in outside left-hand turn lane (white arrow) of westbound roadway, prior to left-hand turn across eastbound roadway at four-leg intersection; Note: black arrow marks approximate point of impact (case photo #08)

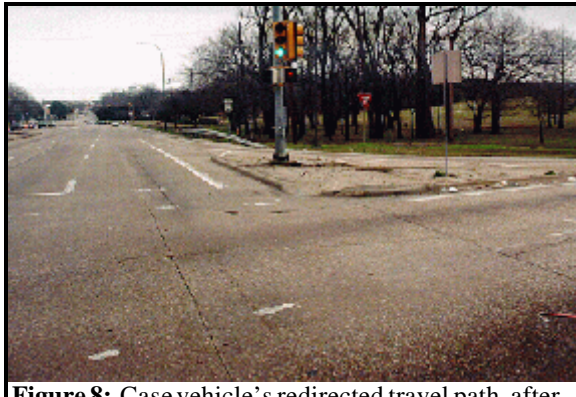
The front left corner and left side of the case vehicle (**Figures 4 and 5**) were impacted by the front of vehicle #2 (**Figures 6 and 7**), causing the case vehicle's driver and front right passenger supplemental restraints (air bags) to deploy. The case vehicle veered off to the southeast (**Figure 8** below) and subsequently impacted a traffic signal light pole (**Figure 9** below) with its front left (**Figure 10** below). The

Figure 8: Case vehicle's redirected travel path, after initial impact with vehicle #2, toward impact with traffic signal pole located on traffic island off southeast corner of intersection (case photo #03)

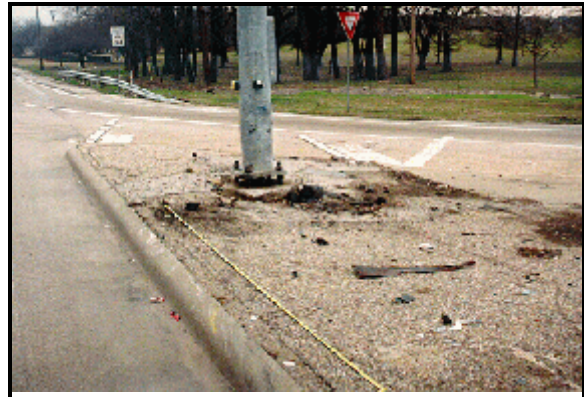
signal light pole was on a traffic island which was located on the southeast corner of the four-leg intersection. The case vehicle rotated approximately 25 degrees counterclockwise and came to rest on the traffic island heading east. Vehicle #2 rotated approximately 80 degrees counterclockwise while moving in a south-southwestward direction post-impact. Vehicle #2 came to rest heading south-southeast and was straddling the outside through lane of the eastbound roadway, within the four-leg intersection of the two trafficways.

Figure 9: East-southeast view of traffic signal pole impacted by case vehicle's front located on traffic island off southeast corner of intersection (case photo #04)
