**REDESIGNED AIR BAG SPECIAL STUDY (RABSS)  
SCI TECHNICAL SUMMARY REPORT**

**NASS CDS CASE NO. 1998-11-208F**

**RABSS VEHICLE - 1998 FORD F-150 PICKUP TRUCK**

**CRASH DATE - NOVEMBER, 1998**

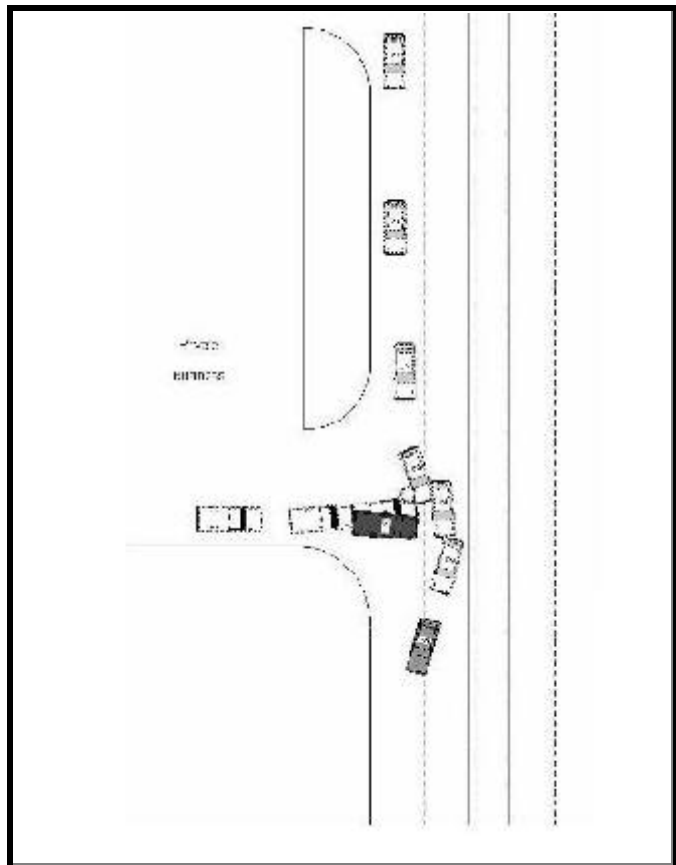
**Figure 7. NASS Scene Diagram.**

This two vehicle crash occurred during the afternoon hours of November, 1998. At the time of the crash, it was daylight with no adverse conditions as the roads were dry. The crash occurred in the outboard westbound lane of a straight and level five lane asphalt roadway (see **Figure 7 - page 4**) at a junction with a private driveway. No traffic control was present at the scene which had a posted speed limit of 72 km/h (45 mph).
