**TRANSPORTATION SCIENCES
CRASH RESEARCH SECTION**

**REDESIGNED AIR BAG SPECIAL STUDY (RABSS)
SCI TECHNICAL SUMMARY REPORT**

NASS CDS CASE NO. 1998-12-229E

**RABSS VEHICLES - 1998 CADILLAC DEVILLE
1998 BUICK CENTURY CUSTOM**

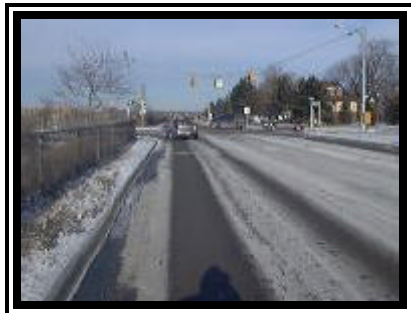
The 49 year old male driver of the 1998 Cadillac Deville was stationary and faced north in the inboard lane (**Figure 1**) of the one-way roadway in anticipation of turning left (west) at the 4-leg intersection. The 42 year old male driver of the 1998 Buick Century was operating the vehicle westbound in the outboard lane (**Figure 2**) of the one-way roadway at a (driver reported) speed of 56 km/h (35 mph) when he entered the intersection and observed the northbound Cadillac cross his path of travel. Neither driver reported any avoidance maneuvers in anticipation of the impending crash.

Figure 1. Northbound approach for the 1998 Cadillac Deville.

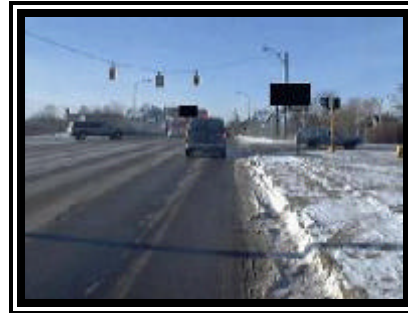
Figure 2. Westbound approach for the 1998 Buick Century Custom.

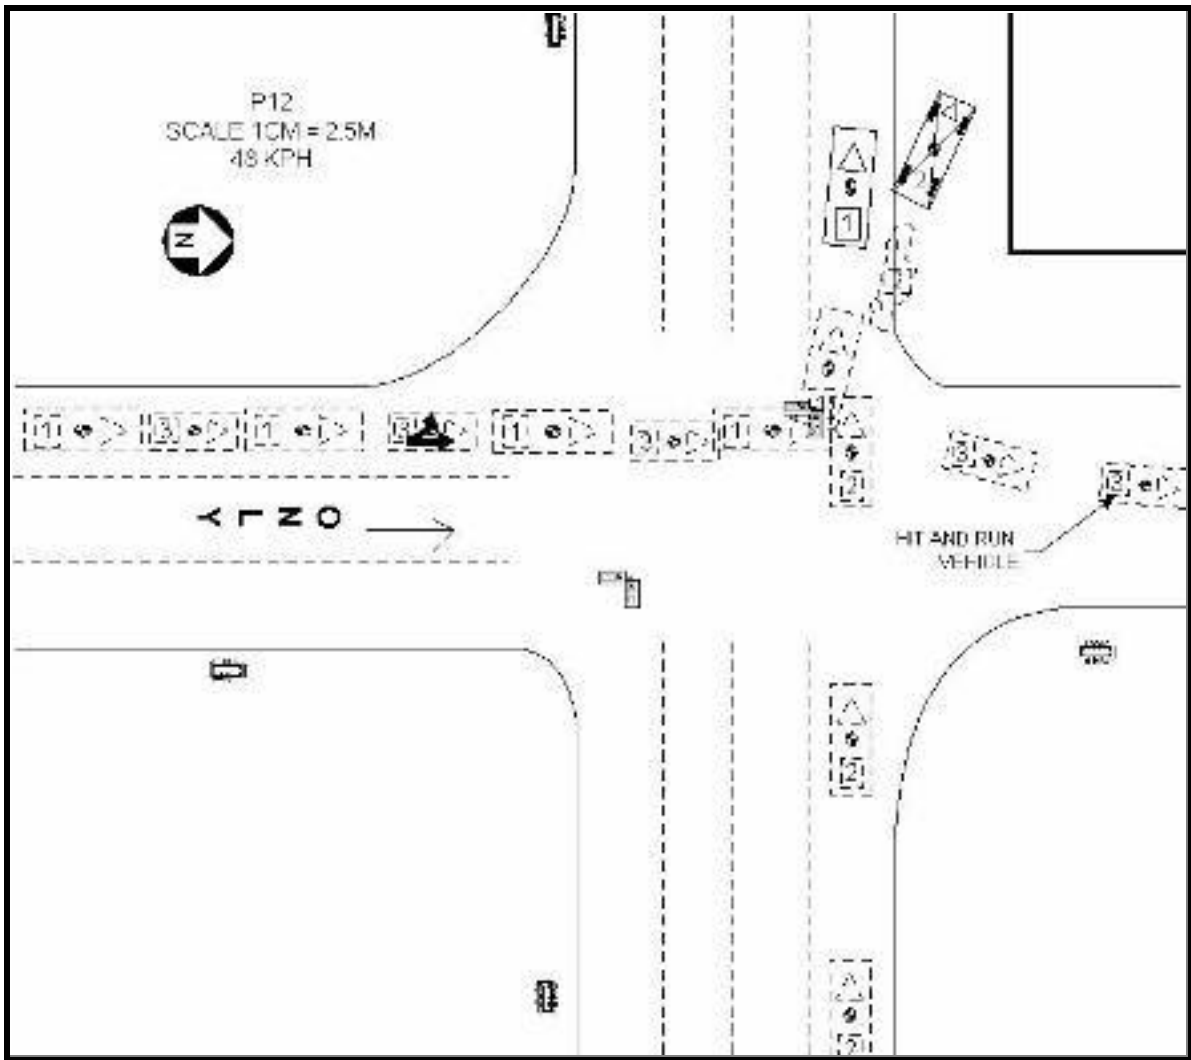
This two vehicle crash occurred during the morning hours of December, 1998. At the time of the crash, it was daylight with no adverse conditions as the roads were dry. The crash occurred in a straight and level 4-leg urban intersection (see **Figure 9 - page 9**) which was controlled by an overhead signal system in green phase for westbound traffic. The northbound roadway consisted of three (one-way)

Figure 9. NASS Scene Diagram.
