**REDESIGNED AIR BAG SPECIAL STUDY (RABSS)
SCI TECHNICAL SUMMARY REPORT**

NASS RABSS CASE NO. 1998-12-803E

RABSS VEHICLE - 1998 CHEVROLET CAVALIER

CRASH DATE - SEPTEMBER, 1998

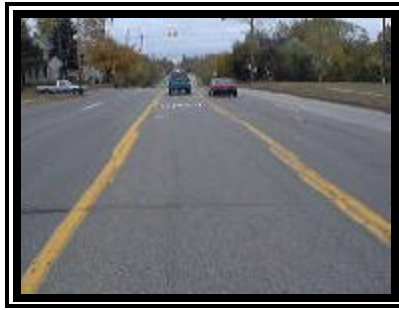
The 74 year old female driver of the 1991 Eagle Premier was operating the vehicle eastbound on the inboard lane of a five lane roadway (**Figure 1**) when she entered the center turn lane and proceeded to turn left (north) at the 3-leg intersection. The 19 year old female driver of the 1998 Chevrolet Cavalier was operating the vehicle westbound on the inboard lane (**Figure 2**) at a (driver reported) speed of 48 km/h (30 mph) when she observed the Eagle cross her path of travel. The Chevrolet driver reported no avoidance maneuvers in anticipation of the impending crash.

Figure 1. Eastbound approach for the 1991 Eagle Premier LX.

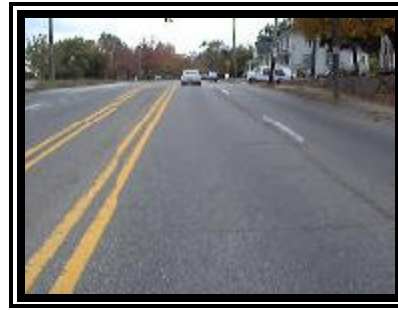
Figure 2. Westbound approach for the 1998 Chevrolet Cavalier.

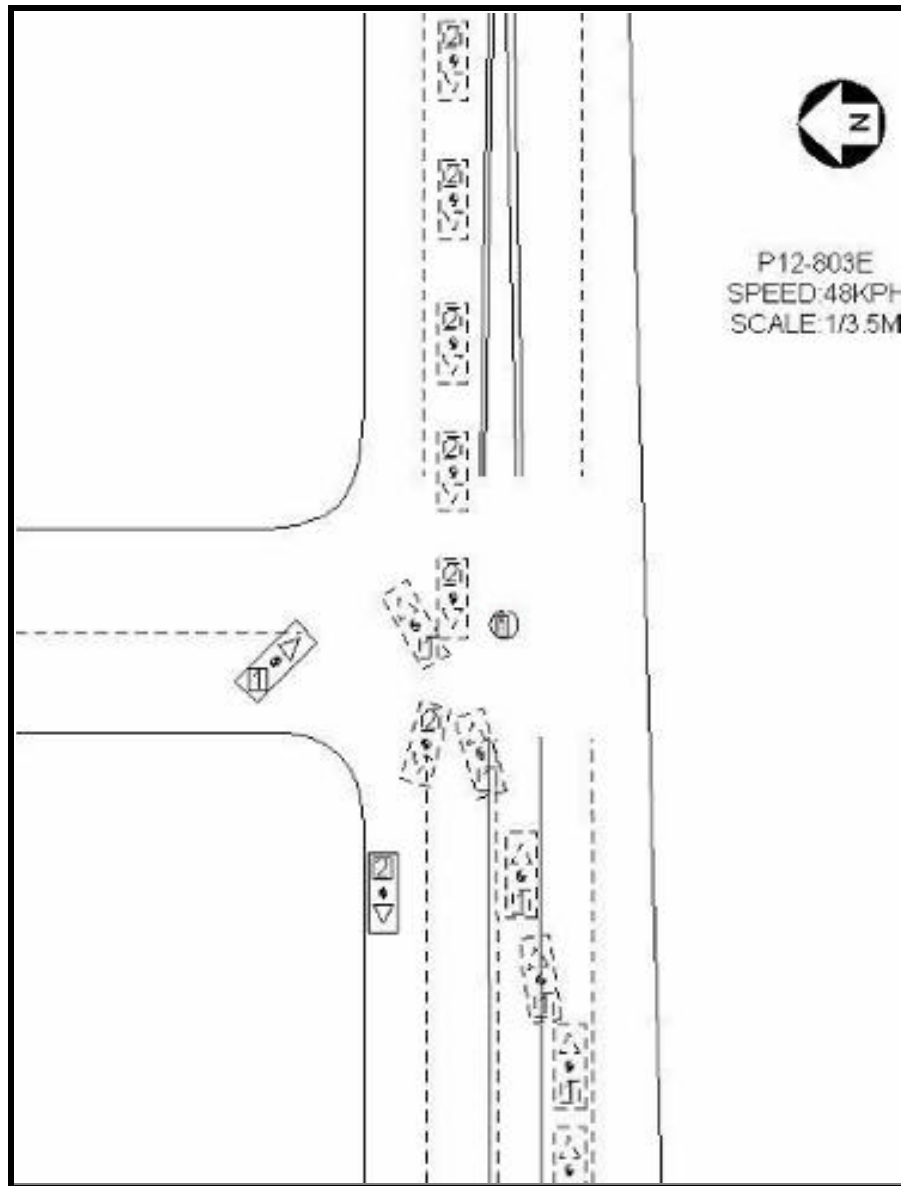
This two vehicle crash occurred during the early evening hours of September, 1998. At the time of the crash, it was daylight with no adverse conditions as the roads were dry. The crash occurred in the inboard westbound lane of a straight and level 3-leg asphalt intersection (see **Figure 7 - page 5**) with a negative grade for eastbound traffic. Traffic was controlled by an overhead signal system in green phase for east/westbound traffic. The posted speed limit at the crash scene was 48 km/h (30 mph).

Figure 7. NASS Scene Diagram.
