Remote, Redesigned Air Bag Special Study

Dynamic Science, Inc., Case Number (1998-049-206C)

1999 Chevrolet Corvette

December/1998

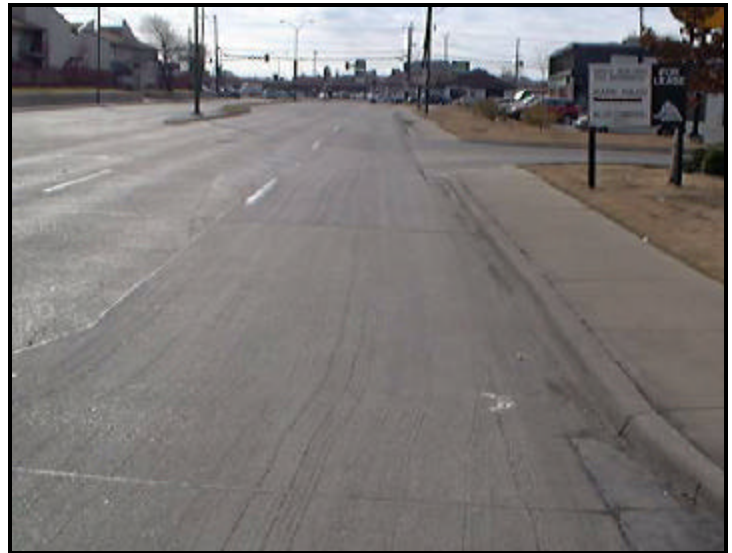
**Figure 3.** Crash scene, approach to impact (V2 perspective)

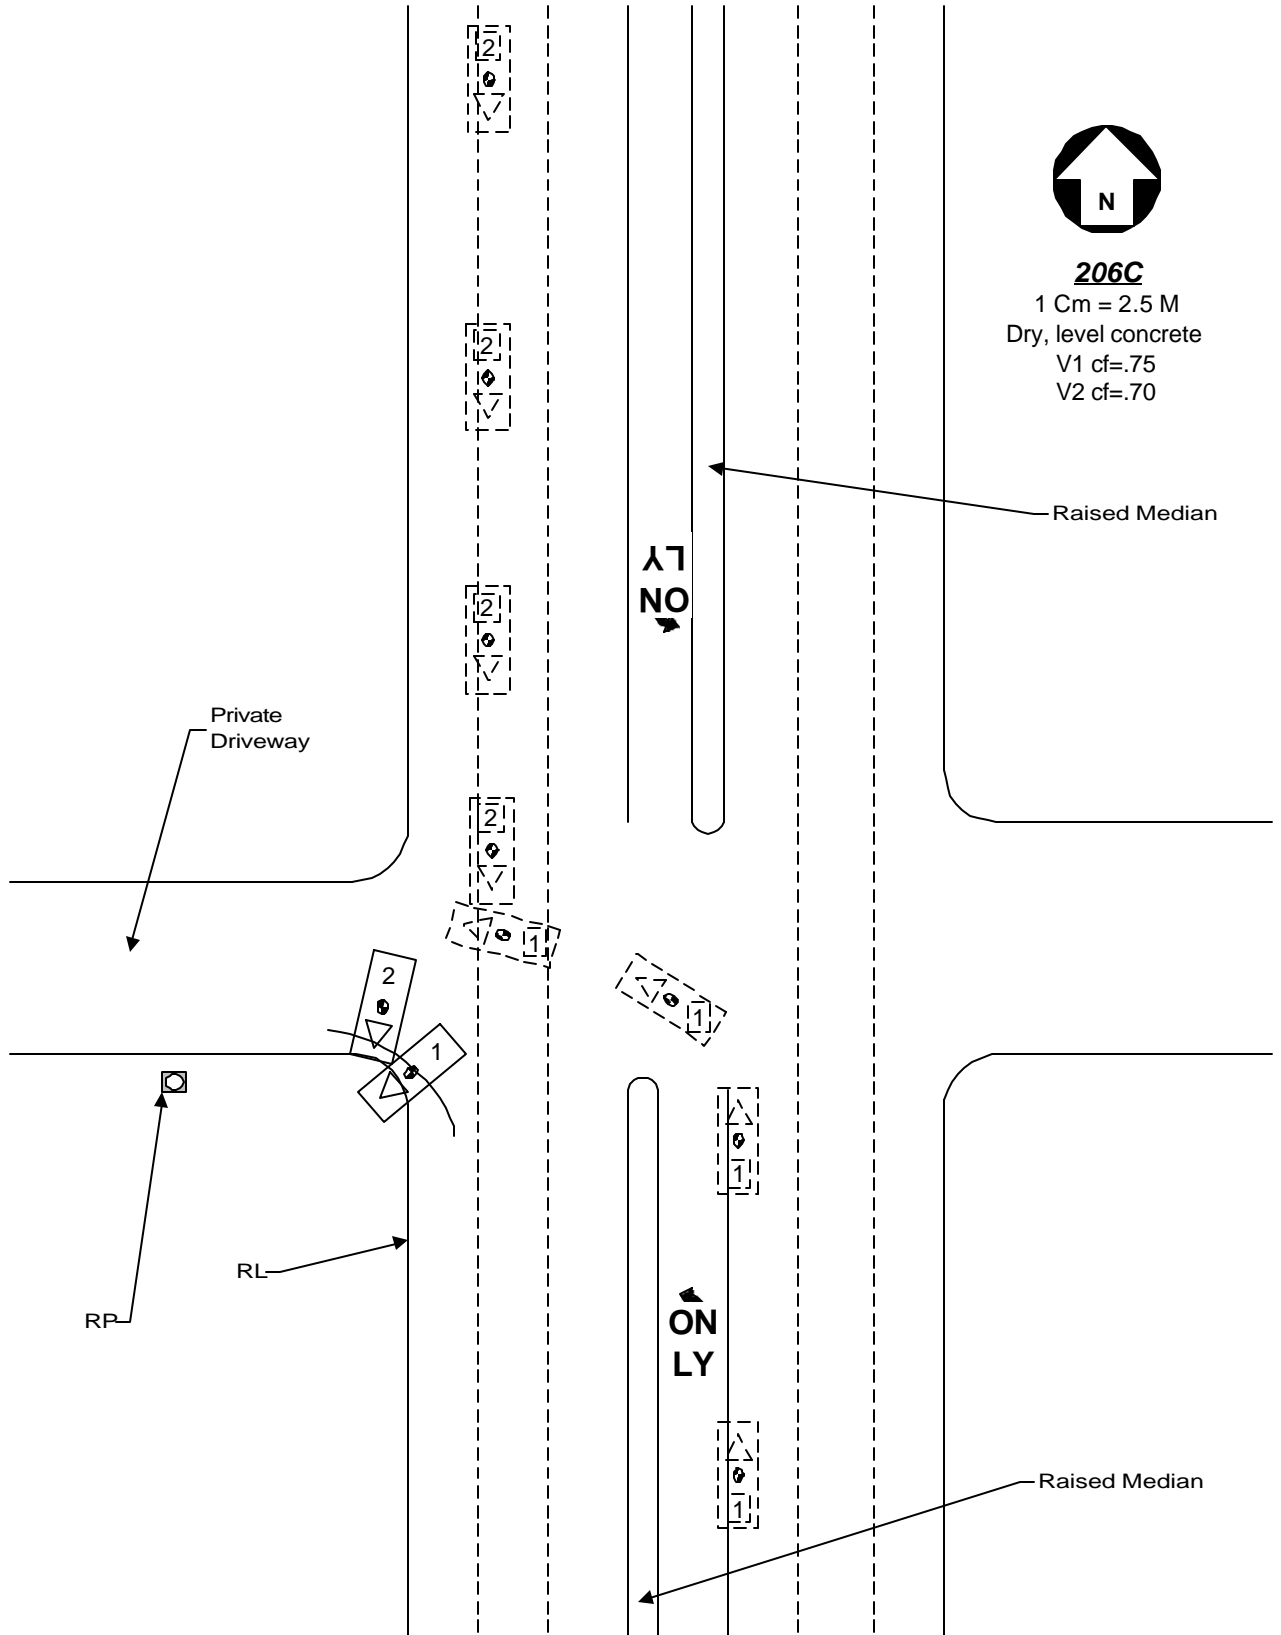
Scene Diagram

There was heavy southbound traffic at the time of the collision and traffic in the center and left lanes had stopped to allow Vehicle 1 to make the turn. The driver of Vehicle 1 initiated the left turn and began crossing the southbound lanes. The driver of Vehicle 2 did not realize that Vehicle 1 was turning and the front plane of Vehicle 2 (11FDEW1) struck the right plane of Vehicle 1 (02RYEW3) in the southbound right lane.

After the impact, Vehicle 1 rotated counter-clockwise approximately 55 degrees and came to rest with its front wheels up on the east curb facing southwest. Vehicle 2 rotated clockwise approximately 15 degrees after impact and came to rest in the driveway facing southwest.
