Remote, Redesigned Air Bag Special Study

Dynamic Science, Inc., Case Number (1998-076-801G)

1998 Nissan Altima

August/1998

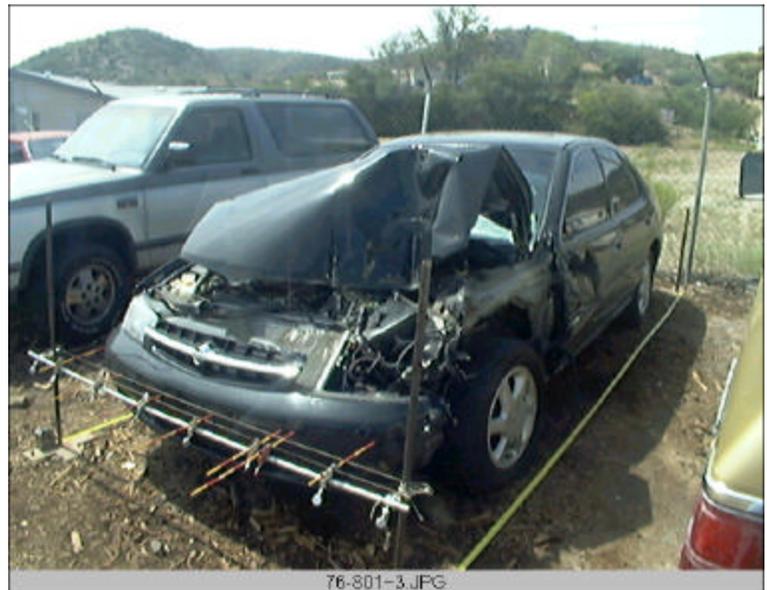
Figure 2. Exterior, Vehicle 2 (Nissan Altima)

Vehicle 2 sustained heavy damage to the hood and engine area, and was towed from the scene due to damage.
