**TRANSPORTATION SCIENCES
CRASH RESEARCH SECTION**

**CALSPAN ON-SITE SCHOOL BUS CRASH INVESTIGATION
CALSPAN CASE NO. CA98-022
SCHOOL BUS CHASSIS: 1993 GMC VANDURA 3500
BODY: THOMAS BUILT MINOTOUR
LOCATION: TENNESSEE
CRASH DATE: MARCH, 1998**

Contract No.
DTNH22-94-D-07058

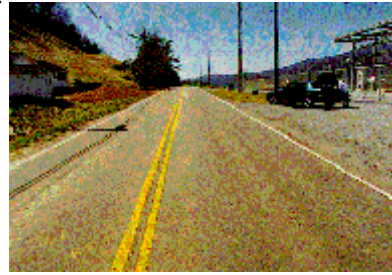
Figure 2. School bus driver's view of the approach of the GMC pick-up truck.

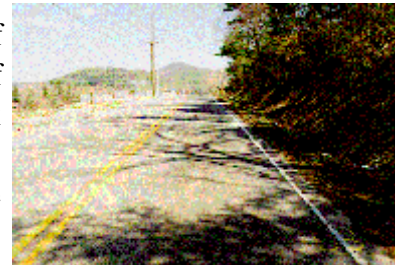
Figure 3. Pick-up truck driver's view at 169 m (553') west of POI.

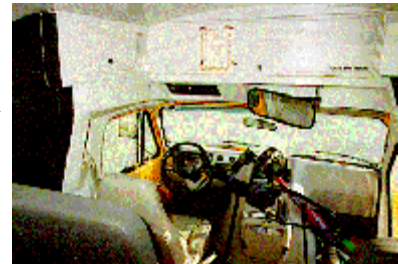
Figure 9. Overall frontal view of the driver's compartment.

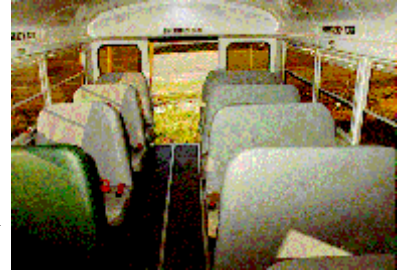
Figure 11. Overall view of the seating capacity of the bus.

The right front seat was supported by four legs that were bolted to the floor. Each leg was terminated with a mounting plate and secured with two 9 mm (3/8") diameter, Grade 5 bolts. The second, third, and fourth rows of right seats were attached to the wall mounted rail with two 8 mm (5/16") diameter Grade 5 bolts. The inboard aspect of the seats were supported by two legs with a mounting plate that was secured with two 8 mm (5/16") diameter bolts for each leg. All seats remained securely fastened to the floor of the bus and there was no buckling/damage to the floor system.

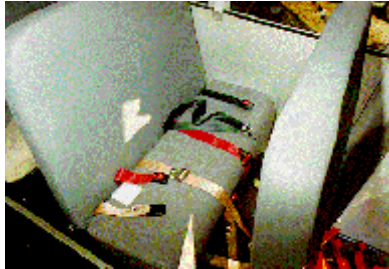
Each seat was equipped with color coded lap belts to aid in the identification of the appropriate component for each position. The left side three passenger seats were equipped with black belt webbings for the outboard positions, red center belt webbings, and beige inboard mounted webbings (**Figure 12**). The right side seats were equipped with black outboard bets and red inboard belt systems

Figure 12. Left side belt configuration.

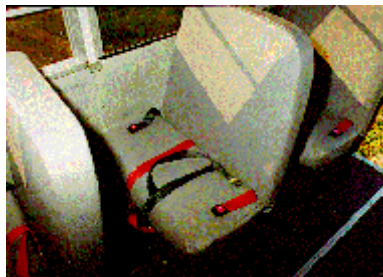
(Figure 13). The belt systems were bolted to a 6.4 cm (2.5") wide plate that was 3.2 mm (1/8") in thickness that was welded across the full width of the seat frame. The seat belt attachment bolts were Grade 5, 11 mm (7/16") in diameter x 2.5 cm (1.0") in length, and were secured with a self locking nut. The right side belt systems were bolted with 11 mm (7/16") diameter Grade 5 bolts to brackets welded to the legs of the seat frames.

Figure 13. Right side belt configuration.

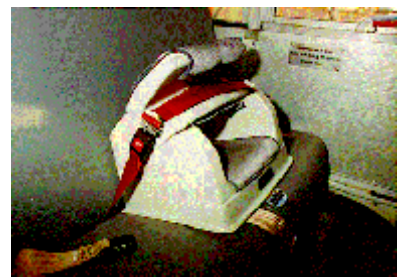
Figure 14. Evenflo booster seat.

In addition to the belt systems, the school bus was equipped with six booster seats to accommodate small children assigned to this vehicle's route. The booster seats were removed from the vehicle and placed in the replacement bus following the crash. There were two types of booster seats on board the bus at the time of the crash, however, only one was in use. The booster seats were manufactured by Evenflo and Cosco. The Evenflo booster seats were identified as a Sight-Seer model (Figure 14), however, the labeling was worn away from the plastic shell. This seat consisted of a plastic shell with a pivoting abdominal restraint shield. The U-shaped shield offered a contoured restraint for the child occupant and a channel to position the belt webbing. The shield pivoted on a tubular rod at the left side of the restraint. A label which identified the placement of the shoulder belt webbing was dated 12/91, therefore the booster seat was approximately six years old. This seat was gray in color with a gray fabric material over a 1.3 cm (0.5") foam padding on the seat base and shield.
