**ONSITE DEPOWERED DRIVER AIR BAG DEPLOYMENT INVESTIGATION**

**VERIDIAN CASE NO. CA98-029**

**VEHICLE: 1998 TOYOTA AVALON**

**CRASH DATE - APRIL 1998**

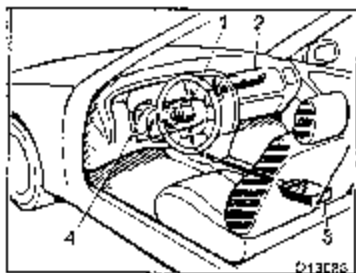
The Toyota was equipped with a Supplemental Restraint System (SRS) that consisted of depowered frontal air bags for the driver and front right passenger. There were no exterior identifiers on the vehicle that indicated the SRS was a depowered system. There also were side impact air bags located in the outboard aspects of the Toyota's front seat backs, refer to **Figure 14**.

The frontal air bag system was controlled by the air bag sensor assembly located in the center console of the Toyota. The sensor assembly consisted of a safing sensor and crash sensor in addition to the air bag diagnostic unit. The sensor assembly also controlled the activation of the seat belt pretensioners. The deployment of the side impact air bags was controlled by the side air bag sensor assembly located under the front seat cushion.
