**ON-SITE AIR BAG/CHILD PASSENGER FATALITY
INVESTIGATION**

VERIDIAN ENGINEERING CASE NO. CA 98-047

VEHICLE #1 - 1995 TOYOTA COROLLA

CRASH DATE - AUGUST, 1998

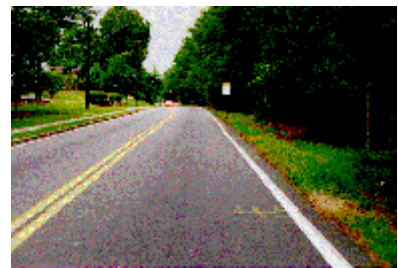
This crash sequence occurred on a suburban two lane roadway in a posted 56 km/h (35 mph) speed zone. The asphalt road surface was dry and straight along the approach to the crash site with a 1.7 percent (1 degree) grade that was positive to the north (travel direction of subject vehicle). The north/southbound travel lanes were delineated by yellow full barrier centerlines and solid white fog lines located at each edge of the roadway. The overall width of the roadway was 7 m (23'). Narrow asphalt shoulders that were approximately 0.5 m (1.6') in width were located outboard of the fog lines. The west shoulder was bounded by a 12.7 cm (5.0") high barrier curb. The east shoulder was bounded by a grassy berm with a 23 percent (13 degree) negative slope to the east that terminated in a shallow drainage area 4.1 m (13.4') east of the east edge of the roadway. A 55.9 cm (22.0") high embankment with a 70 percent (35 degree) positive slope was located outboard of the drainage area (i.e., this positive embankment was the rear wall of a shallow drainage ditch). The northbound travel lane began curving to the left a short distance beyond the point where the right front wheel of the Toyota exited the east edge of the roadway (**Figure 3**). The crash sequence occurred during daylight hours with clear atmospheric conditions.

Figure 3. View of the Toyota's approach to the crash site.

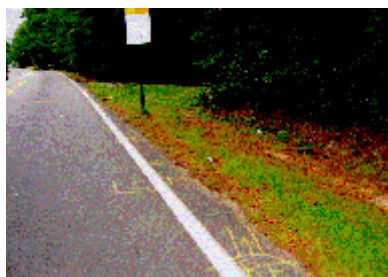
Figure 4. Point where the Toyota exited the roadway.

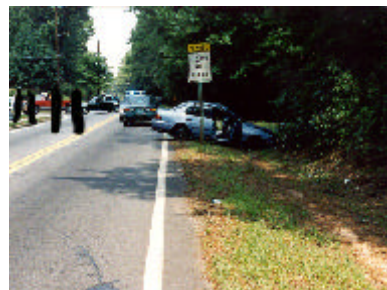
Figure 5. On-site police view showing the Toyota's trajectory and final rest position.

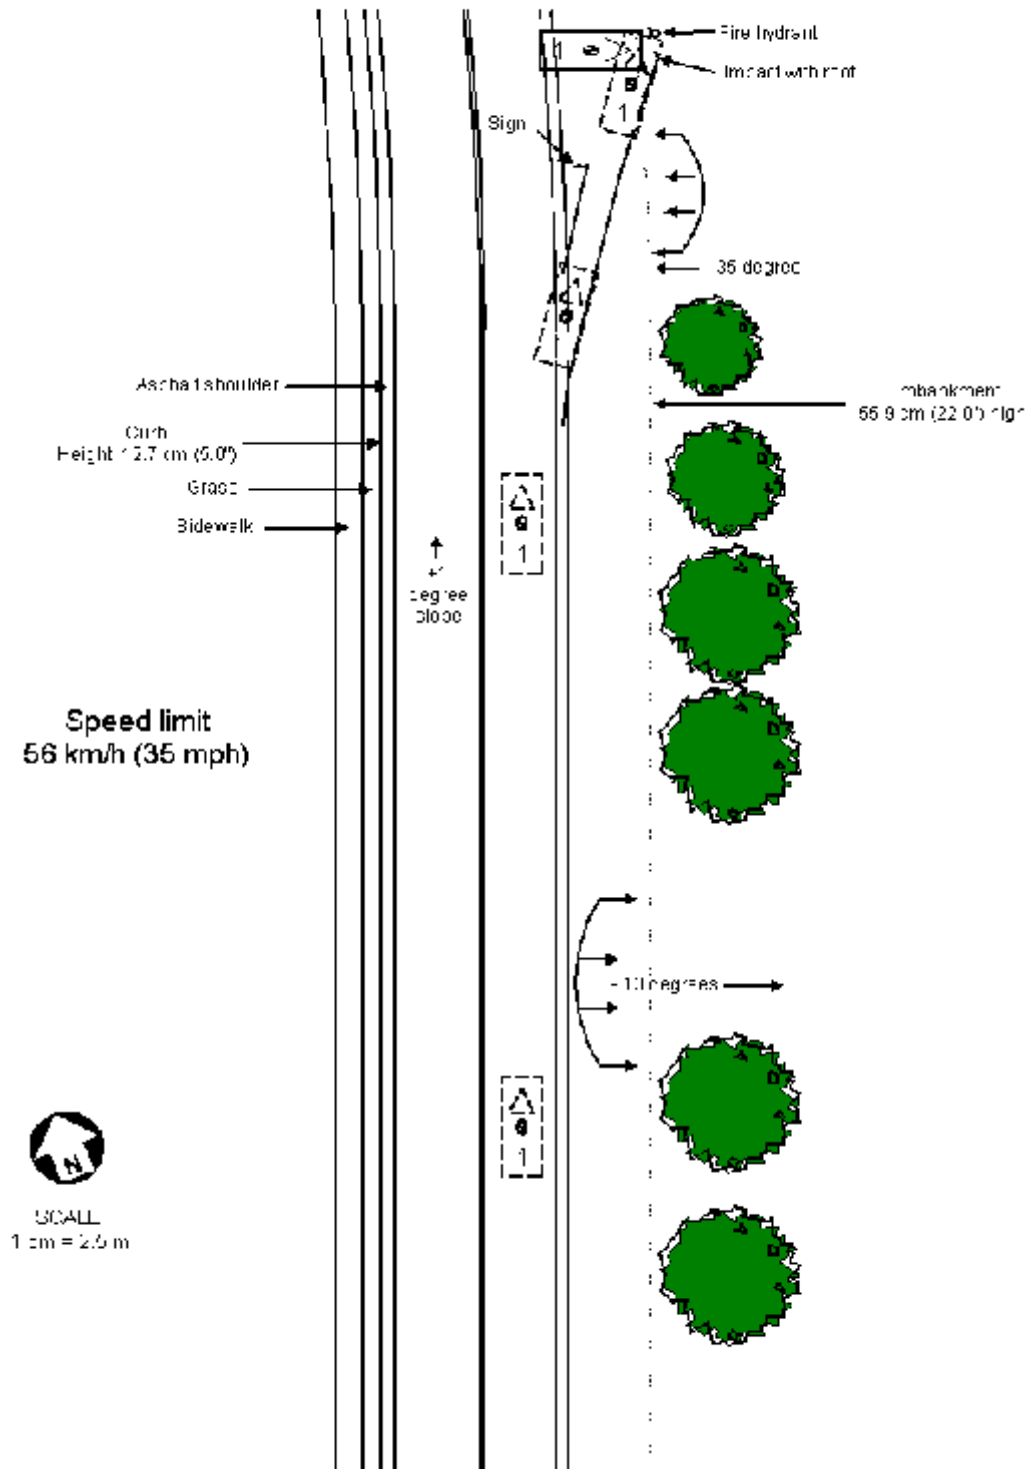
Figure 7. Scene diagram

Following the impact sequence noted above, the Toyota rotated approximately 70 degrees in a clockwise direction and came to rest facing in an east southeasterly direction. At final rest the left side of the Toyota was in line with the fire hydrant that was struck, the vehicle was nearly perpendicular to the roadway, and the rear portion of the vehicle was straddling the east shoulder of the roadway (**Figure 7**).
