THREE-VEHICLE SCHOOL BUS CRASH INVESTIGATION

VERIDIAN CASE NO. CA98-061

LOCATION: NEW YORK

CRASH DATE: NOVEMBER, 1998

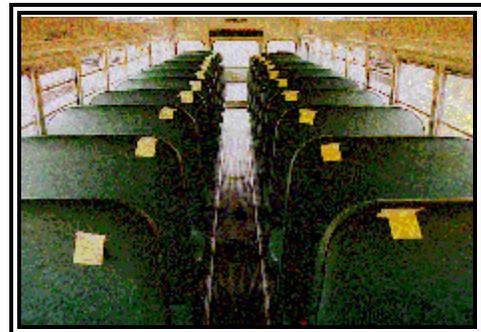
Figure 7 is an overall view of the seating configuration. There were 11 rows of high backed seats symmetrically spaced over the interior area that measured 2.3 m by 8.1 m (7.5 ft by 26.5 ft), width by length. The individual seats measured 97.8 cm by 39.4 cm (38.5 in by 15.5 in) width by depth, and had the capacity to seat three students. The exception was the left seat of row 11 which seated two students and measured 67.3 cm by 39.4 cm (26.5 in by 15.5 in). The seat cushions were 41.9 cm (16.5 in) above the floor. The tops of the seat backs measured 74 cm (29 in) above the seat cushion, 109 cm (43 in) above the floor. The seat backs were reclined 7 to 8 degrees.

Figure 7: Overall view of the bus interior seating arrangement.

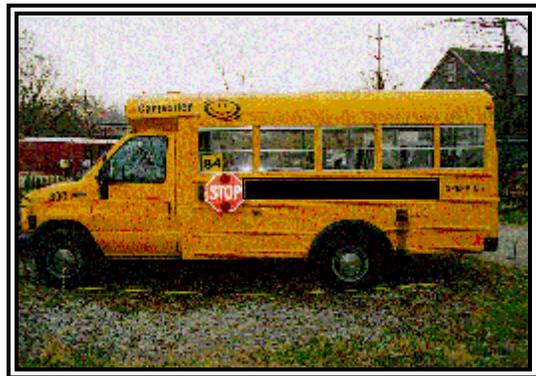
The 1995 Ford E350 van-based school bus was identified by the Vehicle Identification Number (VIN): 1FDJE37F6SH (production sequence deleted), **Figure 11**. The Ford E350 cab and chassis was manufactured as an incomplete vehicle in February 1995. The addition of a Carpenter bus body, model number 017-NY-19-00WC-EMC, completed the manufacture. The Carpenter body had a capacity of 19 children/10 adults. The body's manufacture date was January 1996. The completed bus had a gross vehicle weight rating of 9600 lb. The electronic odometer was inoperative at the time of the inspection.

Figure 11: Left side view of the 1995 Ford mini-bus.
