CASE NO. CA98-066

ELECTRIC POWERED VEHICLE CRASH

1998 FORD ELECTRIC RANGER PICKUP TRUCK

ON-SITE INVESTIGATION

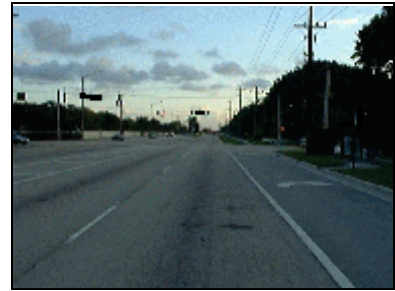
Figure 1 - View of pre-impact trajectory for the Ford prior to entering the intersection

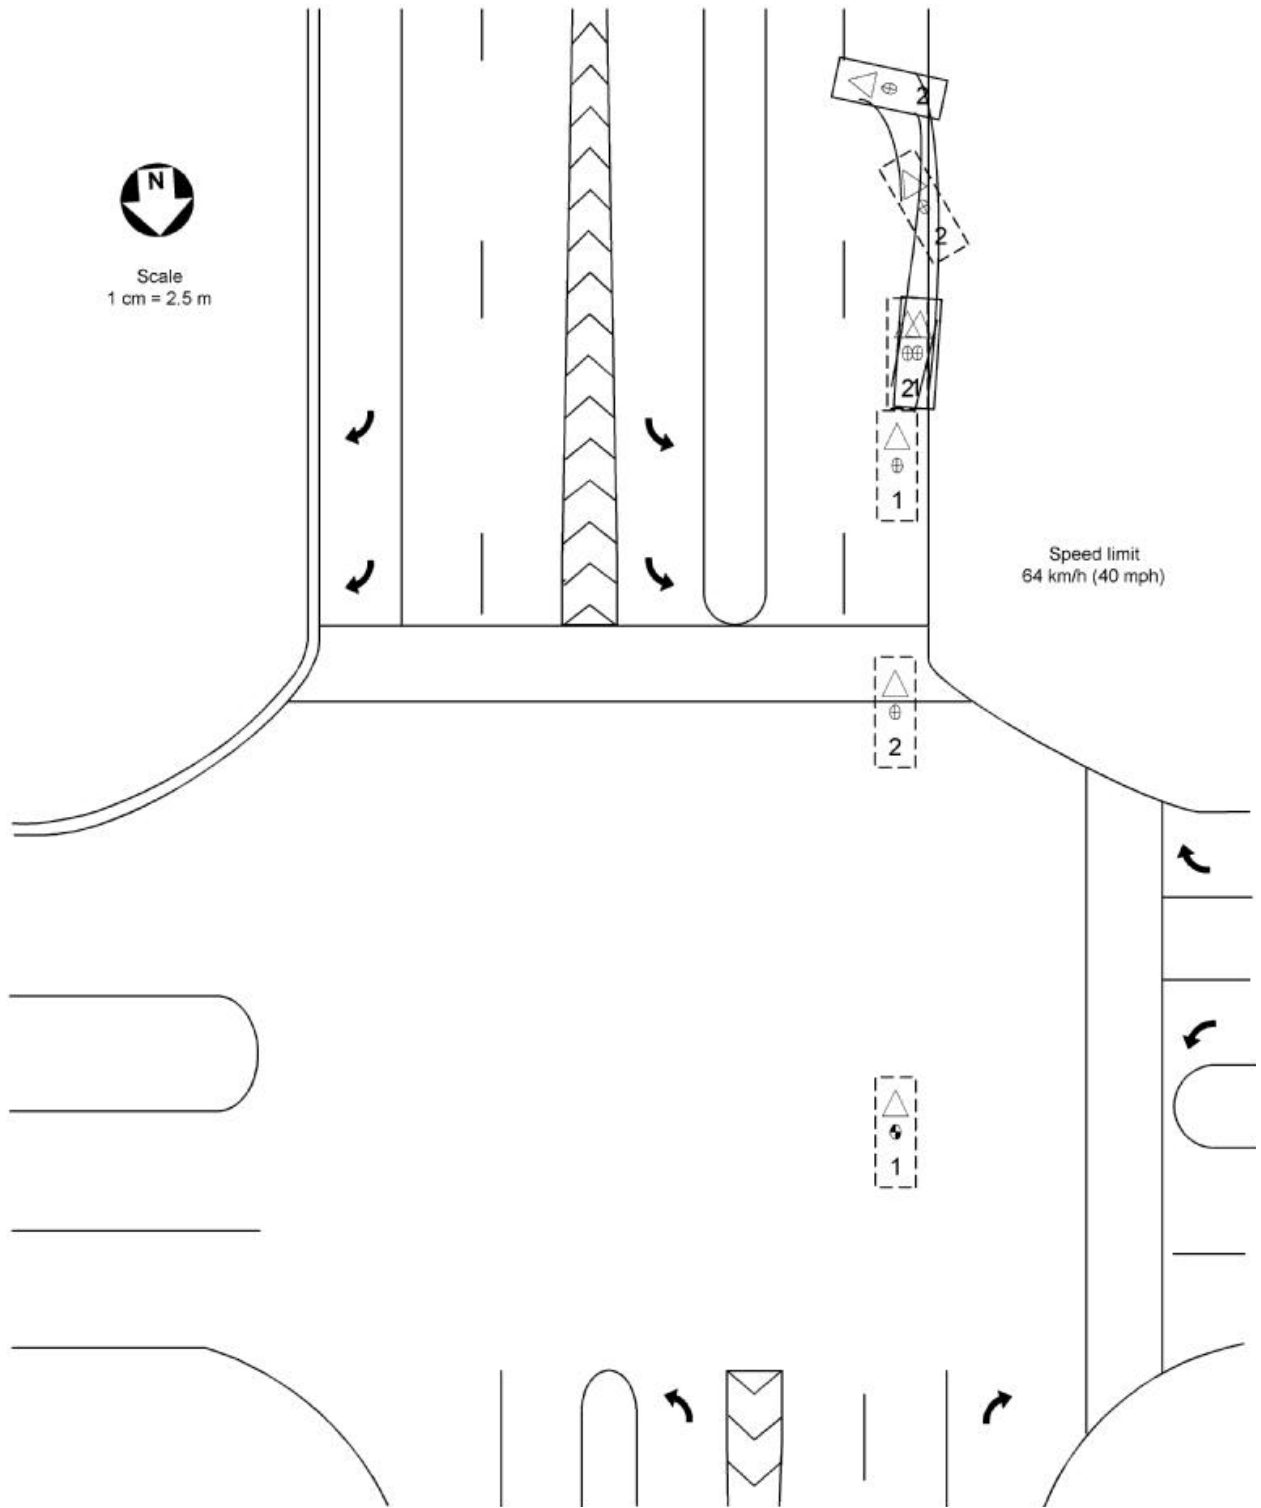
Figure 6 - Scene scaled schematic

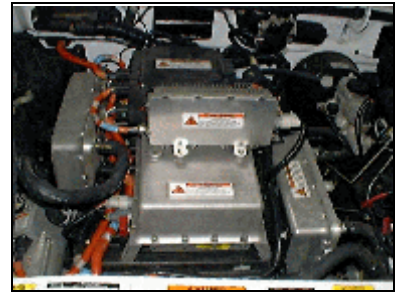
The 1998 Ford Electric Ranger pickup truck was built on the 1998 Ranger gasoline powered platform. The gasoline engine was replaced by an array of electrical components in the engine compartment that included: a power distribution control; a power converter; an electro-hydraulic power steering unit; an air conditioning control; and a heater control (**Figure 12**). A 12 volt lead-acid battery designated to operate the vehicle accessories such as wipers, fans, lights, radio, etc. was located in the forward left area of the engine compartment. Regenerative power to this battery was supplied by the converter located nearby. None of these components were damaged in the crash.

Figure 12- View of the electronic components

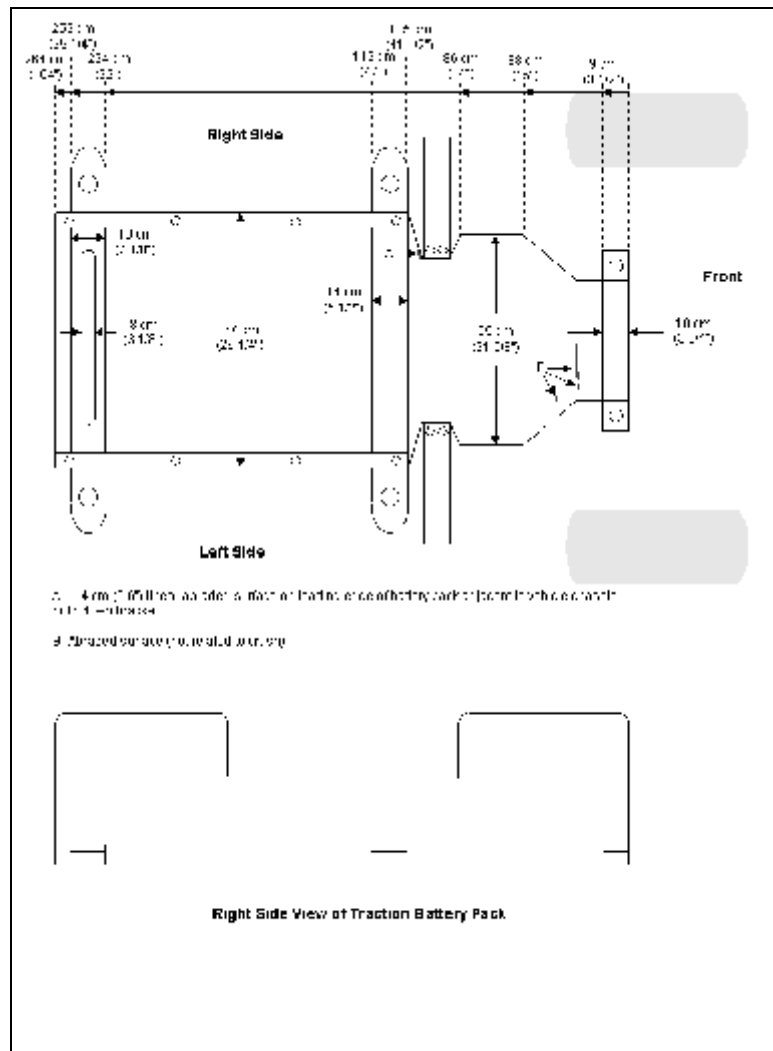
Figure 13

Crash related damage to the traction battery pack consisted of a small abrasion adjacent to the right front axle torsion bar bracket. It measured 1.4 cm (0.6") in length and was located on the leading vertical surface of the tray cutout for the torsion bar bracket and 9.8 cm (3.875") inboard from the right side of the tray (**Figures 13-15**). This mark was attributed to contact with the torsion bar

bracket during the crash sequence. There were other abrasions noted at various locations of the battery pack which were attributed to contact with the installation rack during routine maintenance. The traction battery pack did not appear to have been comprised during the crash.

The lateral profile of the battery pack varied throughout the longitudinal length to conform with the OEM chassis design as illustrated in **Figure 13**. The widest dimension measured 66.7 cm (26.25") and was located rearward of the mid mounting bracket.

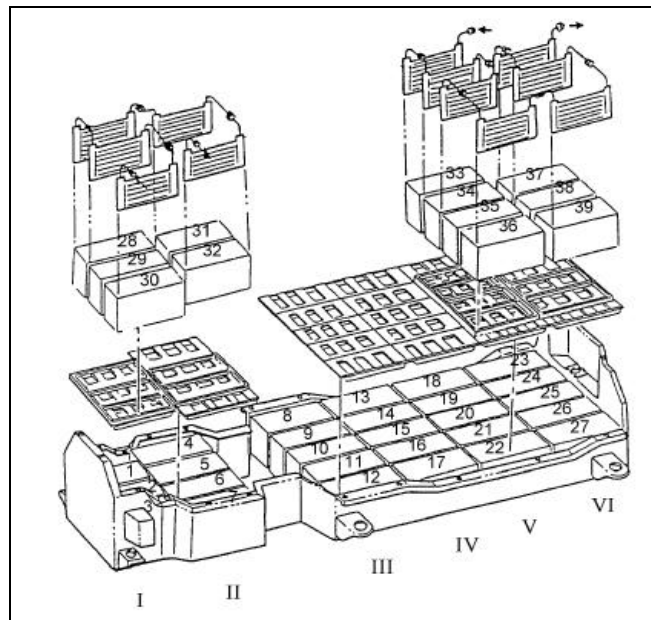
The batteries in the traction battery pack were oriented lengthwise in the battery tray and arranged in a two level configuration (**Figure 16**). The first level contained 27 batteries arranged in six rows beginning at the front of the battery pack and working rearward. The first row (front of the tray) contained 3 batteries, the second row 4 batteries, and the remaining four rows contained 5 batteries in each row. Between battery row two and three, the traction battery pack narrowed to accommodate the front axle torsion bar mounting bracket. This resulted in a 19.1 cm (7.5") separation between the rows.

Figure 16- Schematic of battery layout in traction battery pack as illustrated in the Ford EV training manual

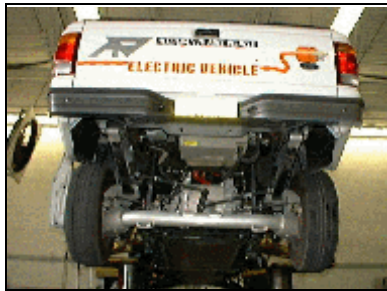
The OEM rear axle of the truck was replaced by a tubular shaped alloy axle which was curved near the wheels to accommodate the transaxle rear wheel propulsion system (**Figures 17 and 18**). The axle was joined by a coupler to the rear portion of the each rear wheel assembly. The following identification label was attached to the forward surface of the axle:

Figure 17- Overall view of the rear axle assembly and electric motor

The single-speed constant-ratio transaxles with a 12.518:1 gear ratio were installed between the rear wheels and the high-efficiency 3-phase AC induction motor. The motor was bolted to a 11.4 cm (4.5") wide support bracket that was located 11.4 cm (4.5") rear of the traction battery pack. Power was supplied to the motor/transaxle by a primary power (2-pin) connector which was located at the rear of the battery tray. These components were not damaged during the crash.

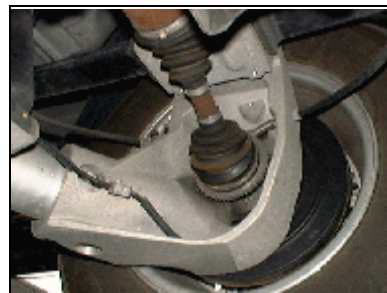
Figure 18- Close-up view of the left rear transaxle and wheel assembly looking rearward from the right side
