SCI/NASS COMBINATION CASE REPORT

CASE NUMBER - NASS-99-11-205J

VEHICLE - 1998 VOLKSWAGEN NEW BEETLE

CRASH DATE - December 1999

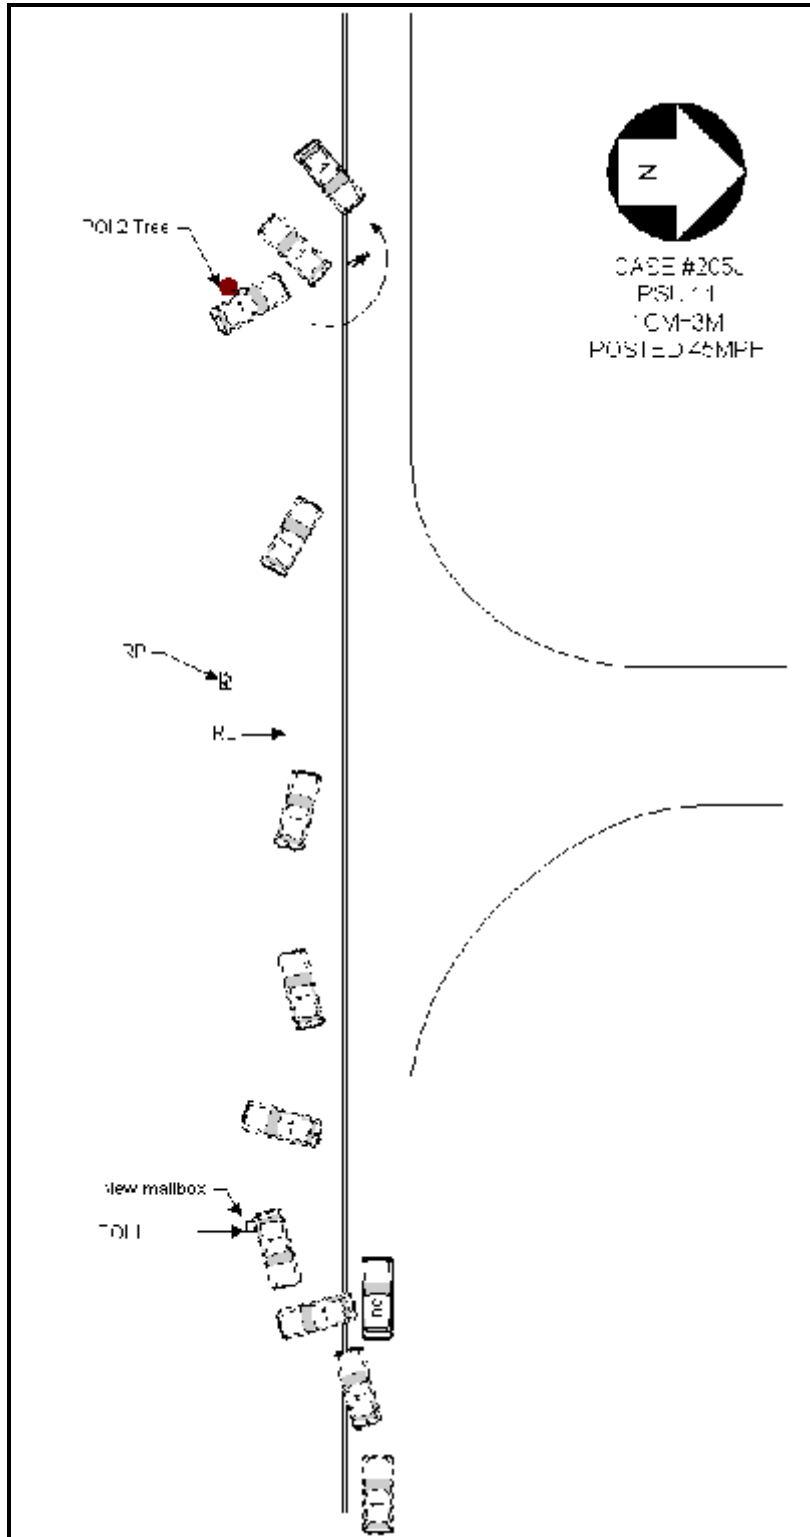
⁴The NASS scene diagram depicts a highly unlikely pattern of rotation. The location of the ejected occupant is not known.
