ON-SITE AIR BAG INVESTIGATION

CASE NUMBER - IN99-002

VEHICLE - 1999 PONTIAC GRAND AM SE

CRASH DATE - January, 1999

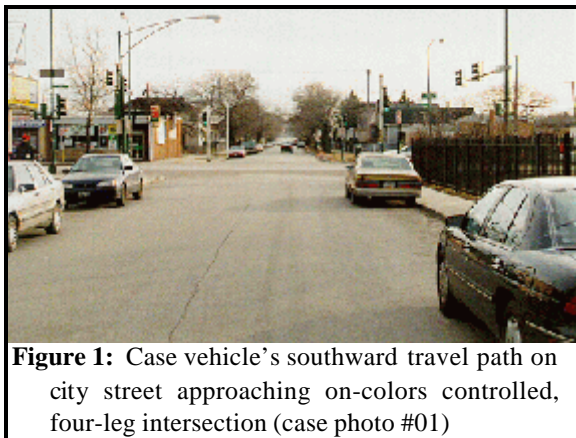
Figure 1: Case vehicle's southward travel path on city street approaching on-colors controlled, four-leg intersection (case photo #01)

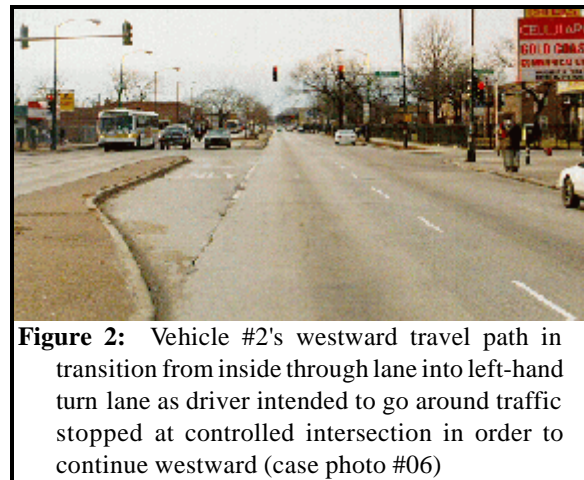
Figure 2: Vehicle #2's westward travel path in transition from inside through lane into left-hand turn lane as driver intended to go around traffic stopped at controlled intersection in order to continue westward (case photo #06)

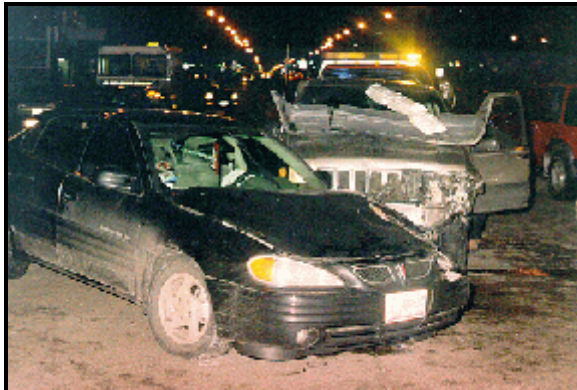
Figure 7: On-scene view looking east at final rest positions of case vehicle (foreground) and vehicle #2 (background); Note: point of impact is in the intersection, in the westbound roadway (for vehicle #2), and between the inside through lane and the left-hand turn lane (case photo #11)

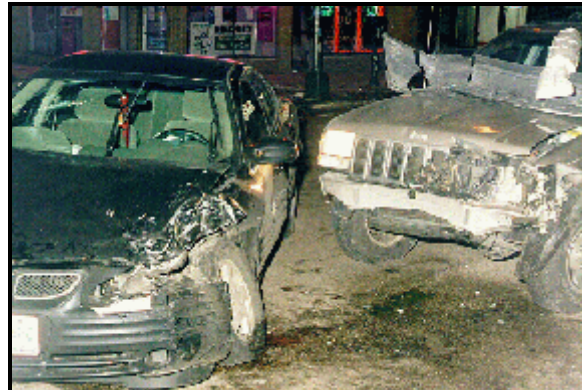
Figure 8: On-scene northeastward view of case vehicle (at left) and vehicle #2 (at right) at final rest; Note: initial contact involved vehicle #2's front left and the case vehicle's left front with a subsequent end slap between the front right half of vehicle #2 and the left front half of the case vehicle (case photo #12)
