ON-SITE REDESIGNED AIR BAG INVESTIGATION

CASE NUMBER - IN99-090

VEHICLE - 1999 CHEVROLET SILVERADO 1500

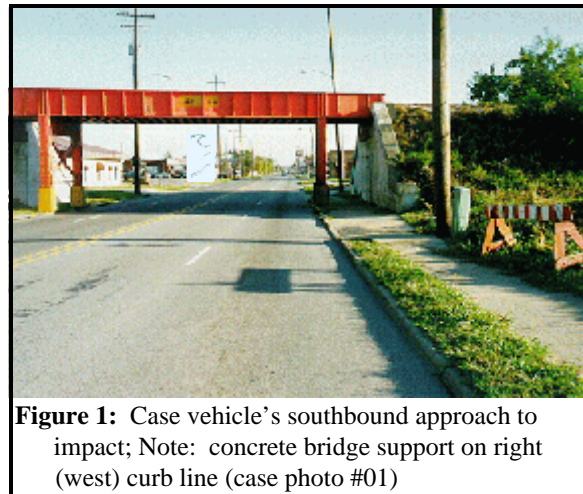
The case vehicle was traveling south in the outside, southbound lane of a four-lane, undivided, city street and intended to continue in its southerly travel path underneath a railroad overpass (**Figure 1**). The case vehicle's driver made no avoidance maneuvers prior to the crash, according to the driver, the front right passenger, and the investigating officer. The case vehicle's driver was internally distracted and did not notice the vehicle drifting off the right side of the roadway. The crash occurred on the west roadside of the trafficway (see **CRASH DIAGRAM**).
