NIST Technical Note XXXX

**Motorcoach Flammability Project
Final Report: Tire Fires - Passenger
Compartment Penetration, Tenability,
Mitigation, and Material Performance**

Erik L. Johnsson
Jiann C. Yang

November 2010

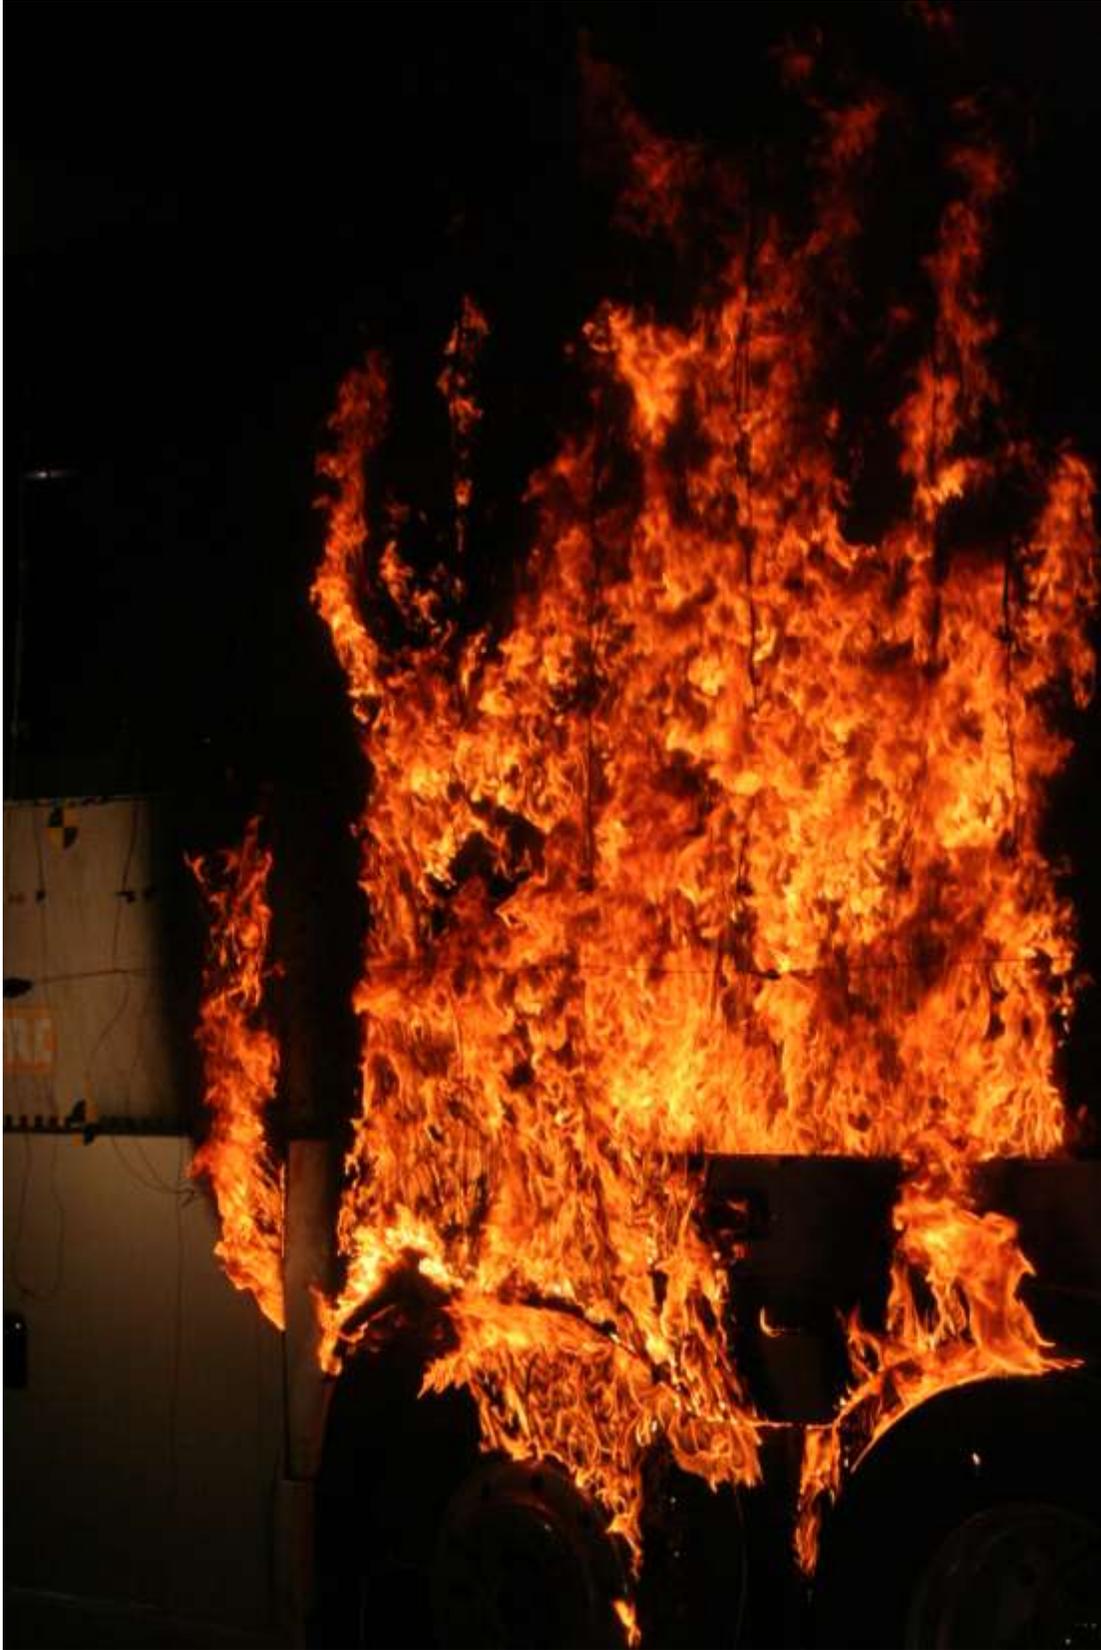
Figure 34 Tag axle wheel heating penetration experiment just under 4 min after the burner was removed.

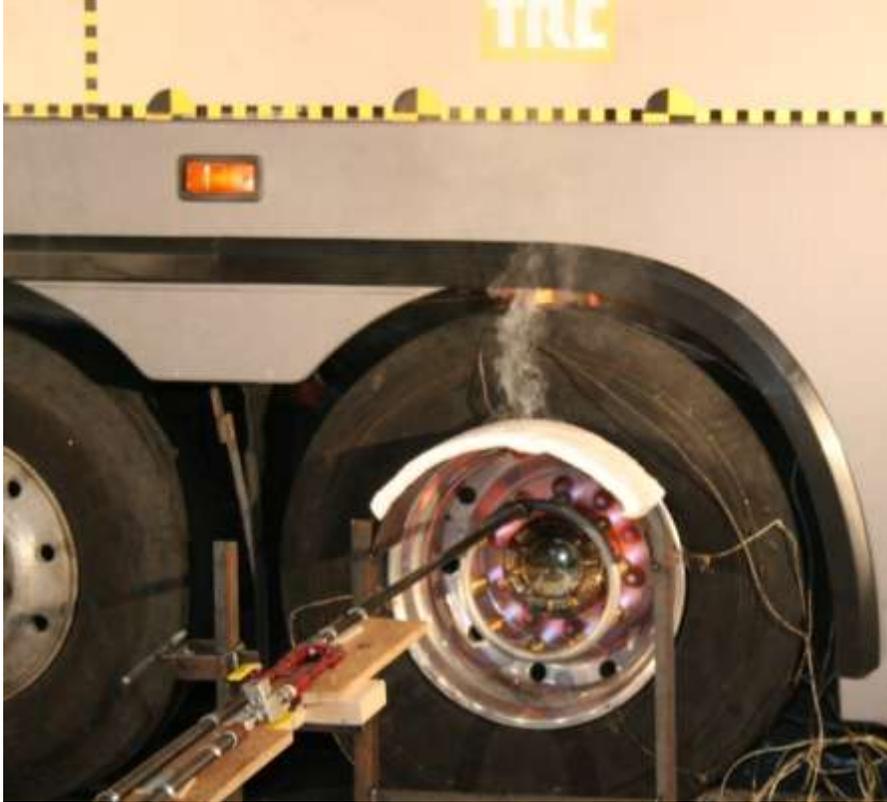
Figure 36 Drive axle wheel heating penetration experiment about 1 min before burner was turned off.

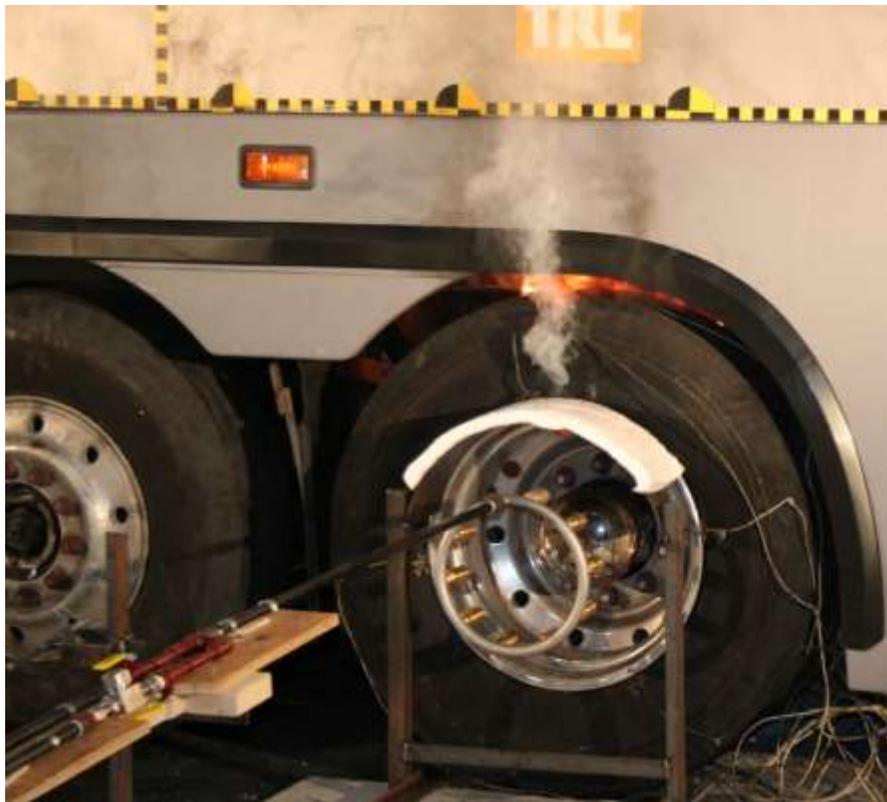
Figure 37 Drive axle wheel heating penetration experiment just after burner was turned off.

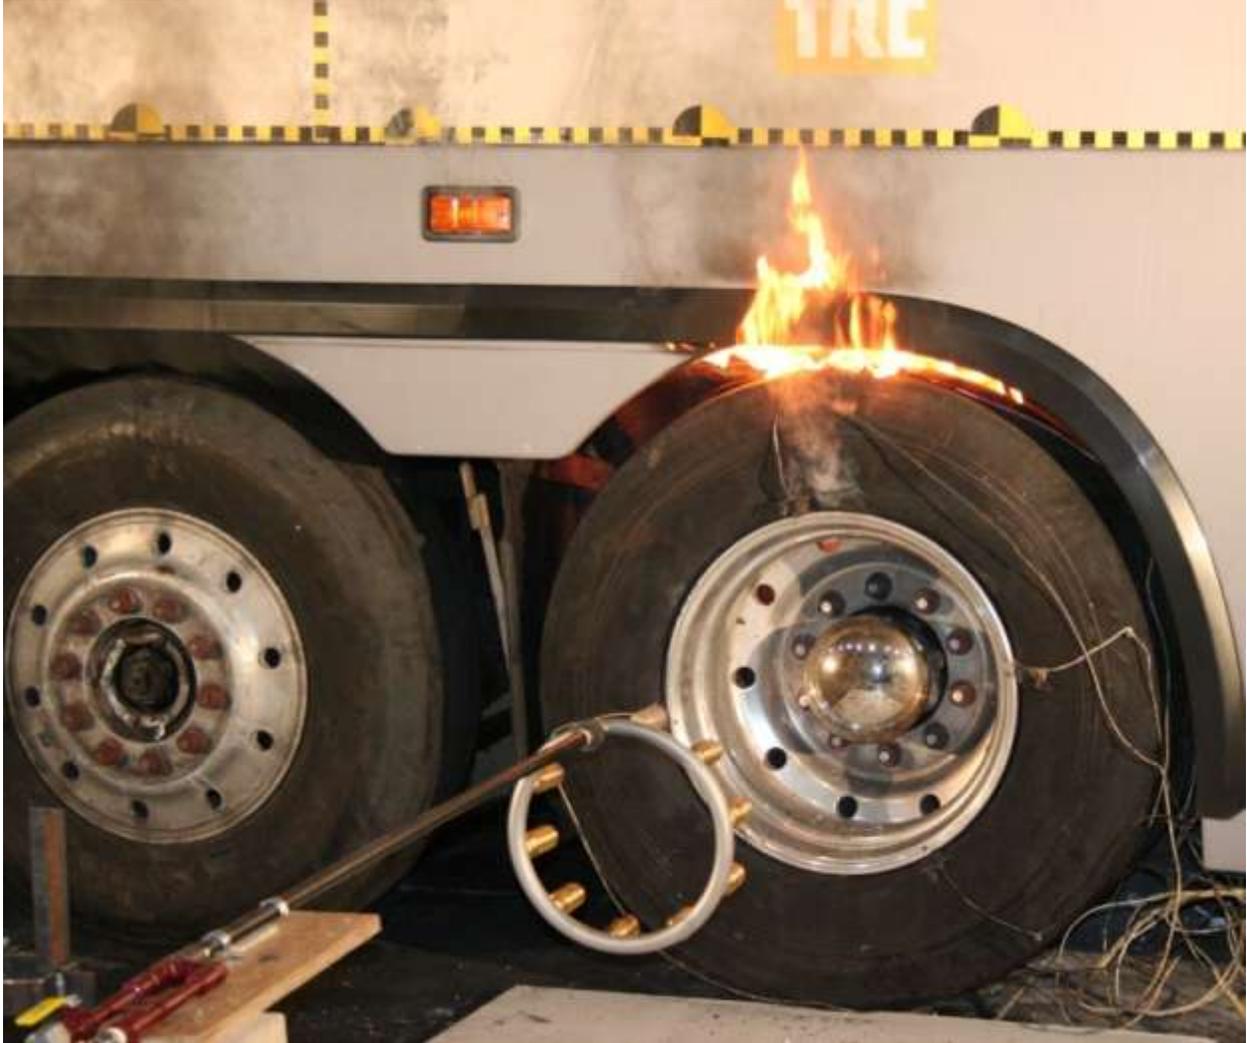
Figure 38 Drive axle wheel heating penetration experiment about 30 s after burner was turned off.

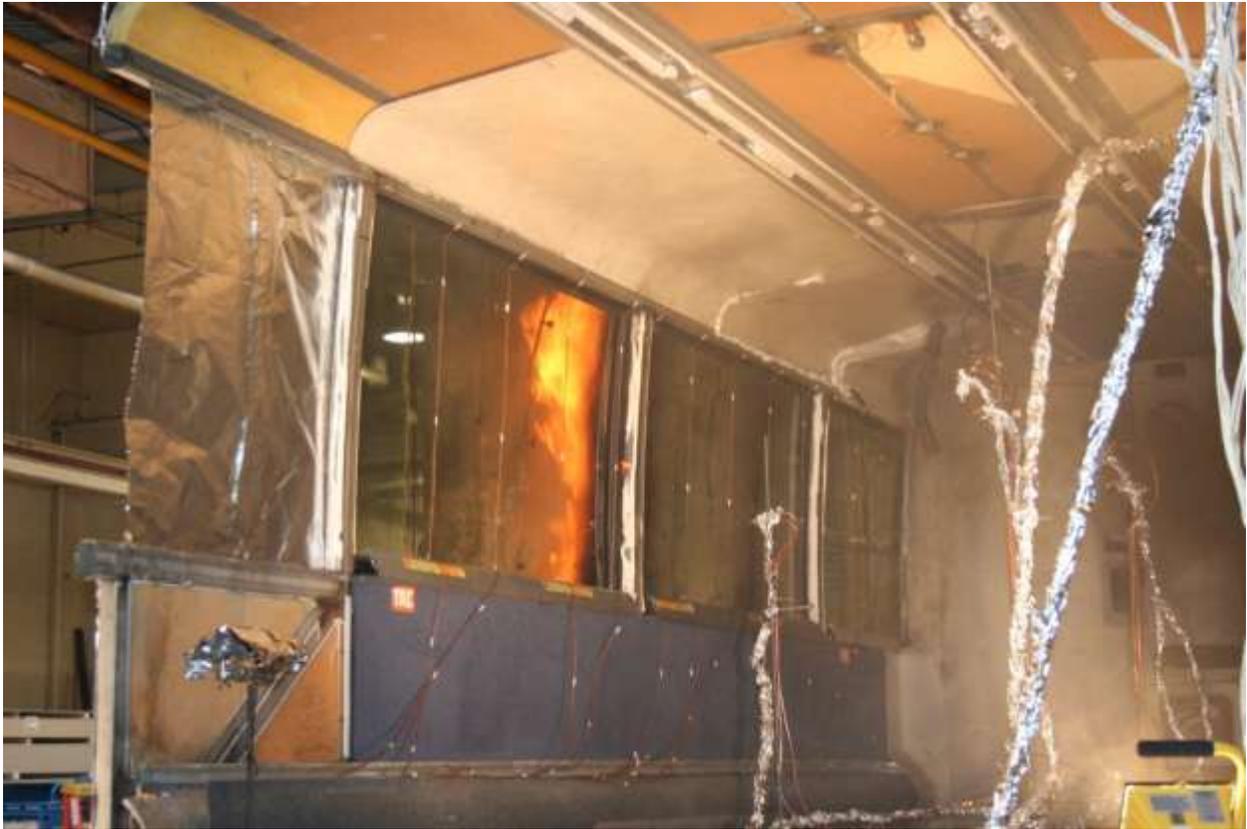
Figure 40 Drive axle wheel heating penetration experiment about 3 min after the burner was removed showing a view of the fire plume from the interior.

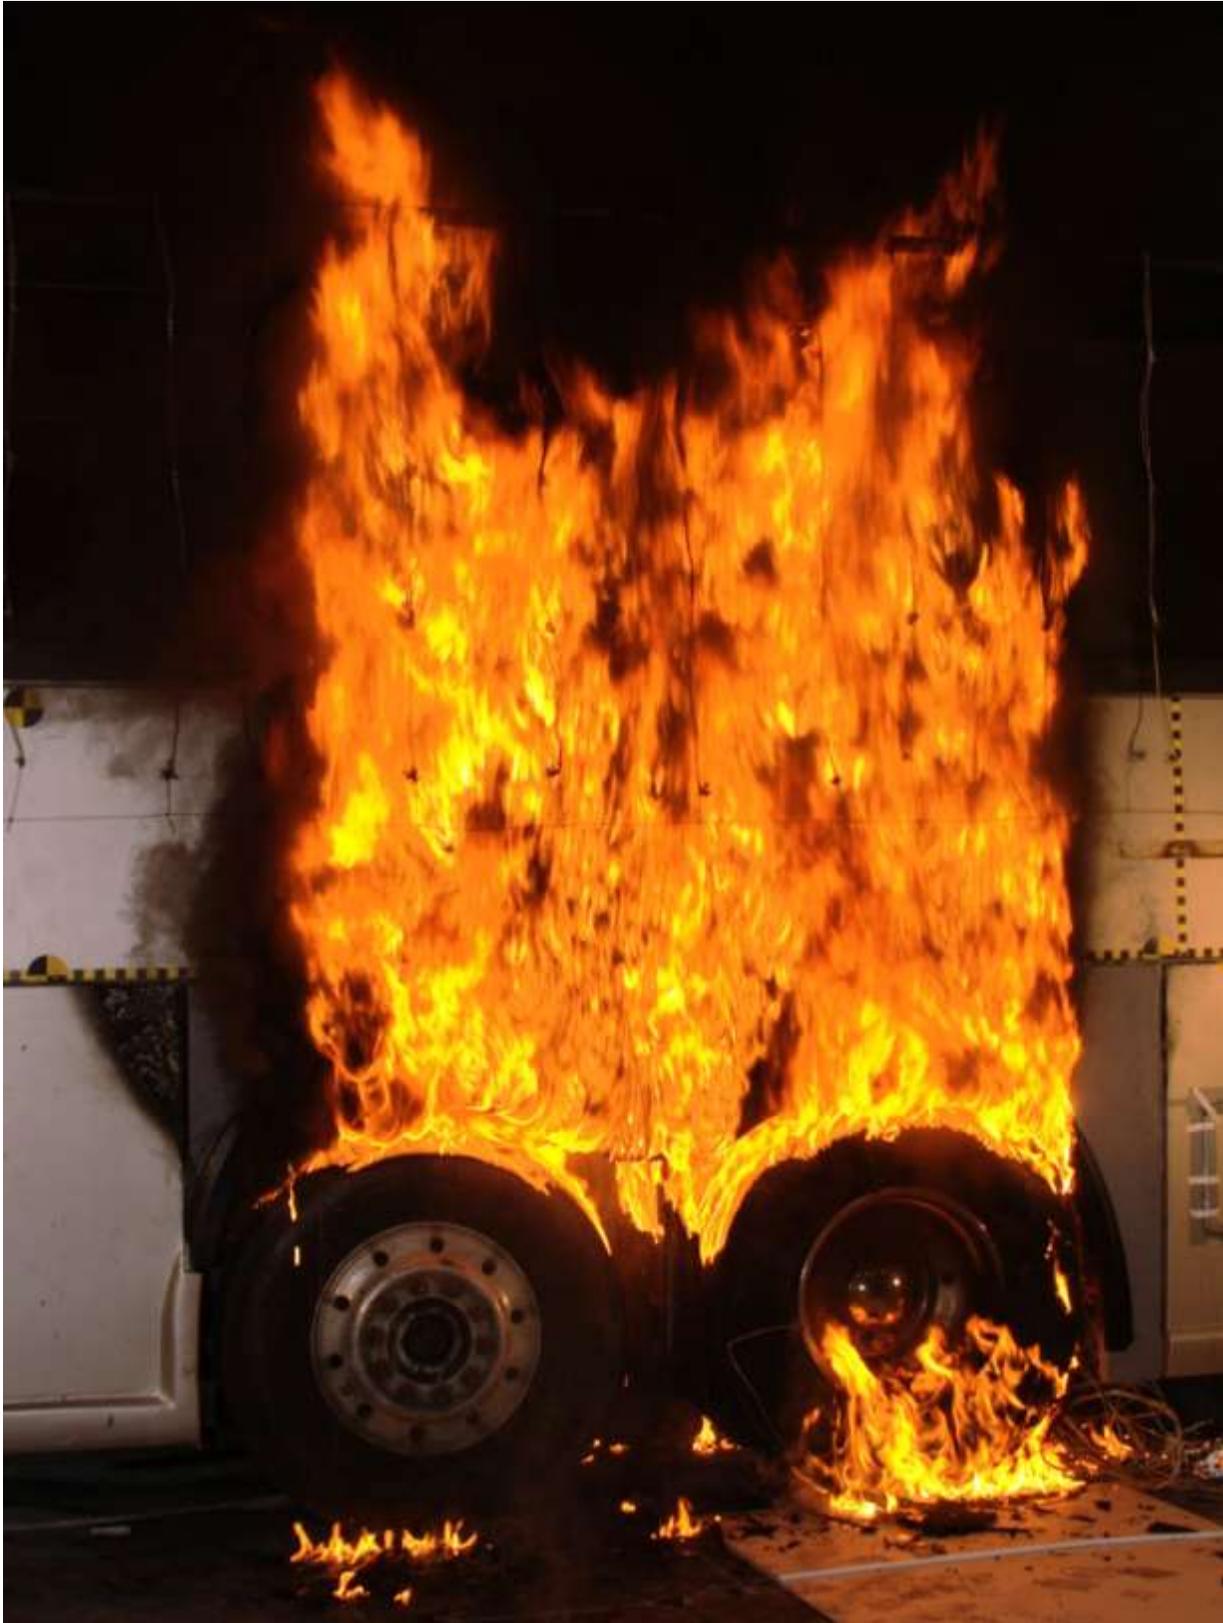
Figure 42 Drive axle wheel heating penetration experiment showing the joined fire plumes within 2 min of fire penetration.

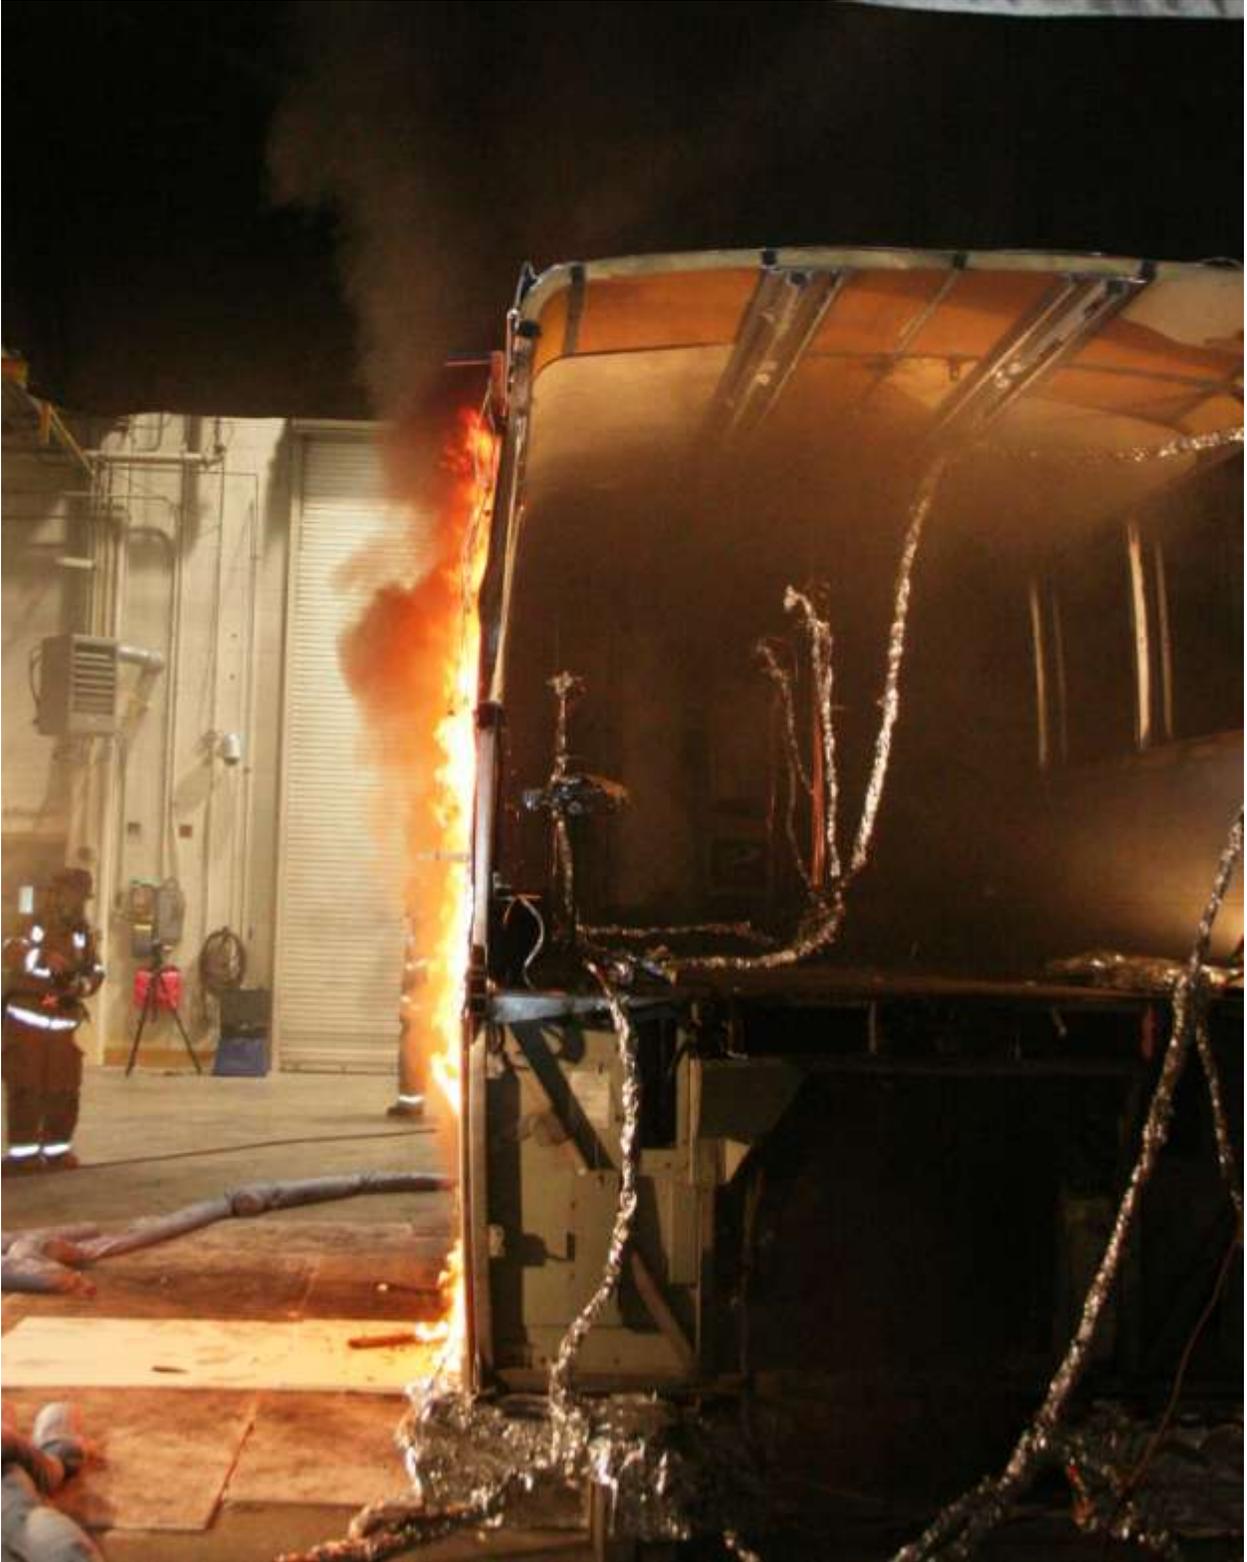
Figure 43 Drive axle wheel heating penetration experiment just under 5 min after burner removal.

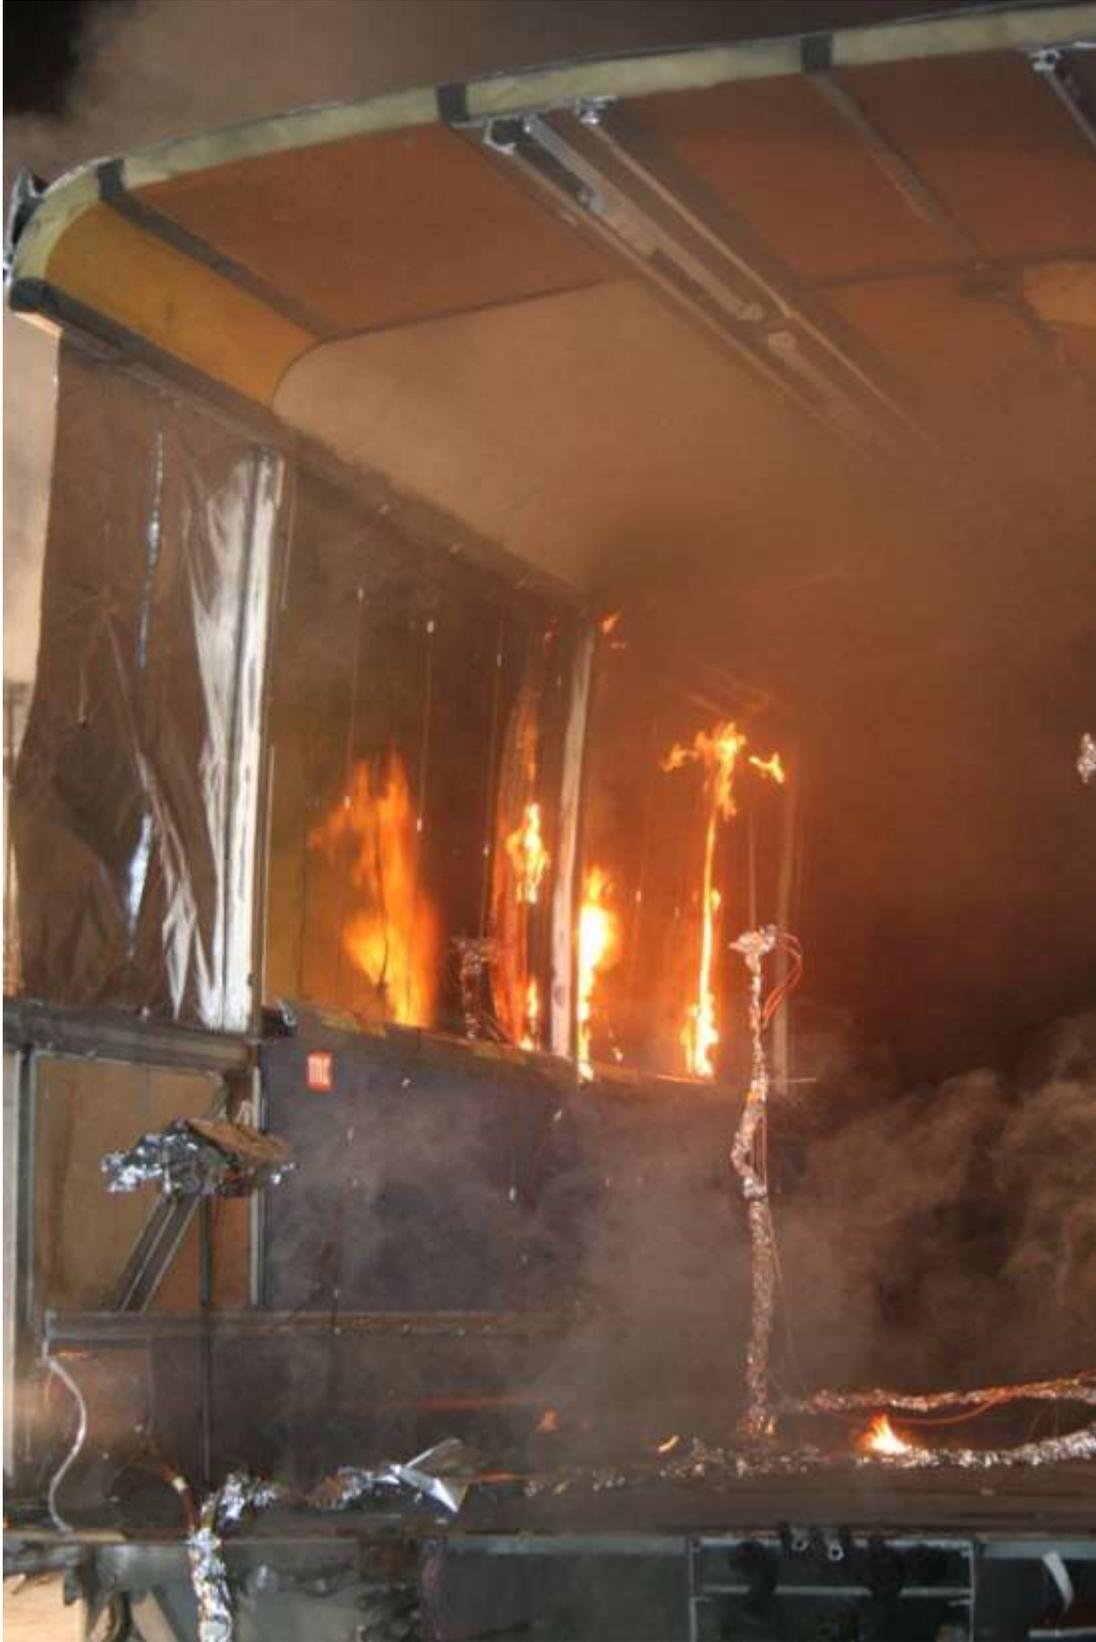
Figure 45 Drive axle wheel heating penetration experiment within a few seconds of fire penetration and at the very beginning of extinguishment.

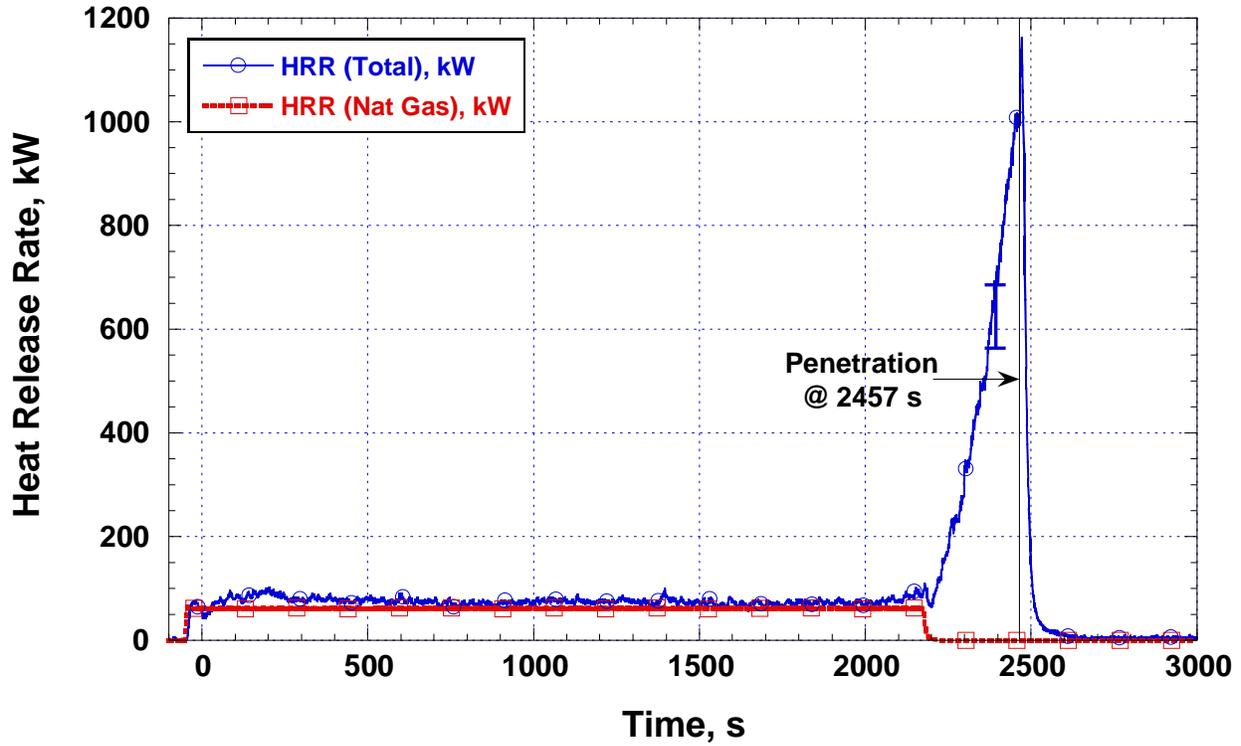
For the first test, the total heat released by the burner and motorcoach materials was 323 MJ, which consisted of 138 MJ (43 %) from the burner and 185 MJ (57 %) from the bus materials. For the second test, the total heat released by the burner and motorcoach materials was 341 MJ, which consisted of 77 MJ (32 %) from the burner and 264 MJ (77 %) from the bus materials. The total heat released during each test was similar, but the drive axle test required much less heating (56 %) for the reasons described in the previous section on event timing. During the drive axle test (#2), 43 % more bus material was burned than in the tag axle test (#1). The drive axle tire fire actually spread to the tag axle tire causing two plumes to merge and involving more of the exterior panel than the single plume from the tag axle test. Also, the tires and exterior panels burned longer before penetration during the drive axle test.

Figure 46 Heat release rate plotted versus time for test 1, the heated tag axle wheel passenger compartment penetration experiment.

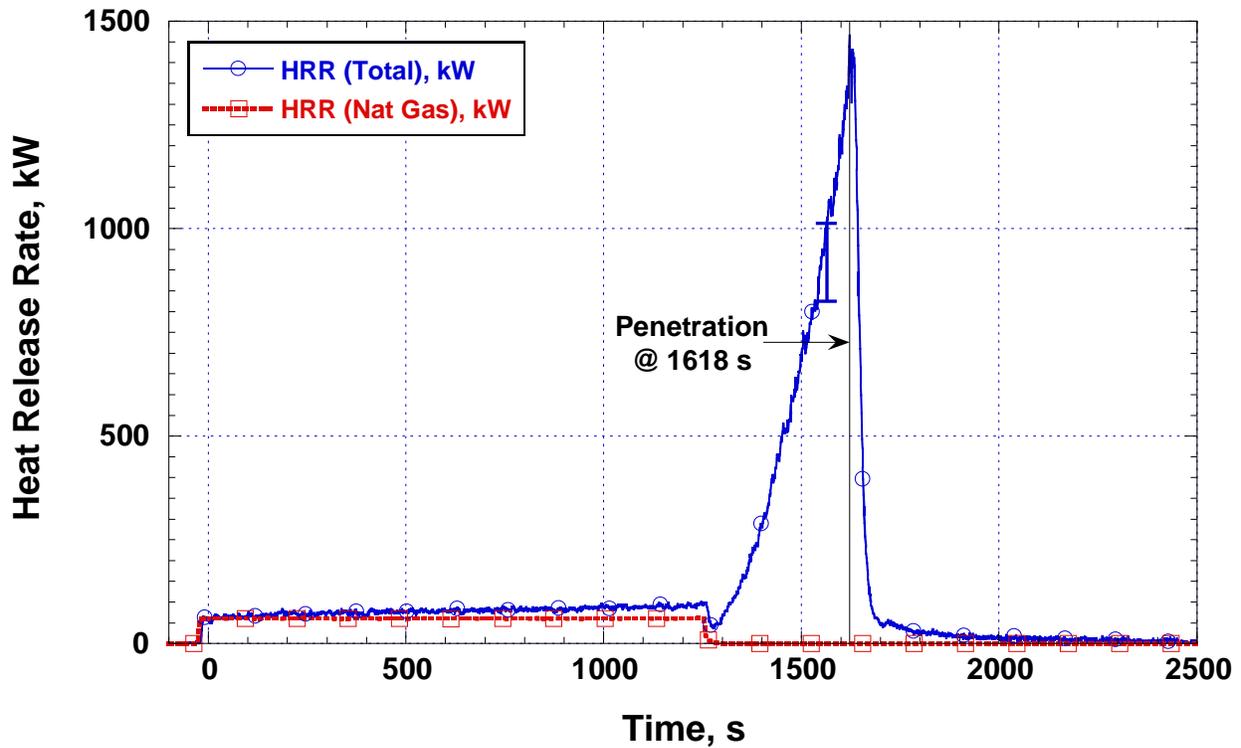
Figure 47 Heat release rate plotted versus time for test 2, the heated drive axle wheel passenger compartment penetration experiment.

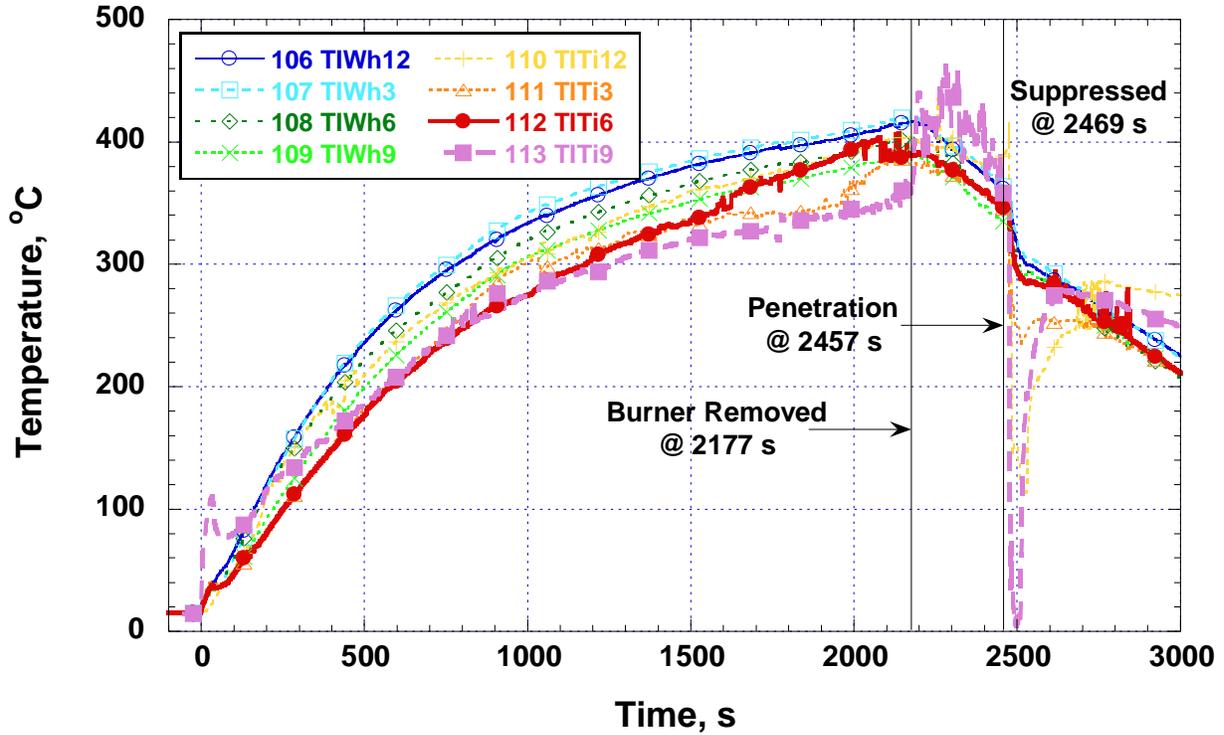
Figure 48 and Figure 49 are plots of temperature versus time for the wheel and tire thermocouples on the right side of the motorcoach. Figure 15 shows the labeling scheme used in the plot legends, and Appendix A provides more detailed location descriptions for these and subsequent plots. For the heated tag axle wheel experiment, the wheel temperatures only led the tire temperatures by about 40 °C. As shown in Table 11, some intermittent ignition of the tire was occurring at 1860 s. By that point, the tire temperatures at the top and bottom positions had exceeded 360 °C. At that same time, the maximum wheel temperatures had just surpassed 400 °C. For the heated drive axle wheel experiment, the wheel temperatures led the tire temperatures by 100 °C to 150 °C. This is easily explained by the fact that the tire temperatures were measured on the outside interface between the tire and wheel rim, but wheel thermocouples were located on the inside surface of the wheel between the outer and inner wheels. Also, the heat from the burner was focused at the inside surface of the wheel which preferentially heated up the inside parts of the tire as well. At the time when flames were seen rising between the tires, the wheel temperatures all exceeded 420 °C. Because a lot of smoke was visible and some wheel temperatures exceeded 400 °C about 7 min prior to visible flames, it's likely that a smoldering or small flaming fire existed between the tires well before flames were seen.

Figure 48 A plot of test 1 (tag axle) temperatures versus time for the heated wheel (Wh) and tire (Ti). Numbers in the labels represent 12, 3, 6, and 9 o'clock positions (0°, 90°, 180°, and 270° from top).

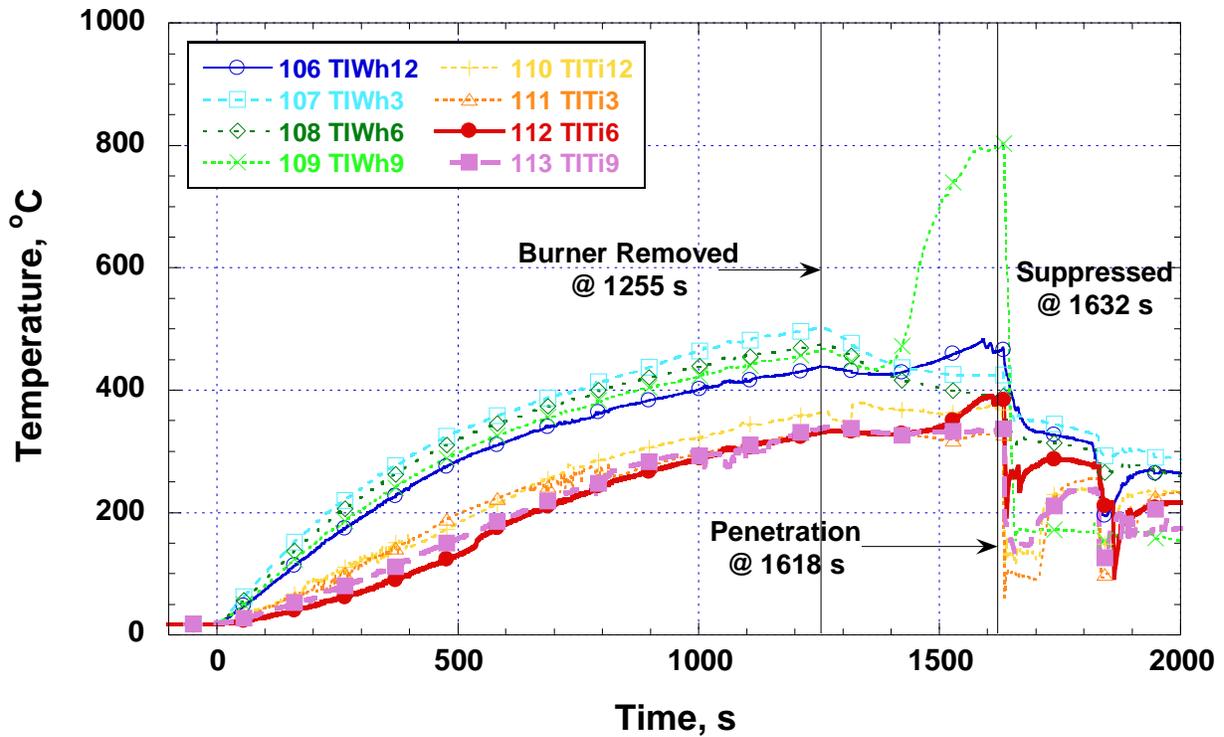
Figure 49 A plot of test 2 (drive axle) temperatures versus time for the heated wheel (Wh) and tire (Ti). Numbers in the labels represent 12, 3, 6, and 9 o'clock positions (0°, 90°, 180°, and 270° from top).

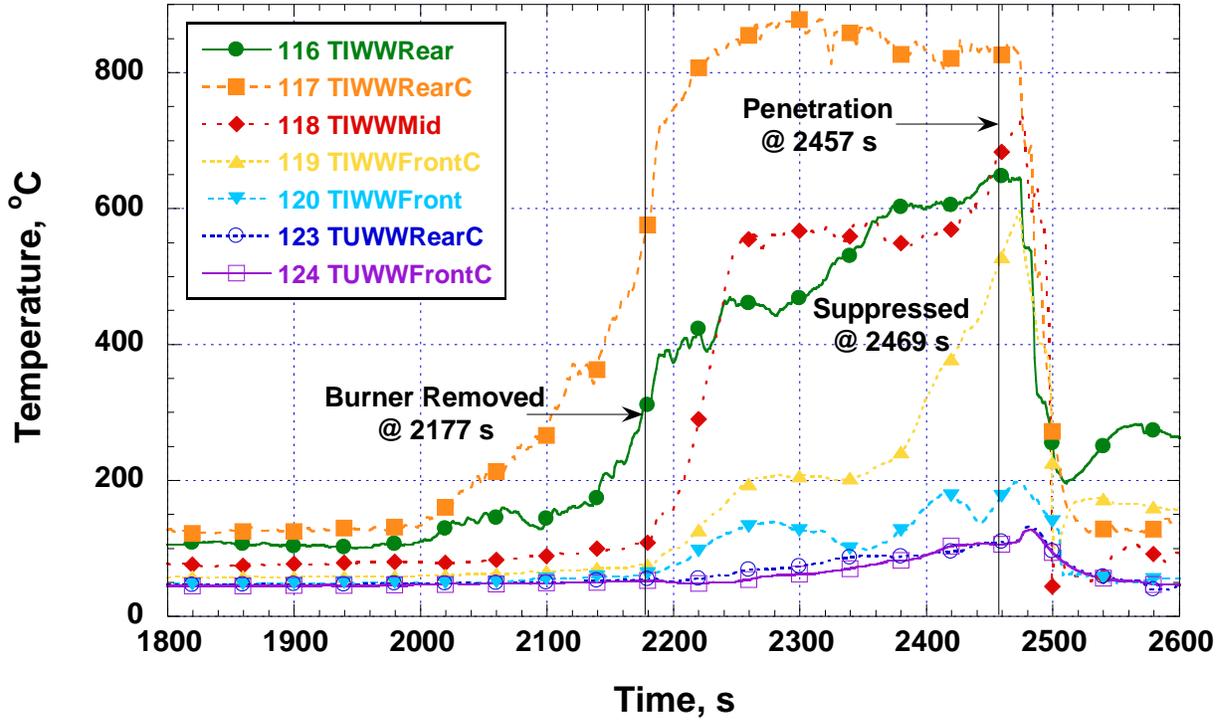
Wheel well gas temperature plots are shown in Figure 50 and Figure 51. The heated tag axle wheel experiment produced the highest temperatures (850 °C) directly over the rear tire and the second highest temperatures (650 °C) directly behind and between the tag and drive axle tires. For the heated drive axle wheel experiment, all but the front most temperature exceeded (900 °C). Far (driver's) side wheel well temperatures were rising, but were below 300 °C at the time of penetration. For the minute prior to penetration, the far side wheel well temperatures rose at about 20 °C/min for the tag axle test and between 40 °C/min and 60 °C/min for the drive axle test.

Figure 50 A plot of test 1 (tag axle) temperatures versus time for the wheel wells. I and U represent ignited and unignited sides, respectively.

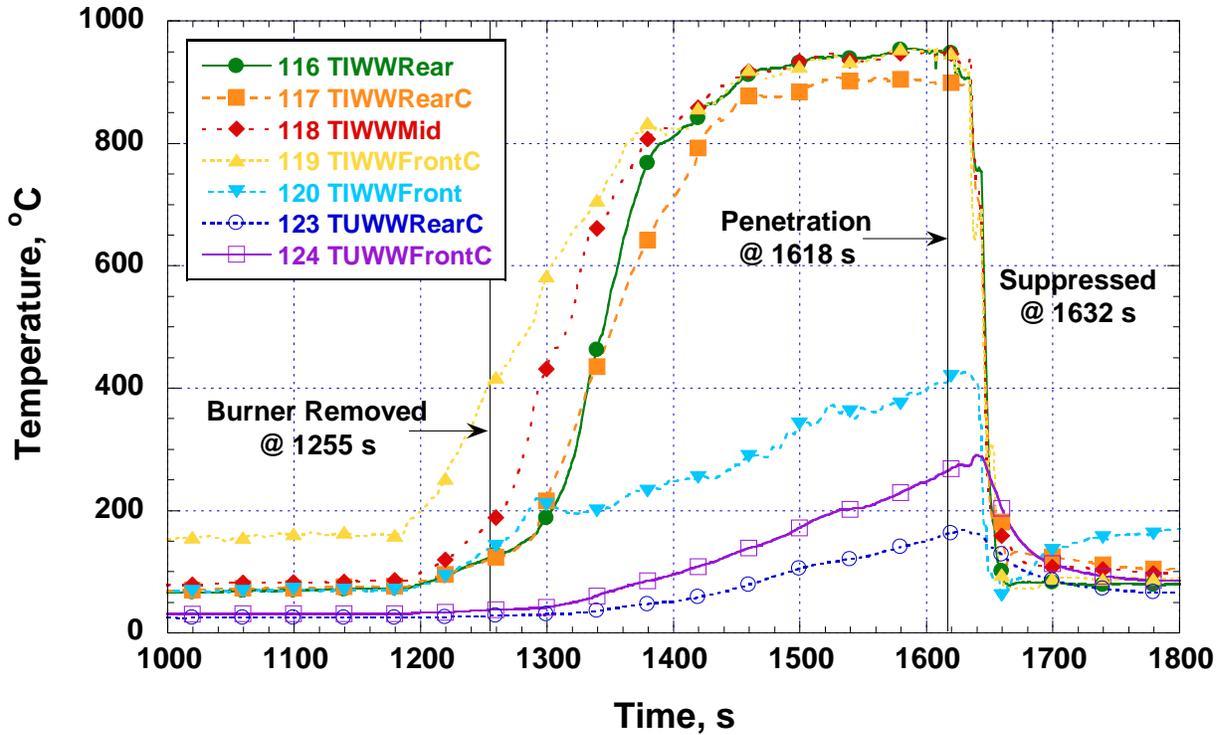
Figure 51 A plot of test 2 (drive axle) temperatures versus time for the wheel wells. I and U represent ignited and unignited sides, respectively.

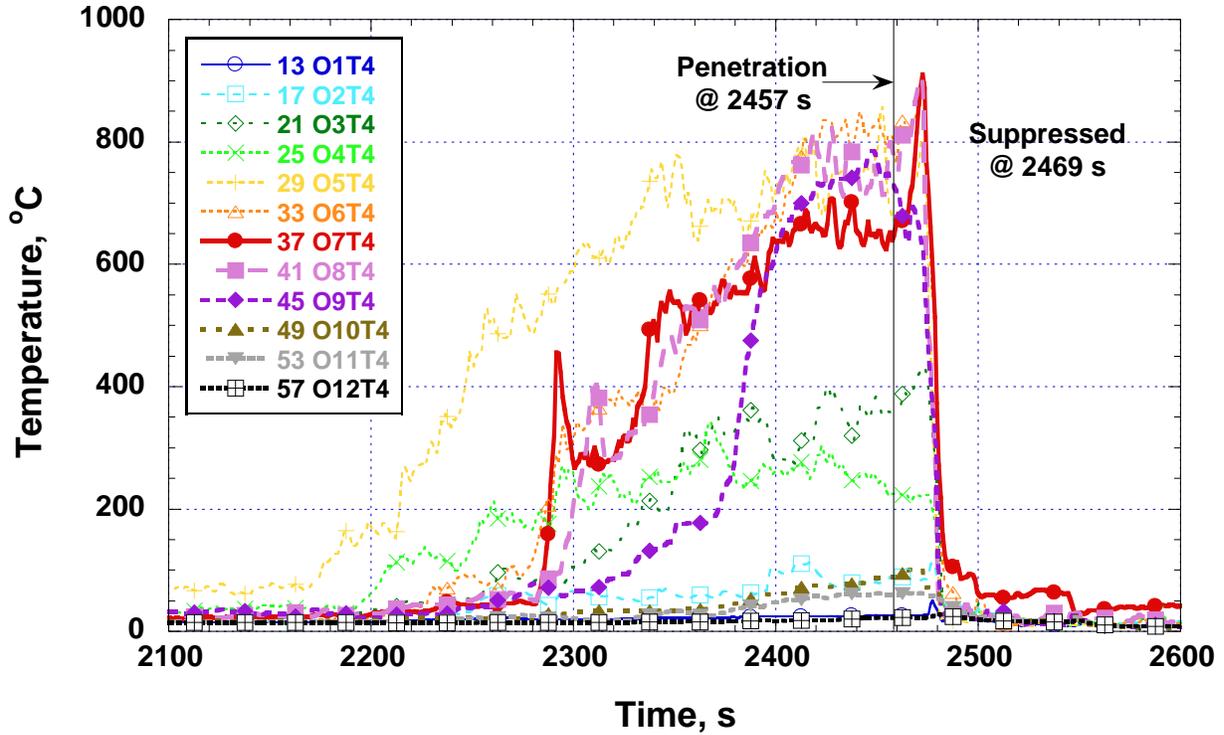
Figure 52 and Figure 53 are plots from both experiments showing temperature versus time for the exterior thermocouples located over the GRP paneling just below the window line. Refer to Figure 16 for the exterior thermocouple locations and Figure 17 for the interior locations. The plots show that before penetration for both experiments, the temperatures in columns 5 to 9 were much higher than those for columns 1 to 4 and 10 to 12 with the exception of column 7 for test 2 which had a lower temperature. For both tests, the temperatures for columns 5 to 9 ranged from 600 °C to 850 °C except for test 2 column 7 which had a temperature of 400 °C at penetration. Column 7 is located just forward of the midpoint between the two axles so the separate fire plumes apparently did not affect the space between the plumes as severely as they did the space directly above them.

Figure 52 A plot of test 1 (tag axle) temperatures versus time for the lowest row of exterior TCs located below the window line 1 cm from the exterior GRP panel. See Figure 16 for labeling system.

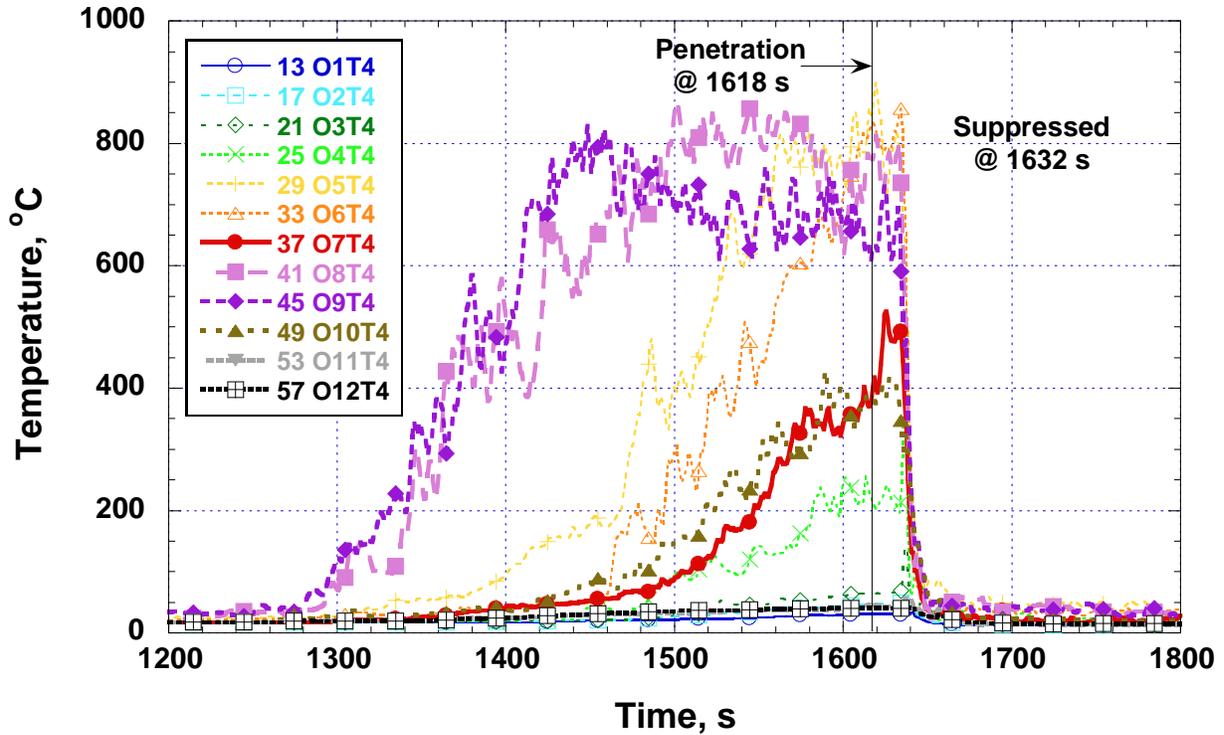
Figure 53 A plot of test 2 (drive axle) temperatures versus time for the lowest row of exterior TCs located below the window line 1 cm from the exterior GRP panel. See Figure 16 for labeling system.

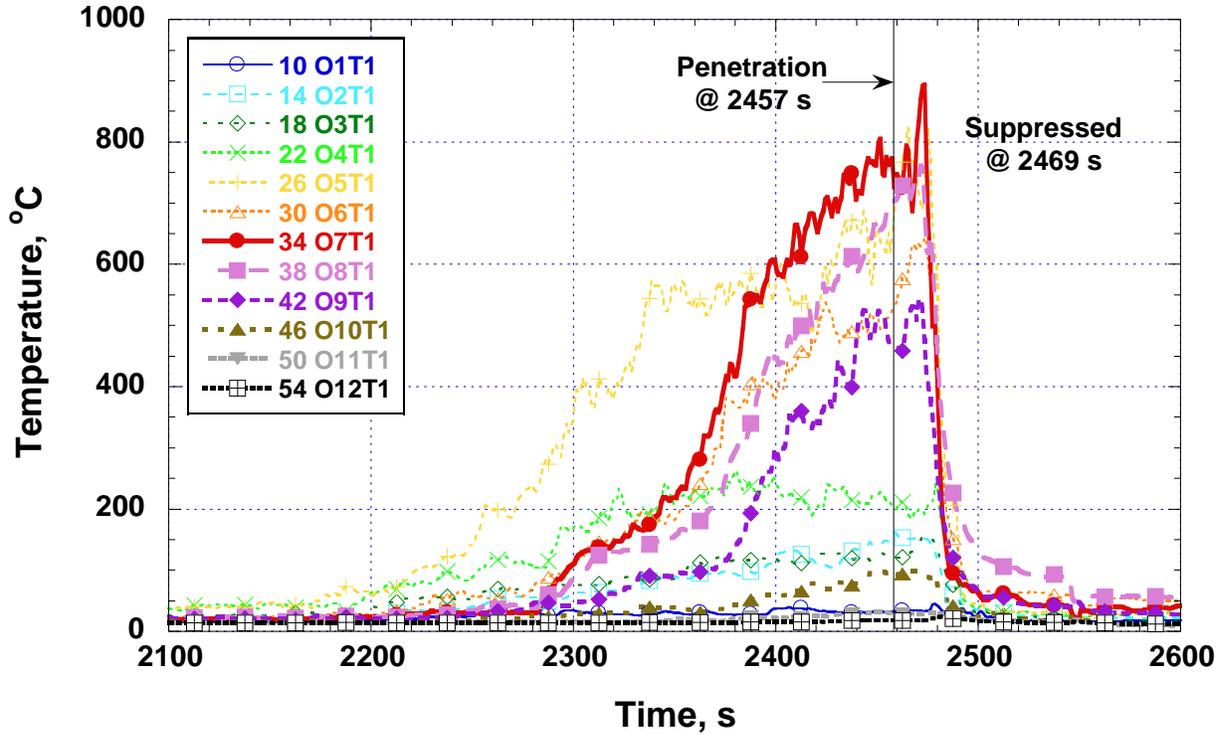
Figure 54 and Figure 55 are plots from both experiments showing temperature versus time for the highest exterior thermocouples located near the tops of the windows. For test 1, columns 5 to 9 are again the hottest. For test 2, temperatures in columns 8 and 9 are high early with columns 5 and 6 (over the tag axle tire) lagging behind by about 1.5 min and 3 min, respectively. As with the lowest position on the panel, column 7's temperature lags even farther behind since it is in between the main plumes.

Figure 54 A plot of test 1 (tag axle) temperatures versus time for the highest row of exterior TCs located 1 cm from window surfaces and about 10 cm from the top of the windows. Figure 16 shows labeling.

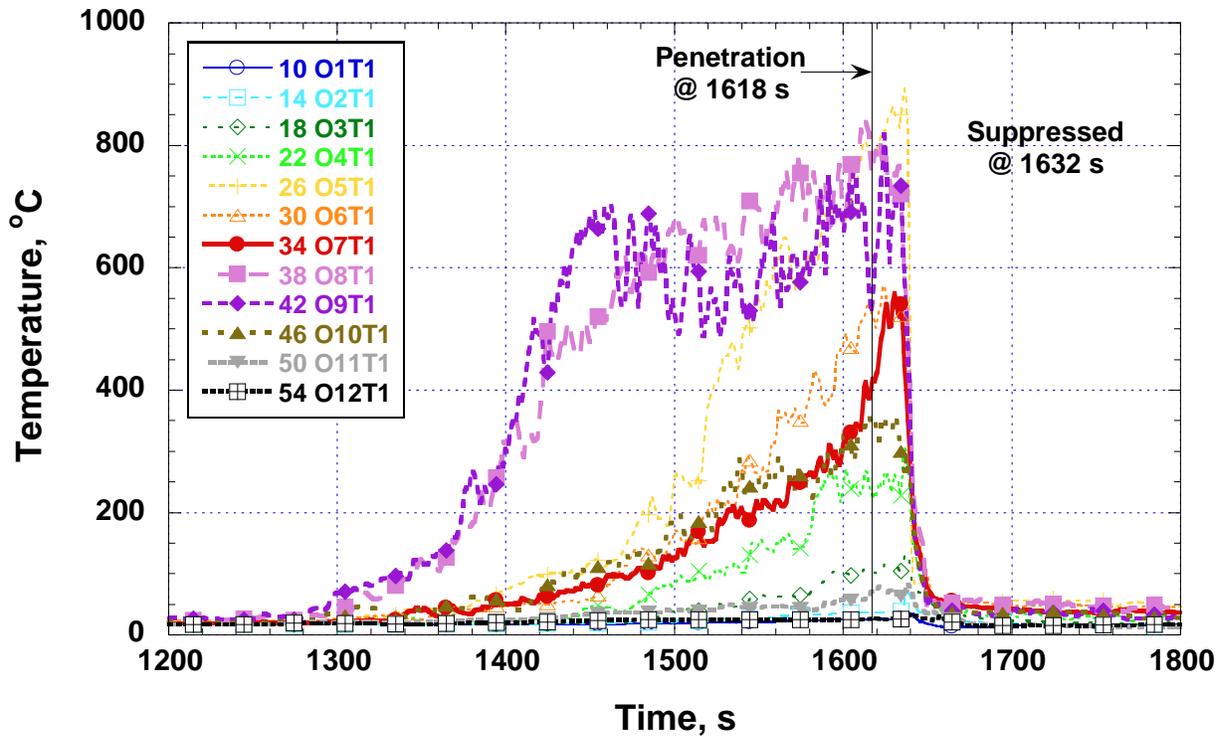
Figure 55 A plot of test 2 (drive axle) temperatures versus time for the highest row of exterior TCs located 1 cm from window surfaces and about 10 cm from the top of the windows. Figure 16 shows labeling.
