NIST Technical Note XXXX

**Motorcoach Flammability Project
Final Report: Tire Fires - Passenger
Compartment Penetration, Tenability,
Mitigation, and Material Performance**

Erik L. Johnsson
Jiann C. Yang

November 2010

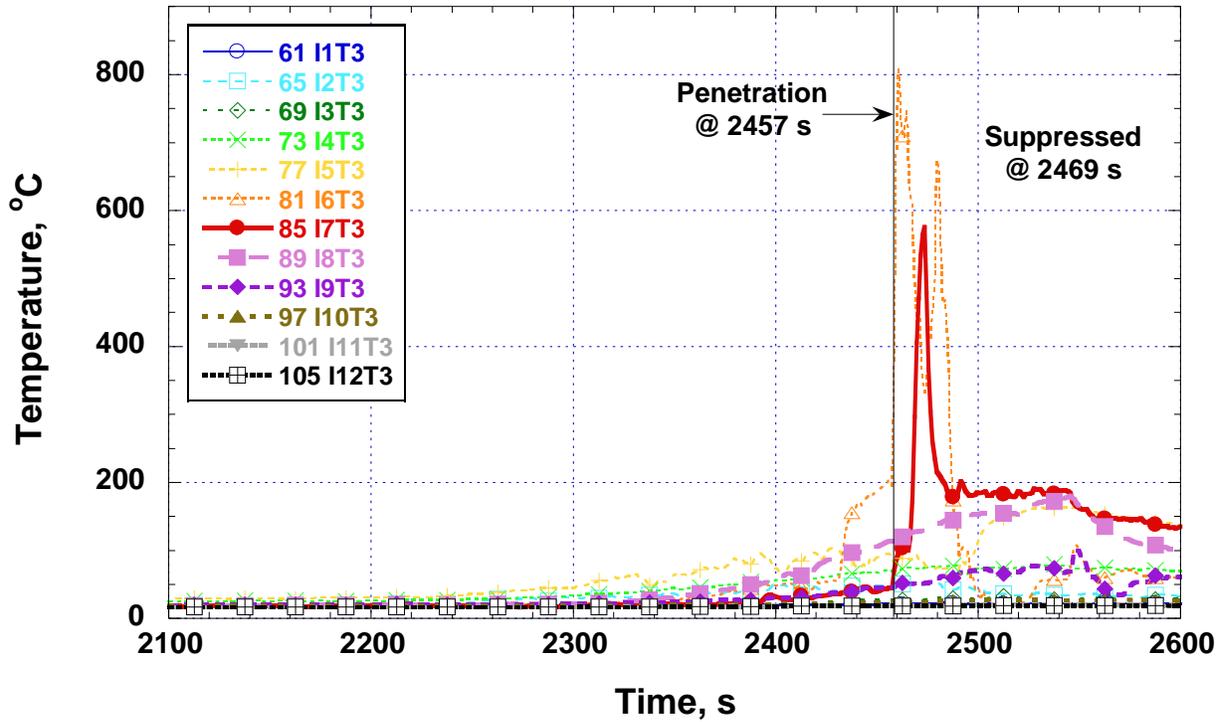
Figure 56 and Figure 57 are plots from both experiments showing temperature versus time for the lowest interior thermocouples located about 3 cm from the bottom of the windows. For test 1, the column 6 thermocouple approached 200 °C for about 30 s and briefly exceeded 600 °C at penetration while the other interior temperatures remained below 100 °C. This indicates that the windows acted as somewhat effective thermal barriers until actual penetration, which occurred near column 6. For test 2, column 8 temperatures rose steadily to 200 °C for the 3 min prior to penetration and then quickly exceed 500 °C along with the column 9 temperature. Again, except when breakthrough occurred, the temperatures remained relatively low.

Figure 56 A plot of test 1 (tag axle) temperatures versus time for the lowest row of interior TCs, 1 cm from window surfaces and about 3 cm from the bottom of the windows. Figure 17 shows labeling.

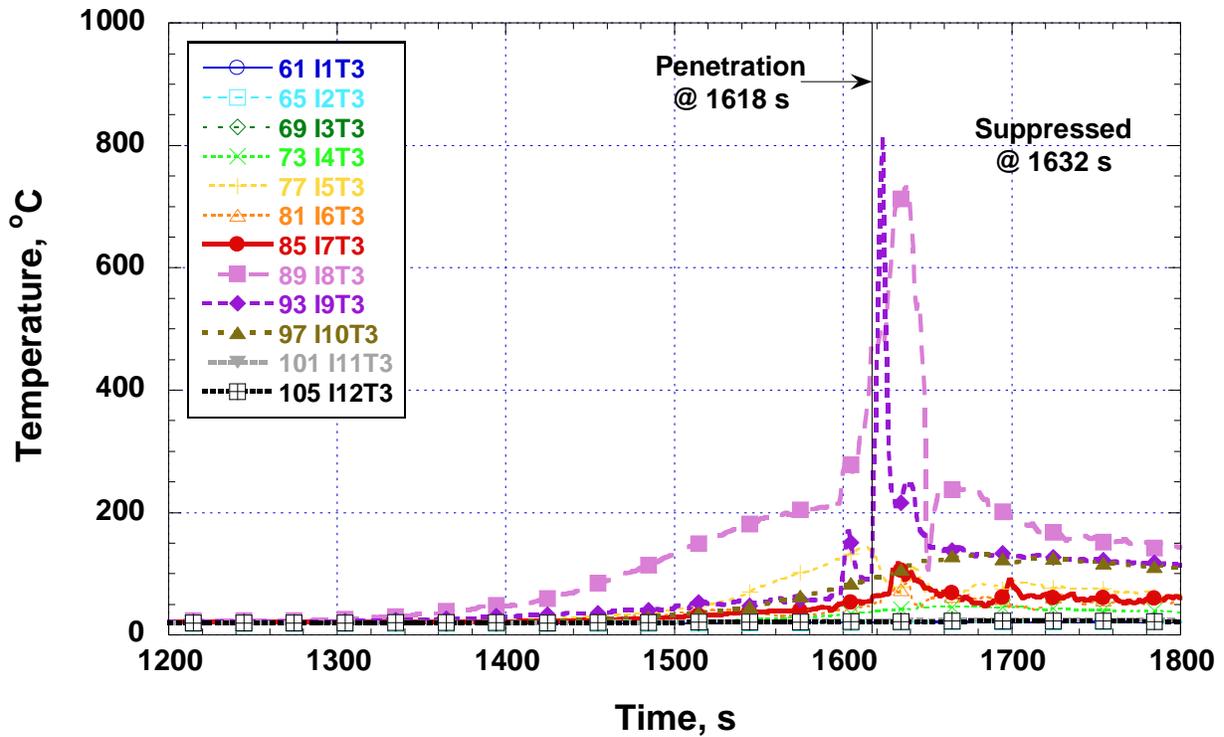
Figure 57 A plot of test 2 (drive axle) temperatures versus time for the lowest row of interior TCs, 1 cm from window surfaces and about 3 cm from the bottom of the windows. Figure 17 shows labeling.

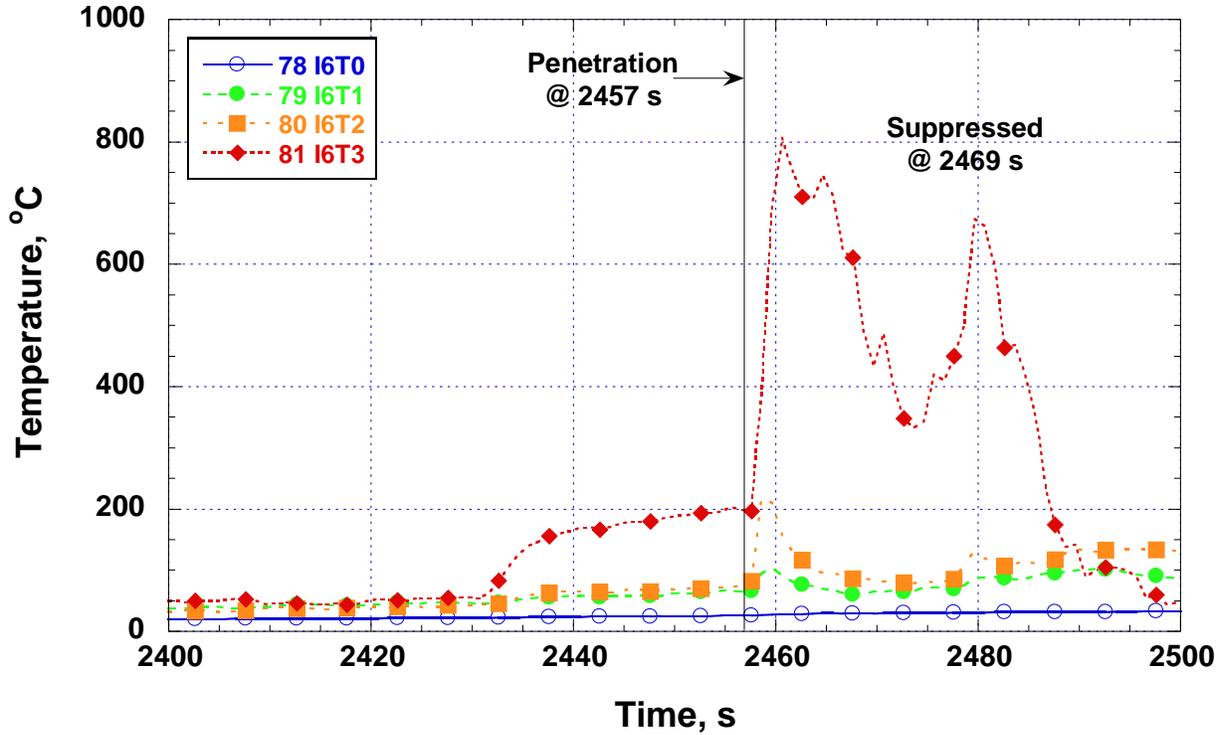
Figure 58 and Figure 59 are plots from both experiments showing temperature versus time for the hottest columns of interior TCs, column 6 and column 8 for test 1 and test 2, respectively. T3 is the lowest position and T0 is above the window. For test 1, column 6 temperature in position T3 rises from 60 °C to 200 °C in the 25 s prior to penetration. T1 and T2 rise from about 45 °C to about 70 °C in the 25 s prior to penetration. For test 2, column 8 temperatures except for position T0 rise from about 200 °C to about 400 °C in the 30 s before penetration. Both plots show a rapid degradation of the windows in the 30 s prior to penetration, when temperature changes inside the window accelerate dramatically.

Figure 58 A plot of test 1 (tag axle) temperatures versus time for the hottest column of interior TCs, array 6, 1 cm from window. T0 was located above the window. See Figure 17 for labeling system.

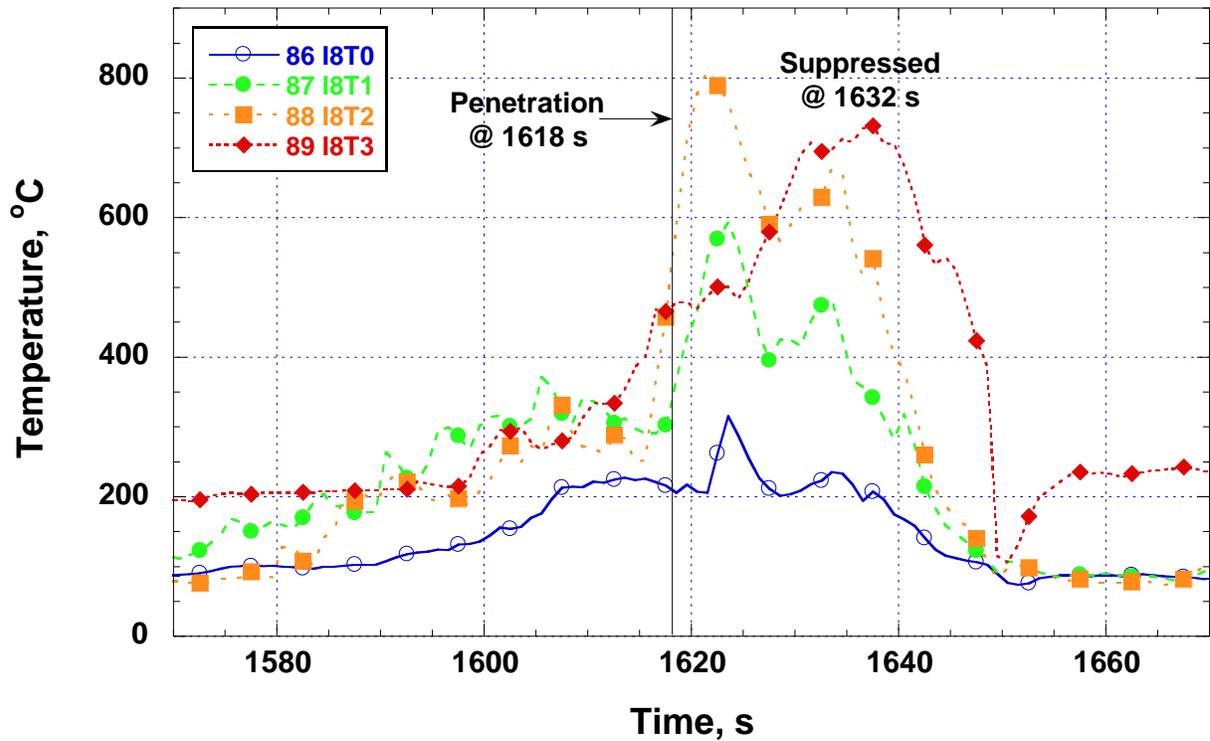
Figure 59 A plot of test 2 (drive axle) temperatures versus time for the hottest column of interior TCs, array 8, 1 cm from window. T0 was located above the window. See Figure 17 for labeling system.

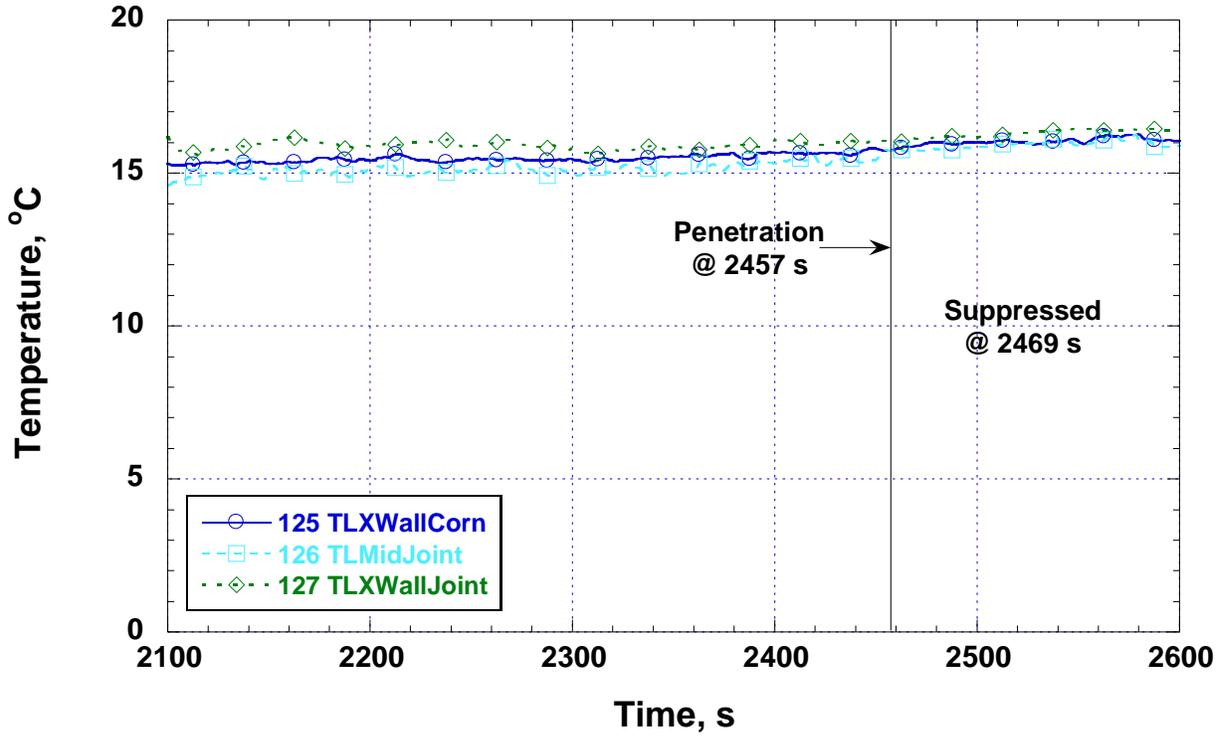
The lavatory floor temperatures shown in Figure 62 and Figure 63 only rose about 1 °C during each test. The floor area near the lavatory is similarly protected from heating from below as the floor areas near the motorcoach walls.

Figure 62 A plot of test 1 (tag axle) temperatures versus time for TCs on the interior floor where the lavatory walls join the exterior wall and floor in the middle of the coach. See Table 8 and Figure 18.

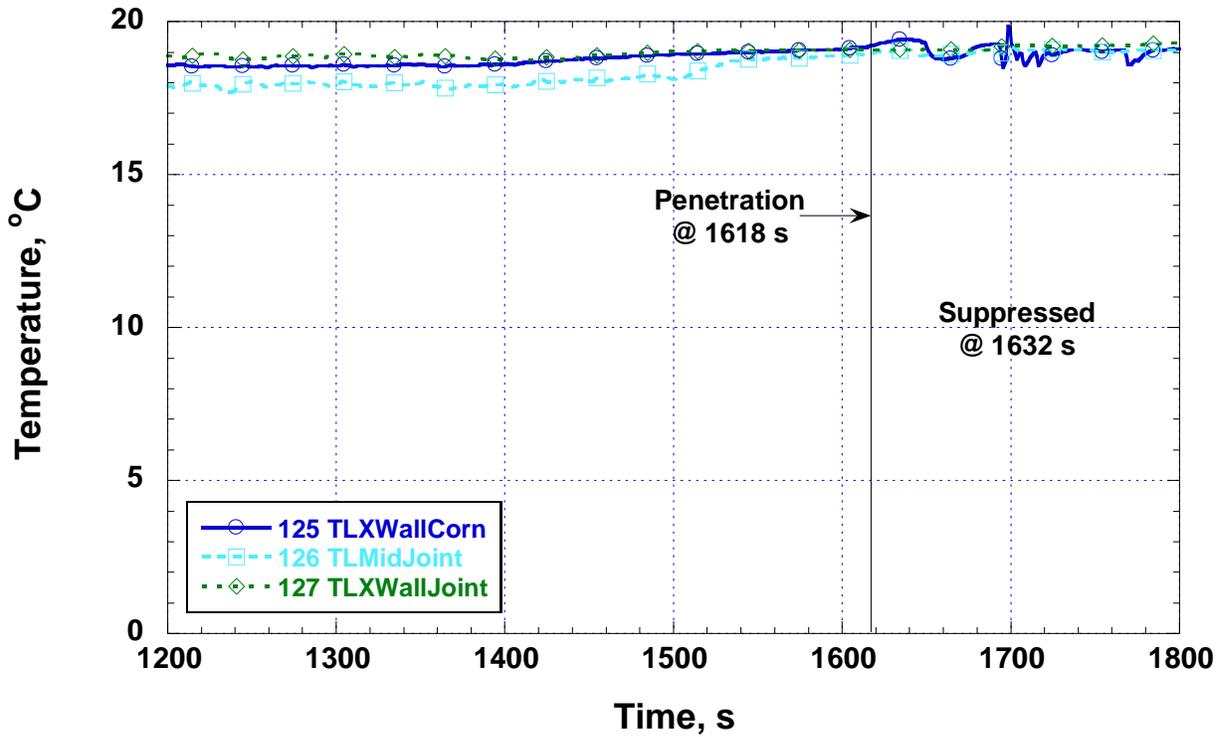
Figure 63 A plot of test 2 (drive axle) temperatures versus time for TCs on the interior floor where the lavatory walls join the exterior wall and floor in the middle of the coach. See Table 8 and Figure 18.

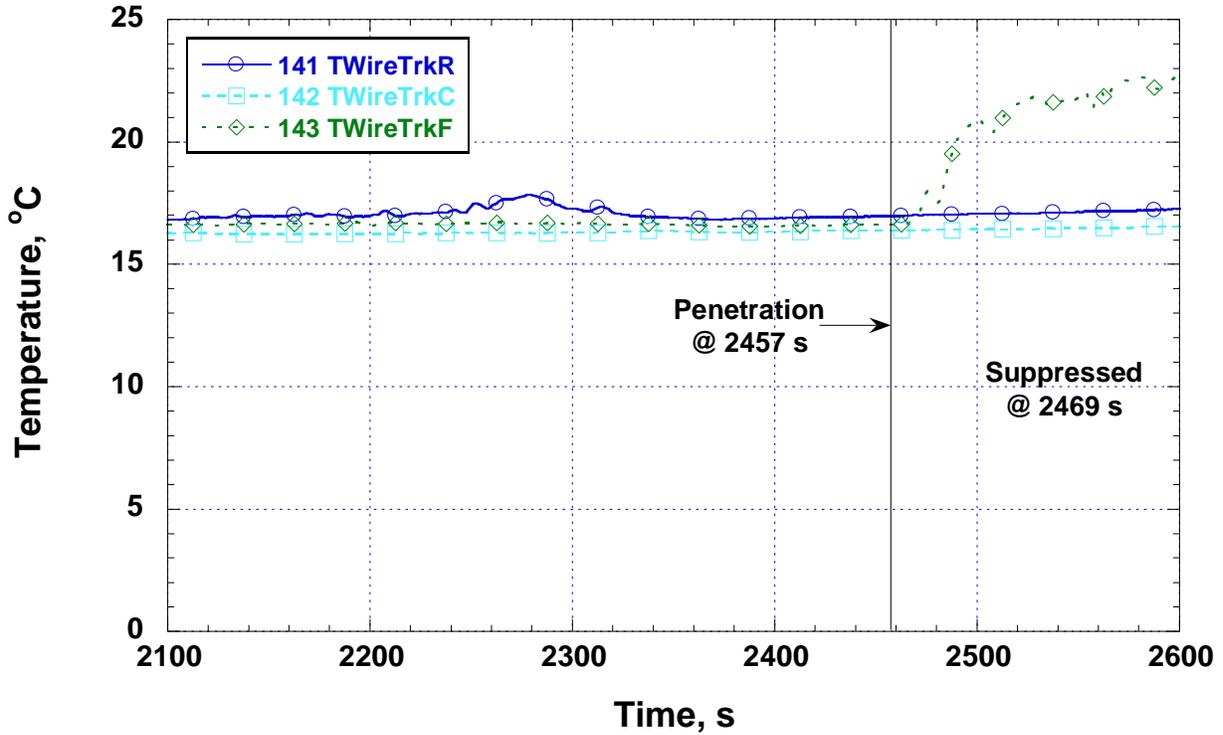
The central tunnel plots of temperature in Figure 64 and Figure 65 show some heating. The test 1 front position rose 7 °C, but the change occurred after penetration and extinguishment. The test 2 front position rose over 25 °C prior to penetration and the center position rose about 15 °C after penetration.

Figure 64 A plot of test 1 (tag axle) temperatures versus time for TCs inside the central tunnel for wires under the interior floor along the centerline of the coach. R, C, and F represent rear, center, and front, respectively, of the test section. Table 8 and Figure 18 describe thermocouple locations.

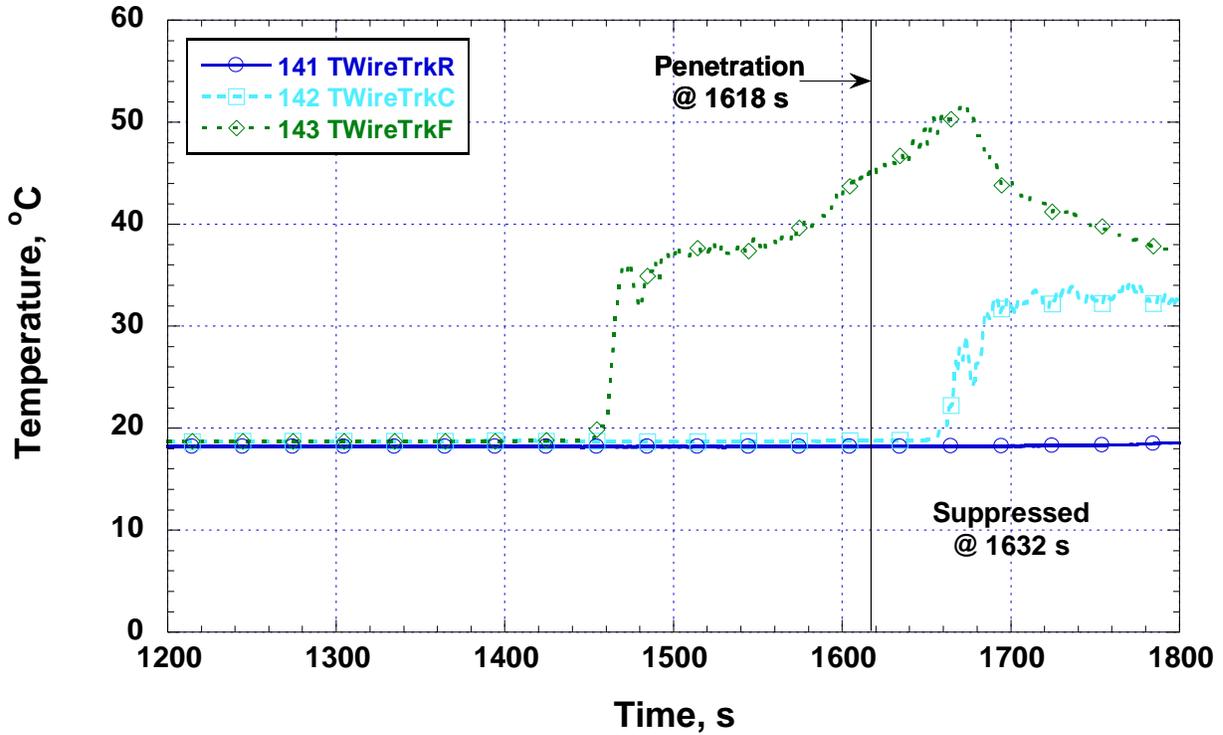
Figure 65 A plot of test 2 (drive axle) temperatures versus time for TCs inside the central tunnel for wires under the interior floor along the centerline of the coach. R, C, and F represent rear, center, and front, respectively, of the test section. Table 8 and Figure 18 describe thermocouple locations.

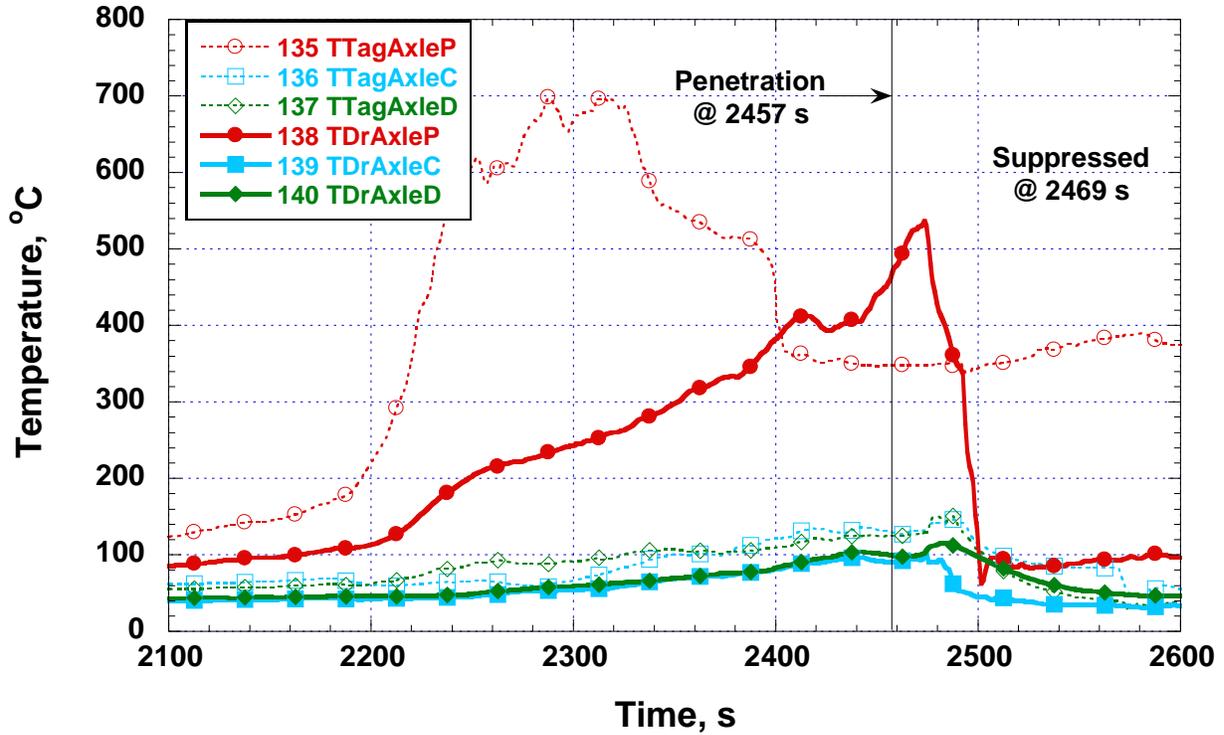
Possible spread of fire along the axles and upward through the floor or to the far side tires and panels was a concern that prompted monitoring of these regions. Figure 66 and Figure 67 are plots of temperature for test 1 and 2, respectively, for the thermocouples located above the two axles. In Figure 66, for the tag axle wheel heating test, both of the right (passenger) side thermocouples over each axle showed significant heating with the tag axle at a maximum temperature of 700 °C and the drive axle maximum at 450 °C. It is surprising that the tag axle right side temperature reached its maximum over 2 min prior to penetration and then dropped down to 350 °C. One possible reason for this is that while the tire continued to burn and flames spread upward to the exterior panel, the fender was consumed more quickly, and its contribution to the fire decreased which provided less hot gases in lower areas such as along the axle. For test 1, the center and driver's (left) side axle temperatures barely exceeded 100 °C before window penetration.

Figure 66 A plot of test 1 (tag axle) temperatures versus time for TCs above the two axles. P, C, and D represent passenger (right) side, center, and driver (left) side, respectively.

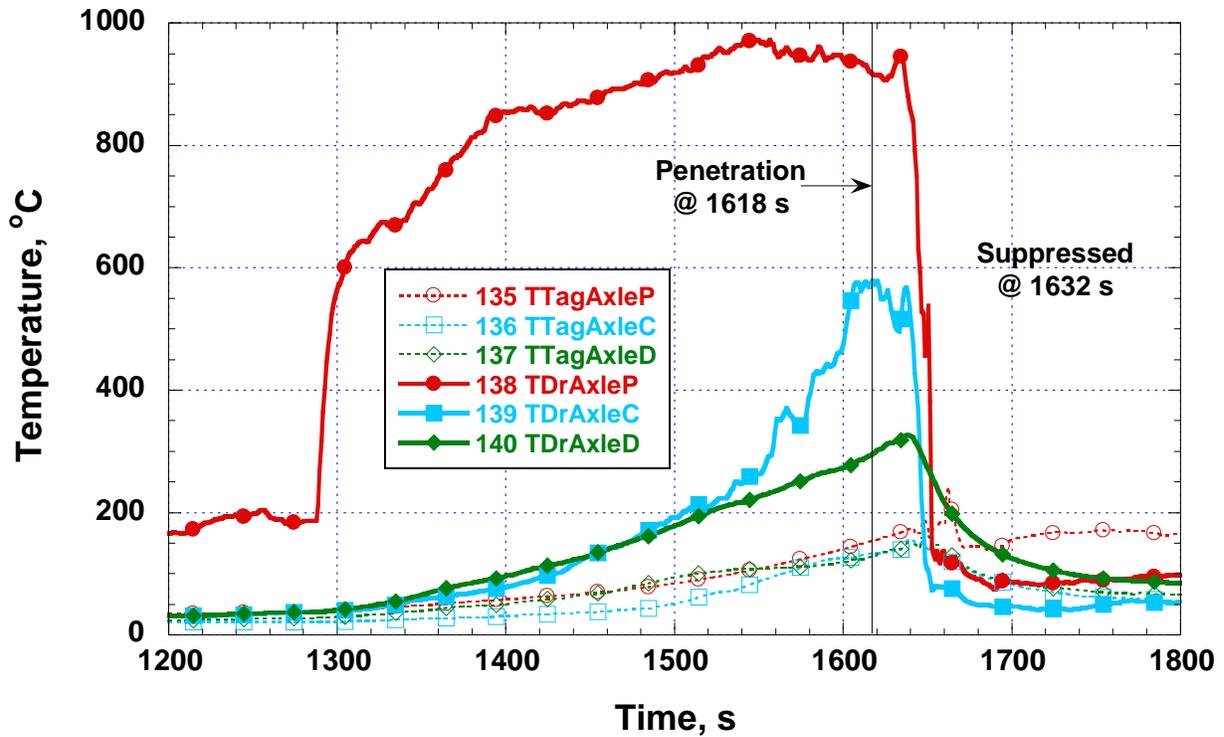
For test 2, Figure 67 shows the drive axle right (passenger) side and center thermocouples rising to 950 °C and 550 °C, respectively. Even the drive axle driver's side thermocouple rose to 300 °C before penetration which is significant in that temperatures over 400 °C generally will ignite combustible materials such as the tire and GRP panels. While right side and center position axle temperatures greater than 550 °C were significant for causing ignition of nearby combustible materials, the interior floor and central tunnel temperatures showed very little thermal penetration. The far (left side) position rose past 300 °C at about 50 °C /min, but it is unknown whether this rate would have continued and whether or not combustible materials would have eventually ignited if the fire were allowed to continue.

Figure 67 A plot of test 2 (drive axle) temperatures versus time for TCs above the two axles. P, C, and D represent passenger (right) side, center, and driver (left) side, respectively.

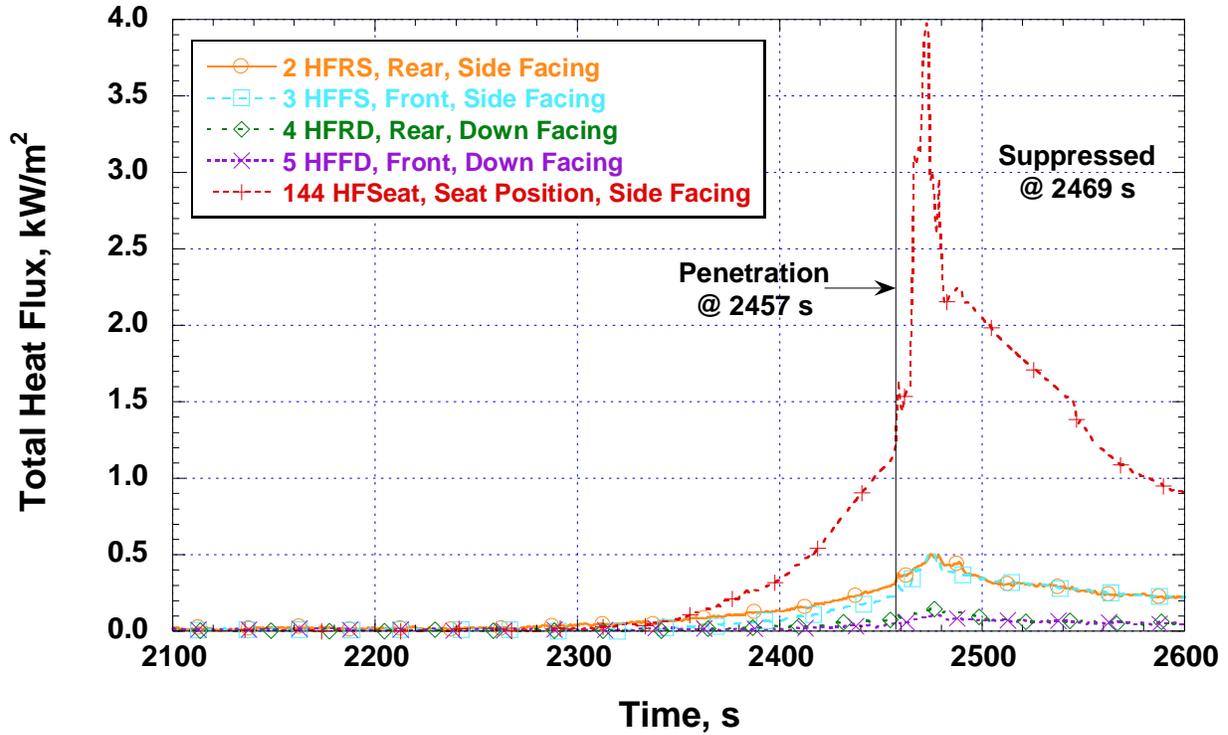
Table 9 lists the locations and orientations of the heat flux gauges corresponding to the following results. Figure 68 and Figure 69 show the heat flux measurements for test 1 (tag axle wheel heating) and test 2 (drive axle wheel heating), respectively. For test 1, only the seat position heat flux rose significantly to about 1.5 kW/m^2 before penetration. After penetration, despite extinguishment activities, the heat flux increased to about 4 kW/m^2 , probably due to the impact of the penetrating fire plume quickly heating the interior even for just the brief period. The other fluxes in test 1 remained below 0.4 kW/m^2 before penetration. At the time of penetration, the accumulated thermal radiation at the seat location was about 16 % of an incapacitating dose. This type of analysis is described in the Thermal Tenability Analysis section.

Figure 68 A plot of test 1 (tag axle) total heat flux versus time for the 5 heat flux gauges in the passenger compartment. Table 9 provides additional descriptions of the locations.

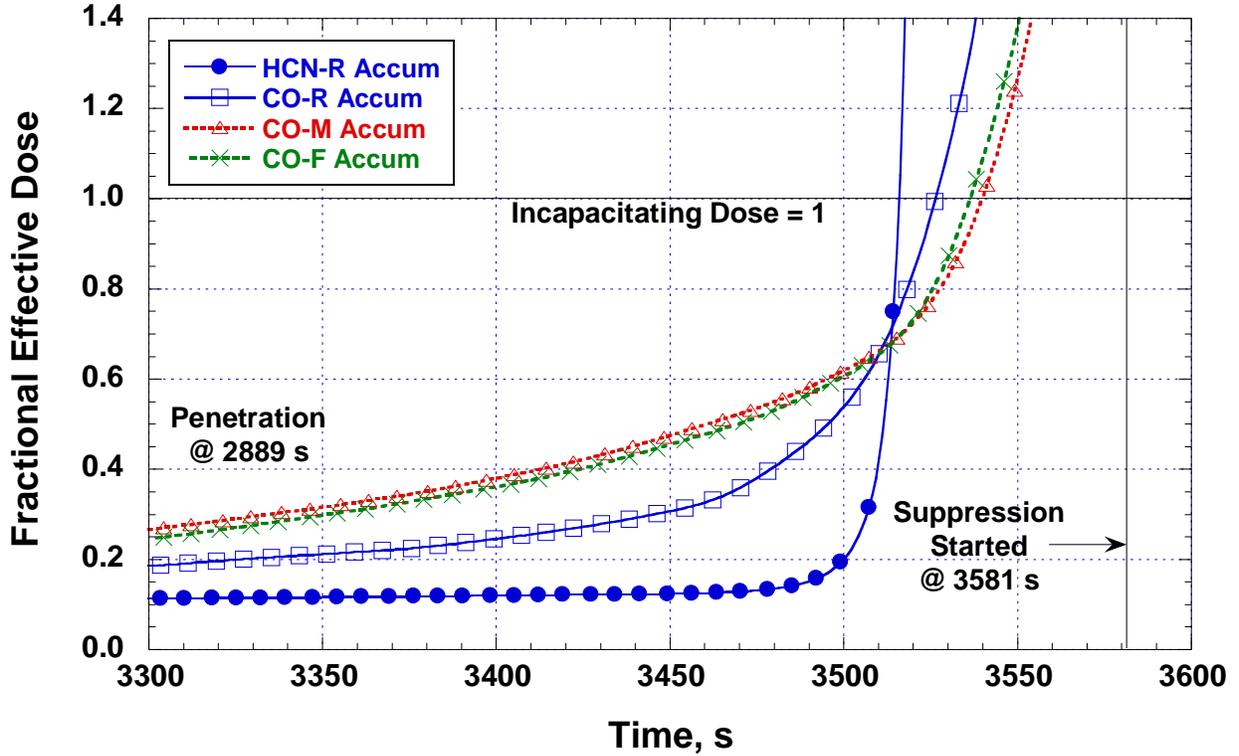
The two terms are plotted separately in Figure 99 for the rear (CO and HCN), middle (CO), and front (CO) sampling positions. When acting alone, the time to incapacitation was 3516 s for rear HCN, 3526 s for rear CO, 3540 s for middle CO, and 3536 s for front CO. Combining the rear HCN with the CO for each position results in the plot in Figure 100. All of the curves converge due to the strong influence of HCN on the totals. The incapacitating dose is reached within 1 s of 3508 s for all three positions. This time to untenable conditions is 10 min 19 s after penetration.

Figure 99 Fractional effective doses for HCN and CO measured at the rear (R), middle (M), and front (F) sampling locations plotted versus time for the tenability experiment.

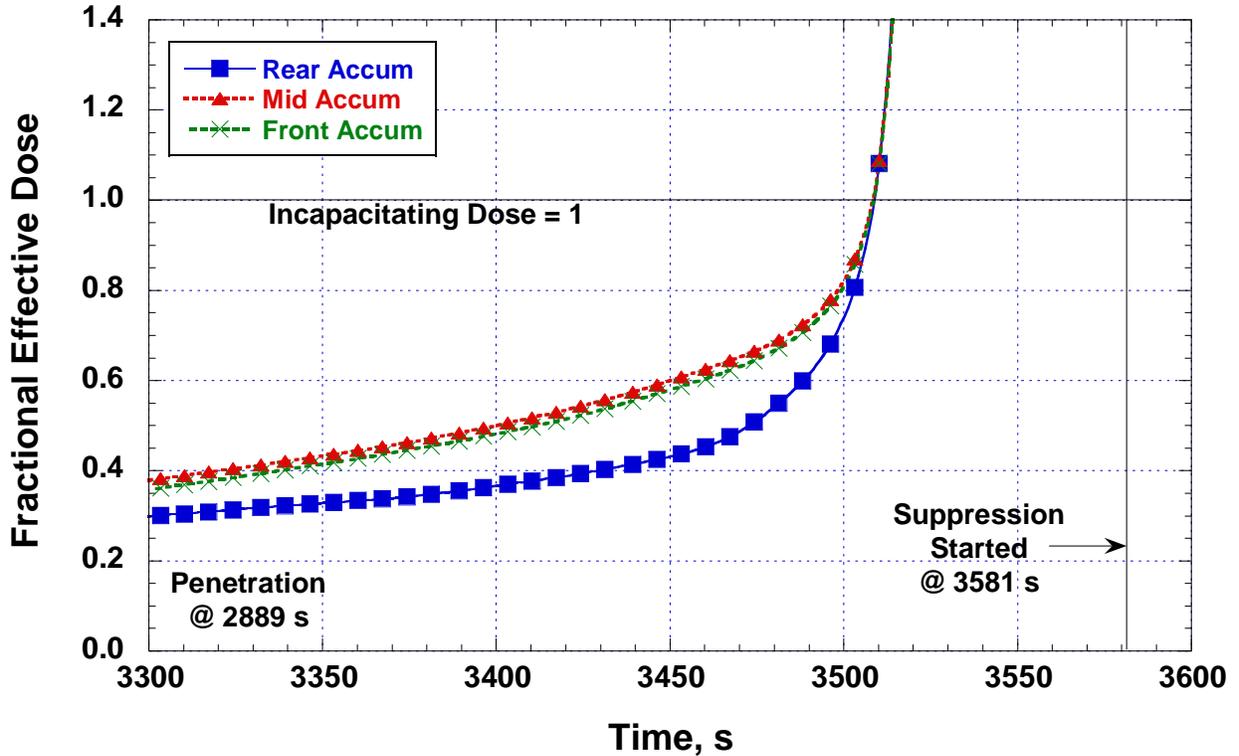
Figure 100 Total (both CO and HCN) fractional effective doses for the rear (R), middle (M), and front (F) sampling locations plotted versus time for the tenability experiment.

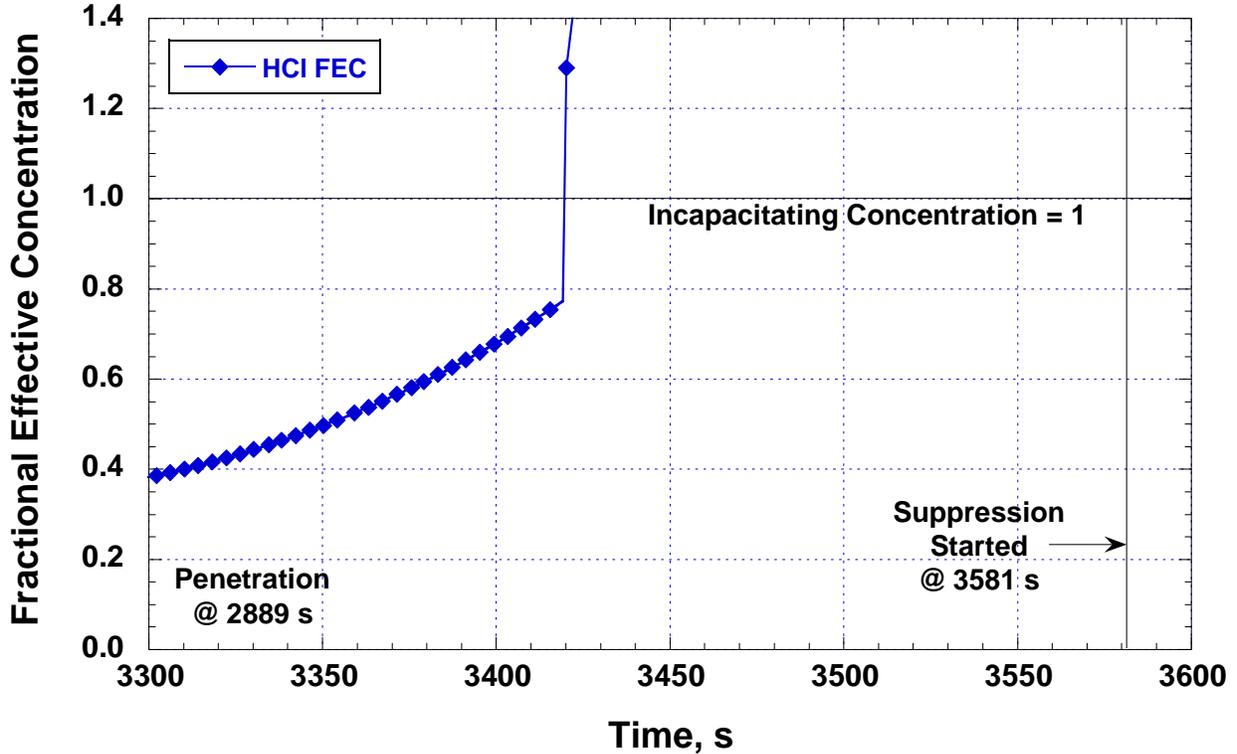
The plot in Figure 101 shows that the FEC for HCl increases rapidly at 3419 s and crosses the incapacitating dose line at 3420 s which is 8 min 51 s after penetration.

Figure 101 Fractional effective concentration for HCl measured with FTIR at the rear sampling location plotted versus time.

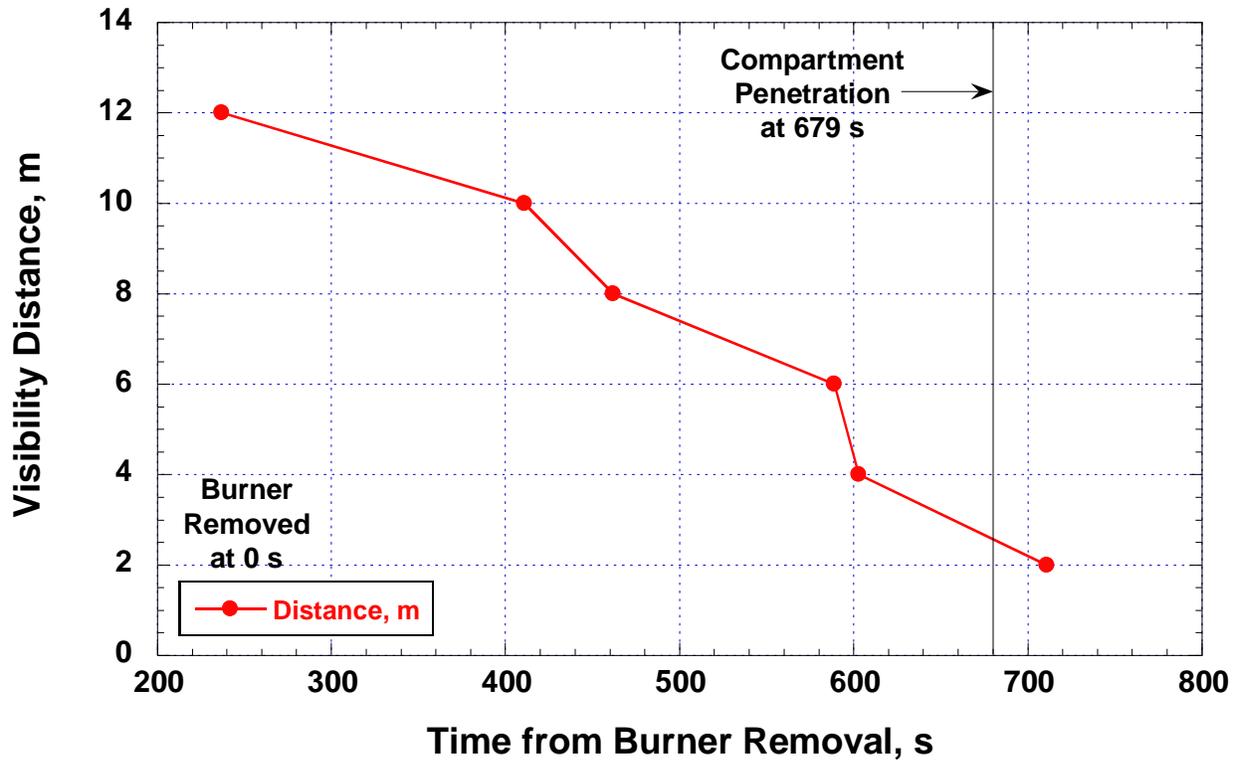
The video recording of the exit signs to determine visibility resulted in the times and distances listed in Table 17. Analysis was accomplished by viewing of the video recording and determining the times that signs could not be seen based on the judgment of the viewer. Sign visibility may have been slightly enhanced by the low level of ambient light within the motorcoach. The plot in Figure 102 shows the relationship between the visibility distance and tire ignition time. The trend in the plot shows a linear decrease in visibility distance with time. It is interesting that smoke from the tire fire resulted in nearly no visibility in the motorcoach interior even before fire penetrated into the passenger compartment.

Figure 102 Visibility distance plotted versus the time from burner removal for the exit signs during the tenability experiment.

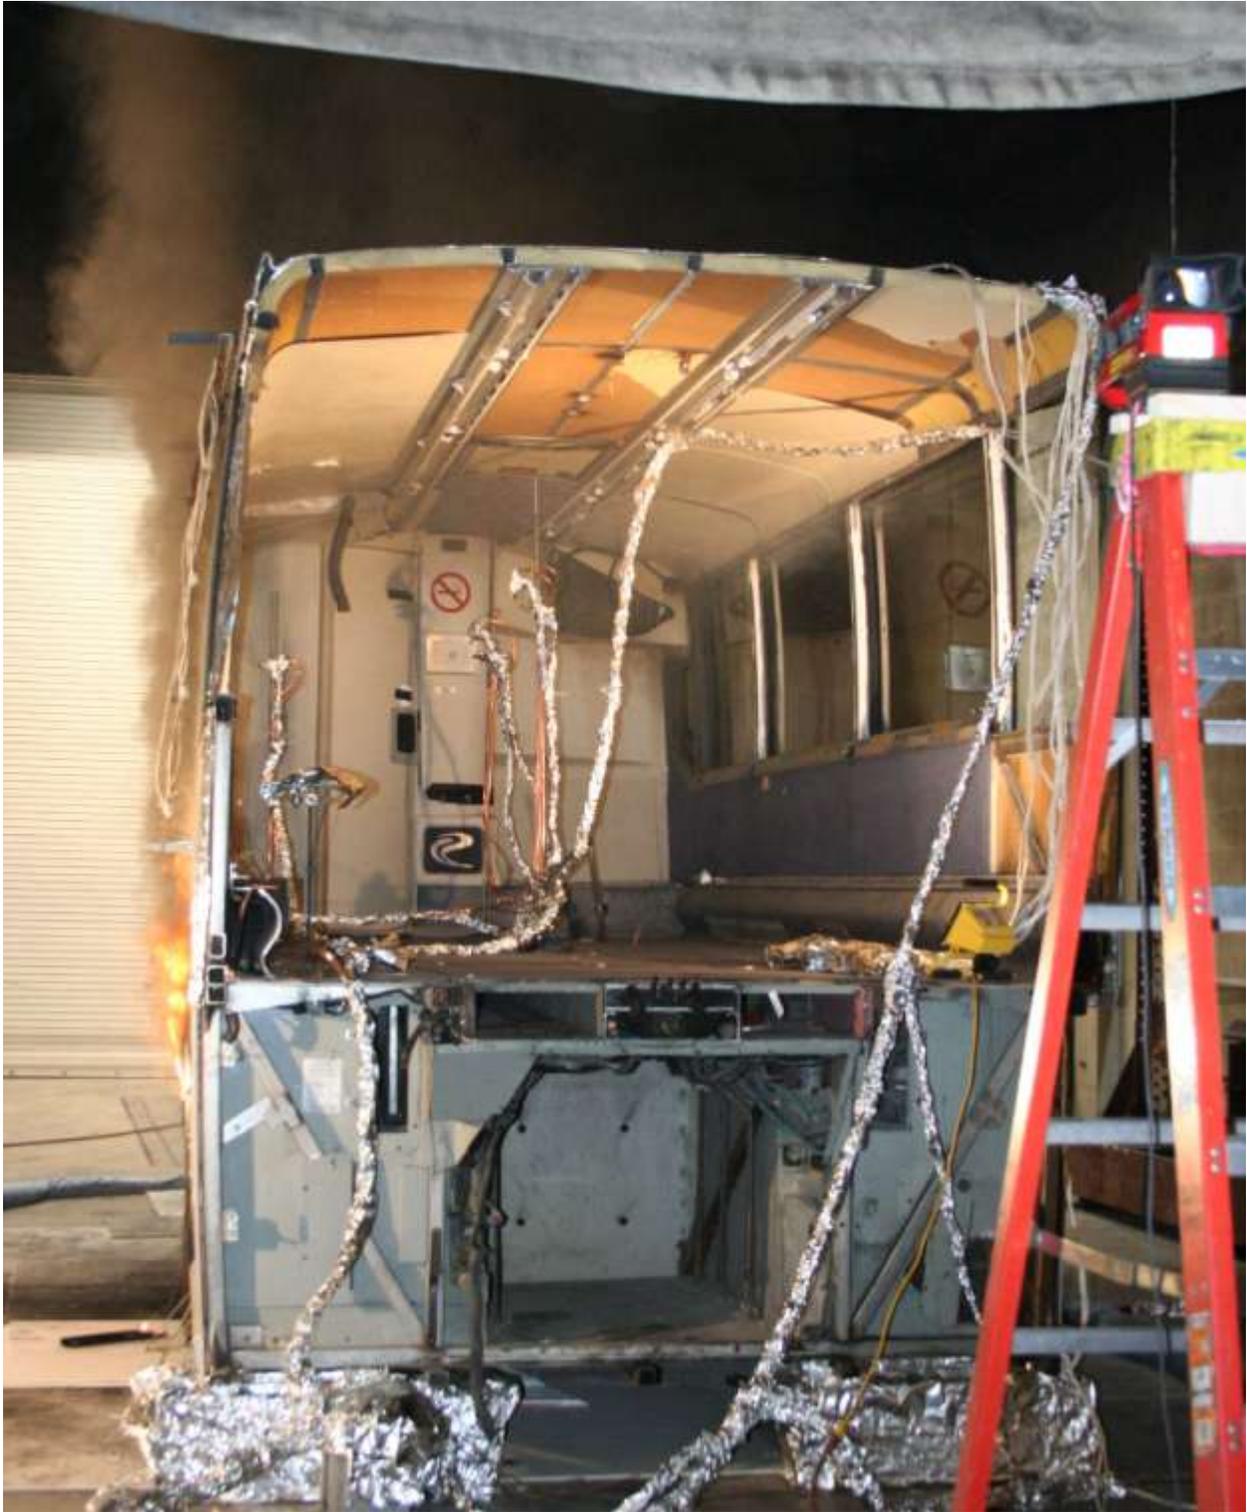
Figure 114 Drive axle wheel heating penetration experiment just over 1 min after burner was removed.

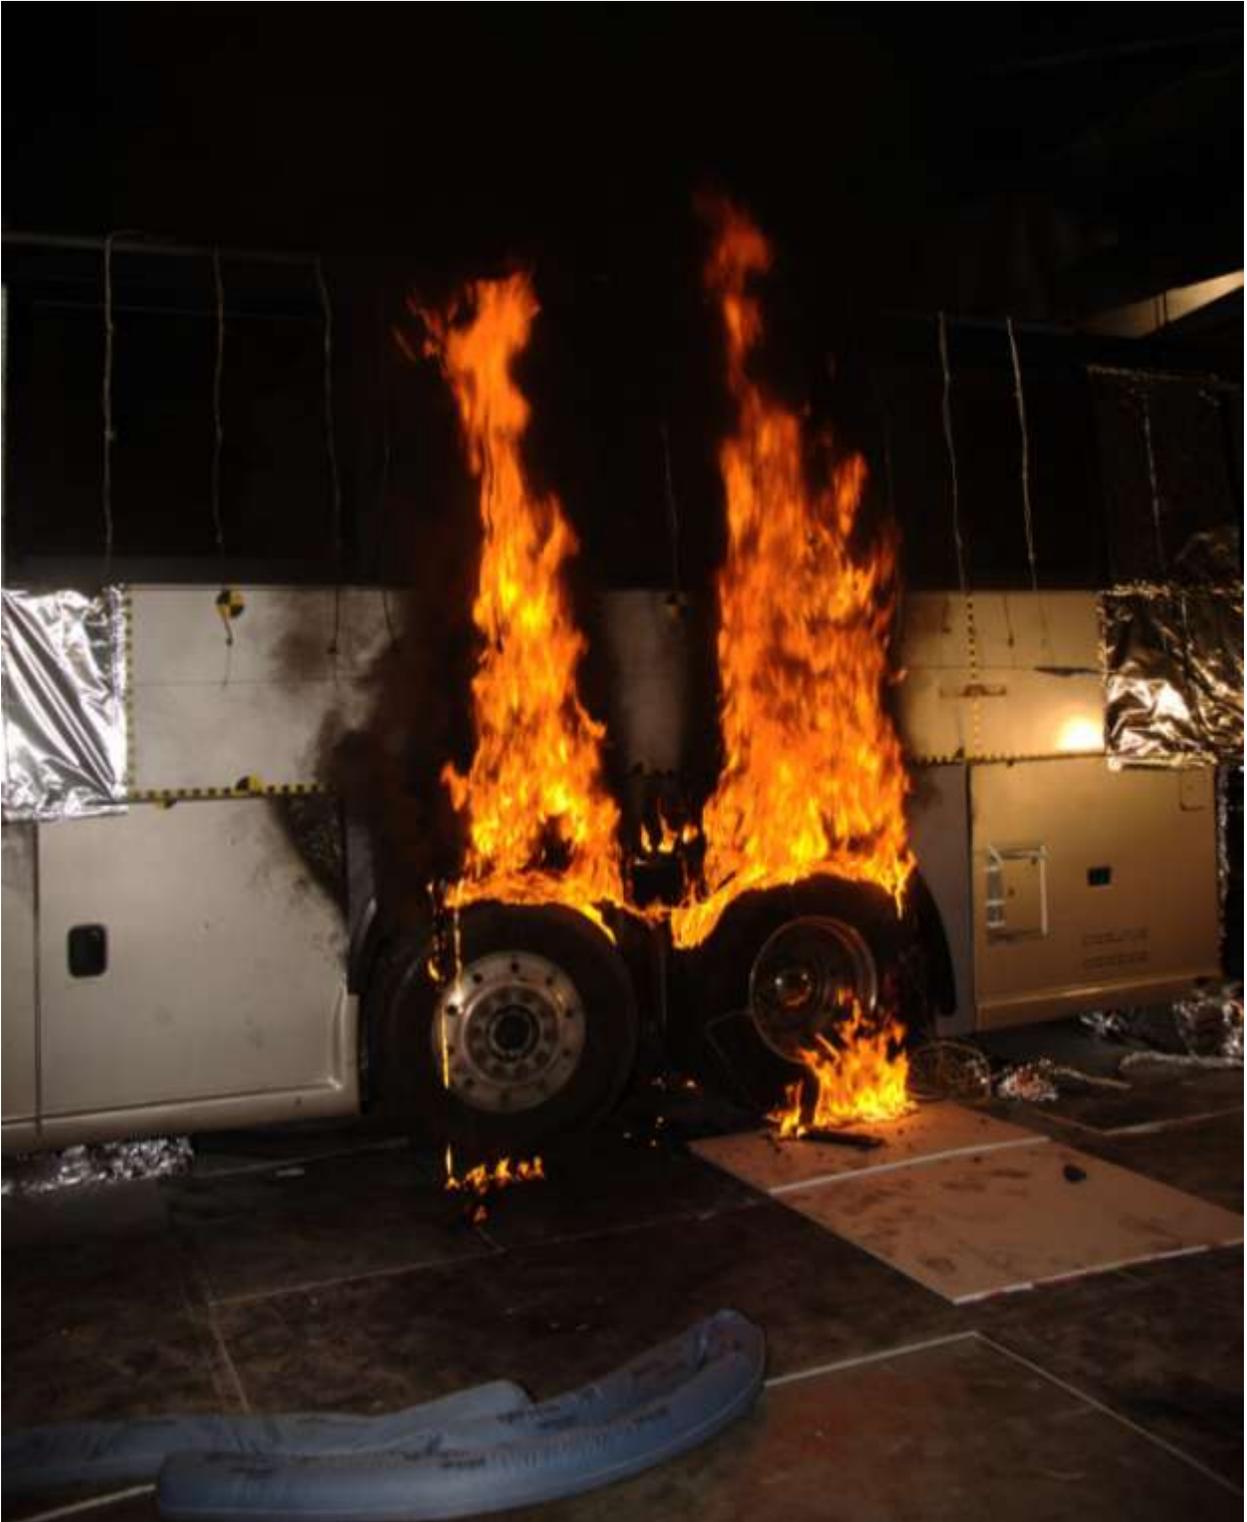
Figure 115 Drive axle wheel heating penetration experiment showing large fire plumes on each tire.

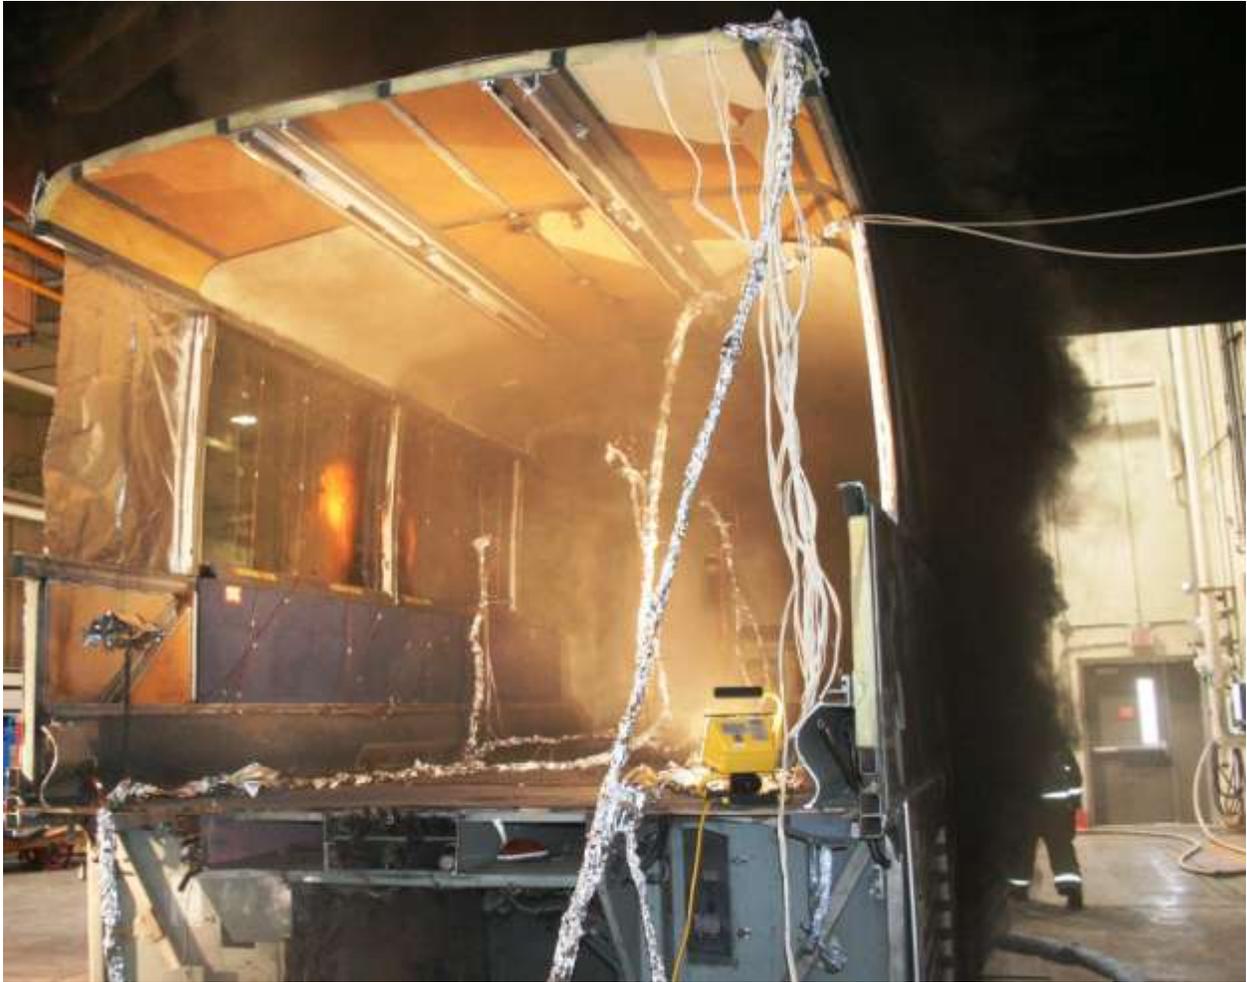
Figure 116 Drive axle wheel heating penetration experiment showing smoke on driver's side 4 min after burner removed.

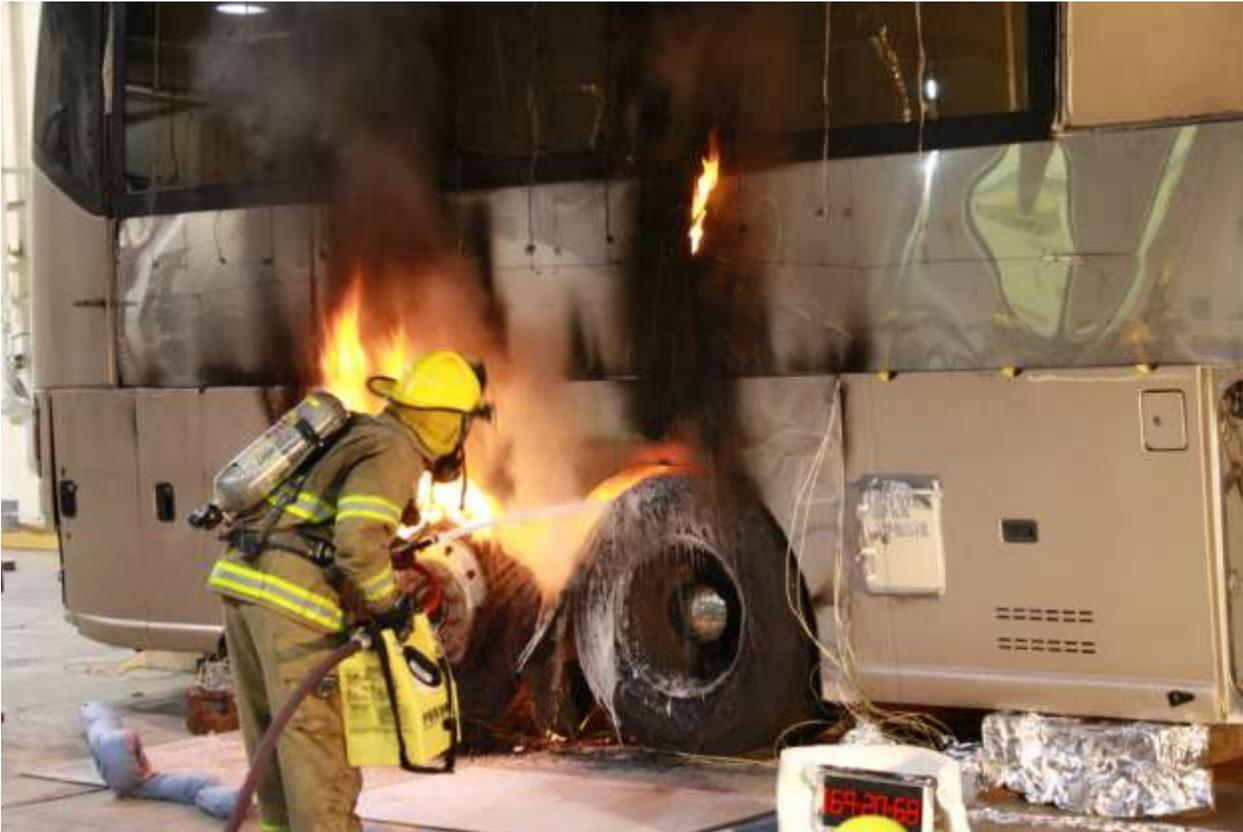
Figure 119 Steel exterior panel fire-hardening experiment at the beginning of suppression.
