NIST Technical Note XXXX

**Motorcoach Flammability Project
Final Report: Tire Fires - Passenger
Compartment Penetration, Tenability,
Mitigation, and Material Performance**

Erik L. Johnsson
Jiann C. Yang

November 2010

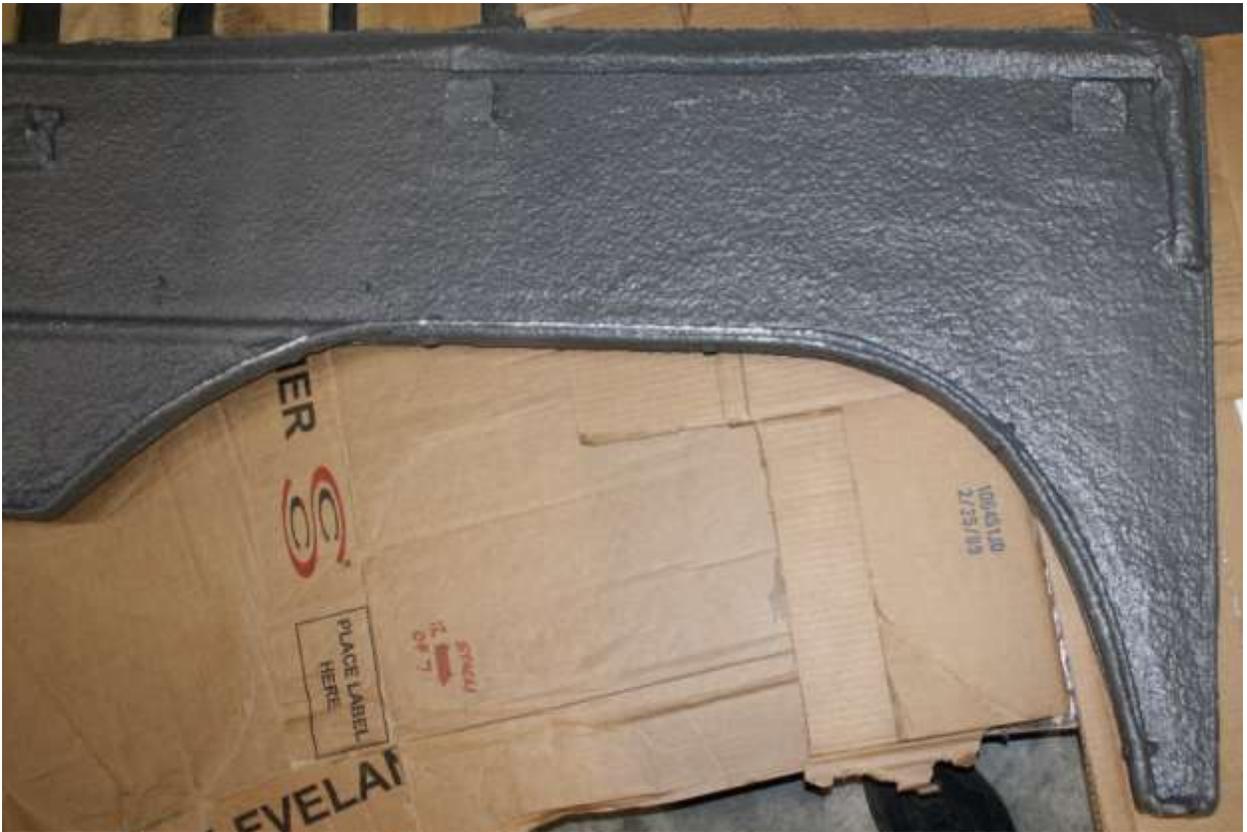
Figure 121 Intumescent coating fire-hardening experiment close-up of coated fender.

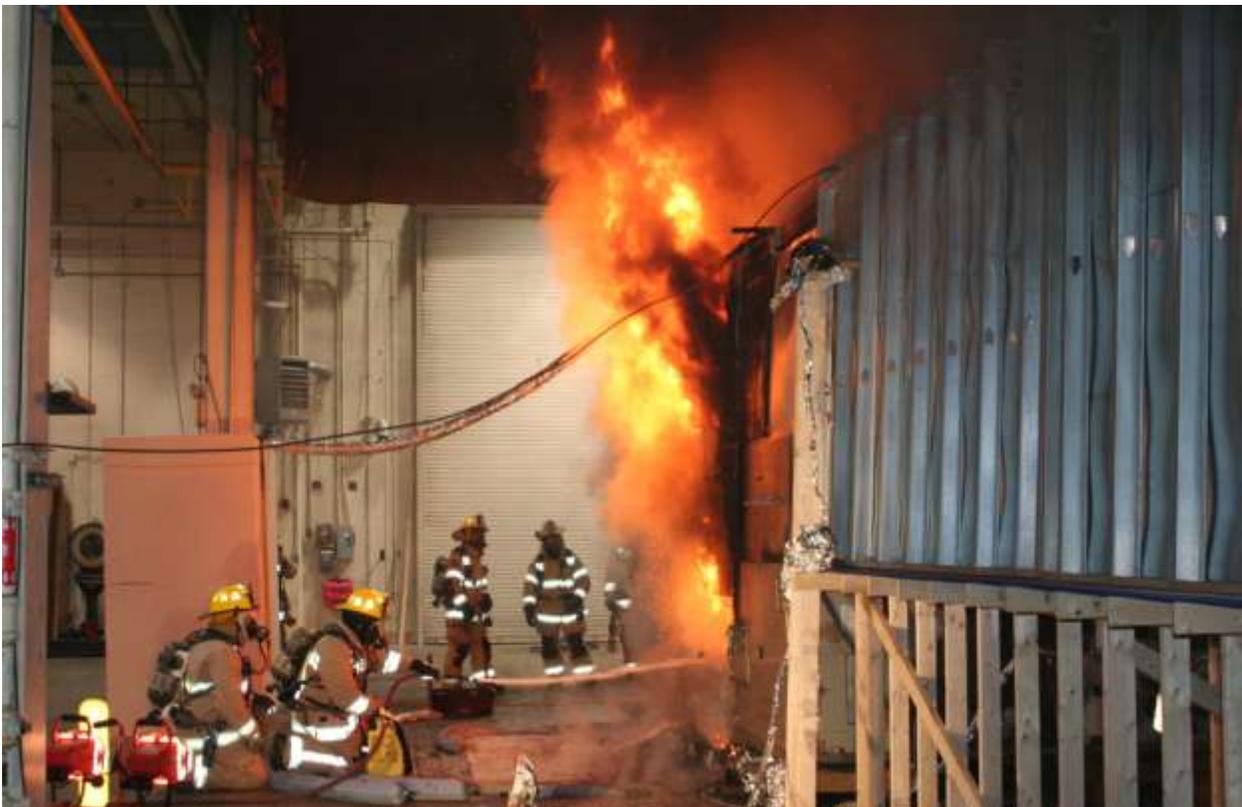
Figure 123 Tenability experiment at the beginning of suppression.
