Case 505 : Narrative

Case Vehicle (A): 1999 Dodge
Type: Caravan, 4-door minivan
Driver: 18-year-old female
CDC: 12-FCEN-3

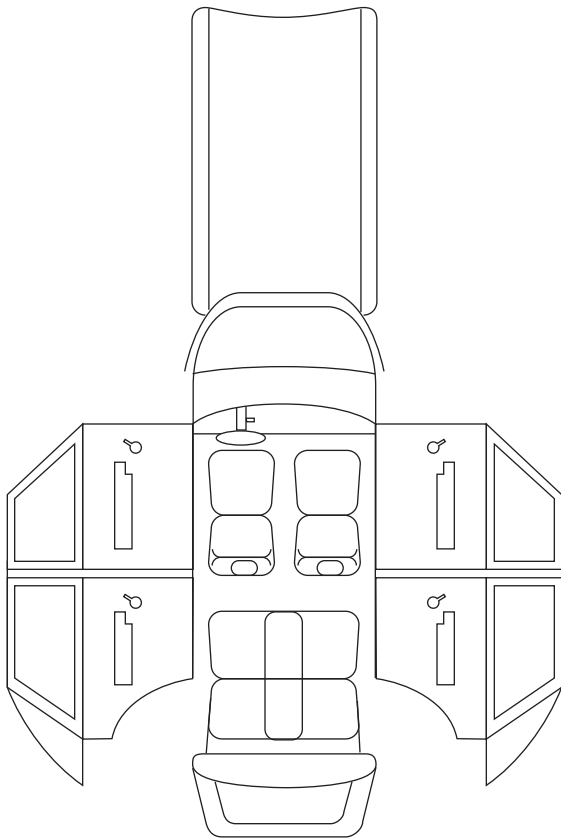
A: knee bolster, 6-cm scuff to right
B: glove compartment, 10-cm to right, 7-cm to center
C: right-front sunvisor, blood
