**CALSPAN ON-SITE NON-DEPLOYED AIR BAG INVESTIGATION
CALSPAN CASE NO. 96-4
LOCATION: CONNECTICUT
VEHICLE: 1995 CHEVROLET K1500 PICKUP TRUCK**

Contract No. DTNH22-94-D-07058

TECHNICAL REPORT STANDARD TITLE PAGE

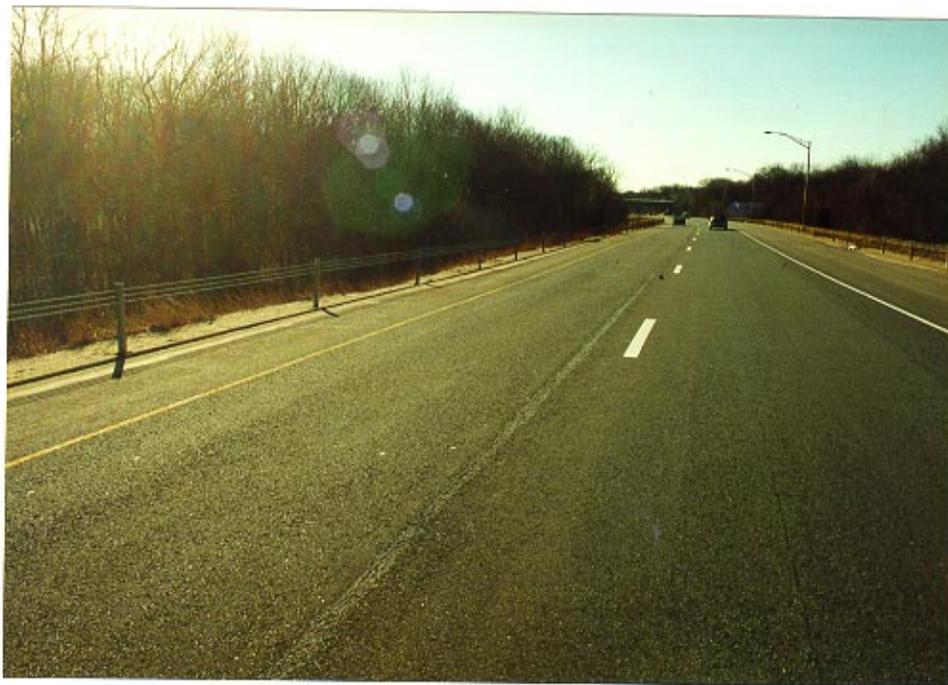
The impact displaced the snow plow truck to its left as it crossed the inboard travel lane and departed the inboard shoulder. The front mounted snow plow subsequently contacted the cable guardrail system and displaced three of the 7.6 x 5.7 cm (3.0 x 2.25") I-beam posts. There was no damage reported to the plow or truck from the subsequent impact sequence.

3. Post-impact trajectory of the snow plow.

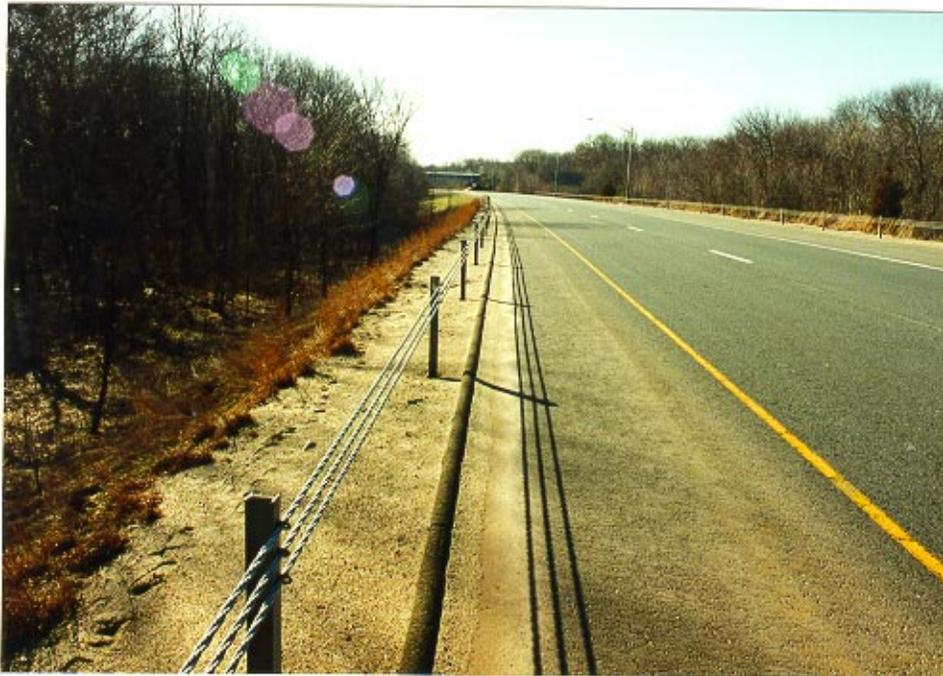
6. Final rest area of the Chevrolet pickup truck.

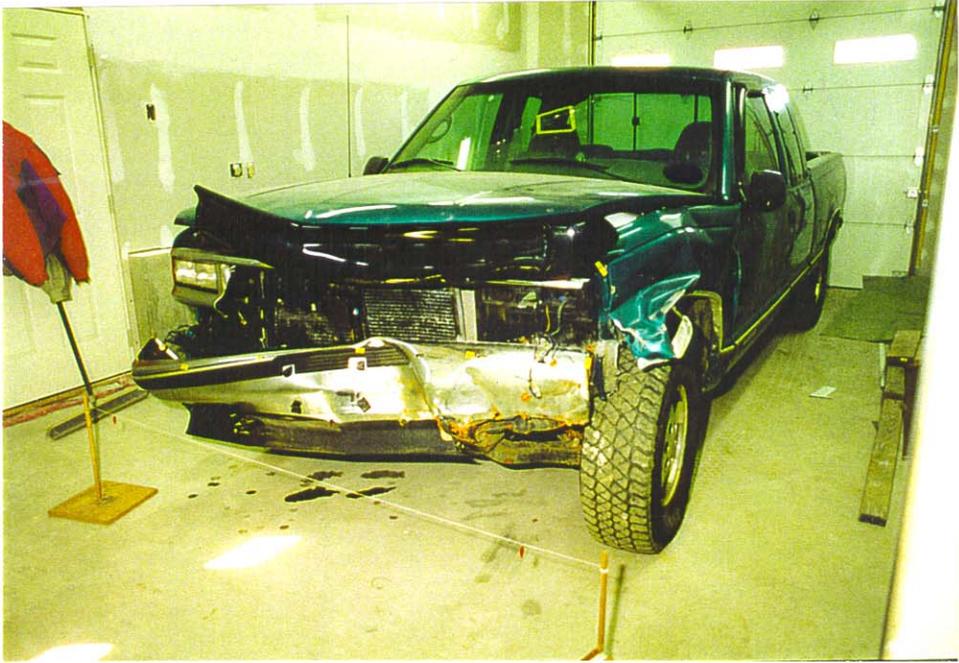
The 1995 Chevrolet 1500 series pickup truck sustained moderate frontal damage as a result of its initial impact sequence with the wing snow plow that was mounted to the right side of vehicle #2. Maximum crush was 28.2 cm (11.1") located at the left corner of the front bumper. The direct contact damage began 13.3 cm (5.25") left of center and extended 76.2 cm (30.0") to the left bumper corner. The off-set frontal impact deformed the entire width of the frontal structure resulting in a combined induced and direct damage length (Field L) of 170.2 cm (70.0"). Crush values at bumper level were as follows: $C_1 = 28.2$ cm (11.1"), $C_2 = 25.1$ cm (9.9"), $C_3 = 23.1$ cm (9.1"), $C_4 = 9.5$ cm (3.75"), $C_5 = 0.6$ cm (0.25"), $C_6 = 0$ cm (-2.9").

Damaged components from the frontal impact sequence included the bumper, grille, left headlamp assembly, hood, aftermarket bug deflector, radiator support panel, radiator and air conditioning condenser, left front fender, and the left frame rail (vertical and rearward displacement).

11. Left front three-quarter view of the Chevrolet pickup truck.

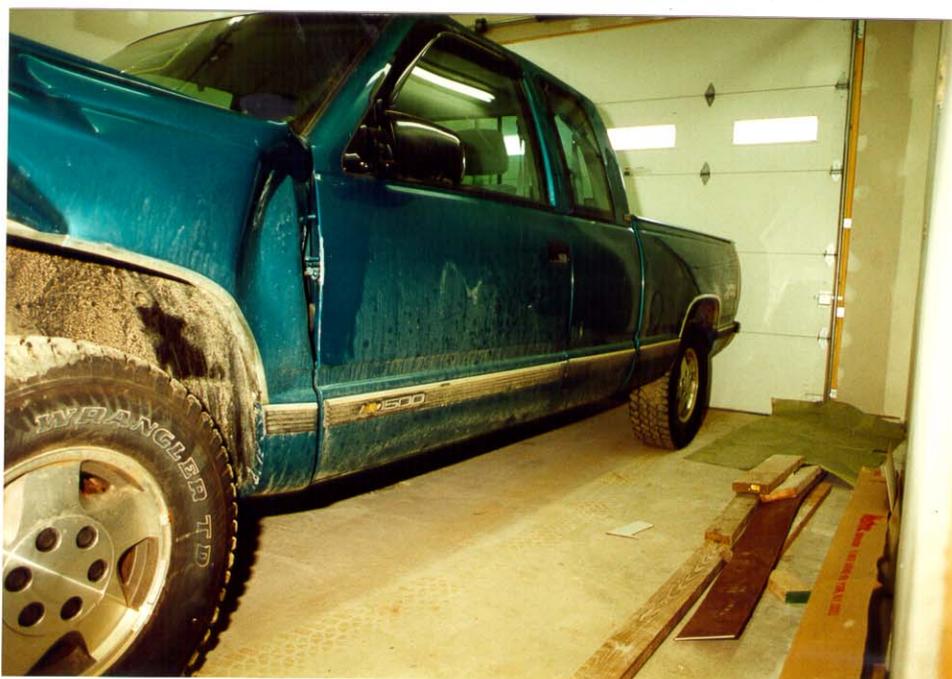
14. Left side view of the Chevrolet pickup truck.

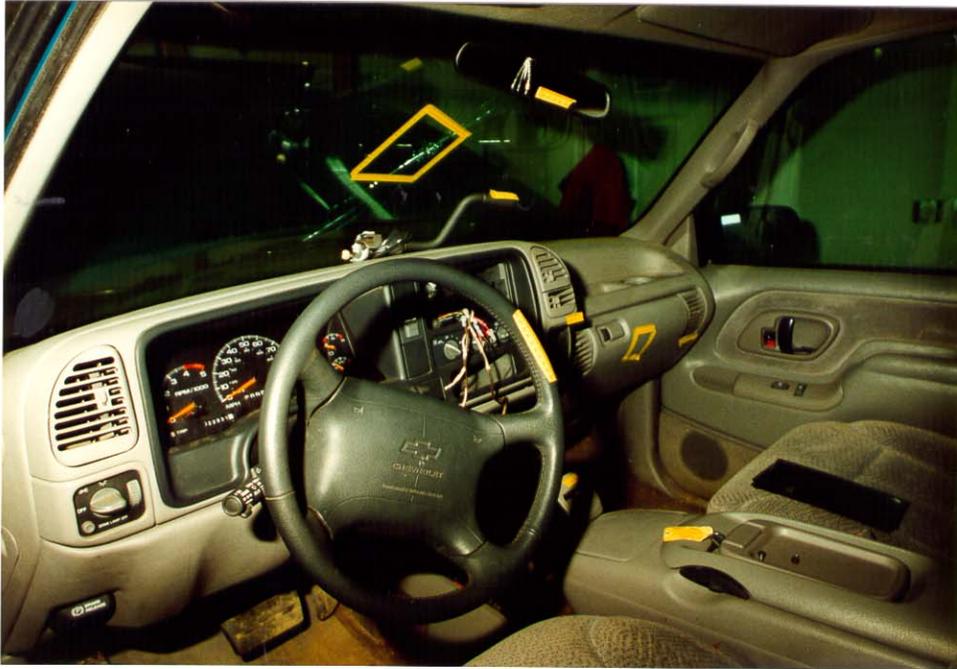
The interior of the Chevrolet pickup truck sustained moderate damage that was associated solely with occupant contact. There was no interior component intrusion or deformation associated with the exterior damage. The driver was not wearing the manual 3-point lap and shoulder belt system. At impact with the snow plow, he initiated a forward trajectory and contacted the right side of the steering wheel rim and the column mounted transmission selector lever. Although no wheel damage occurred, the contact sequence fractured the selector lever from the steering column. It should be noted that there was no compression of the energy absorbing steering column. The driver's forehead subsequently contacted the rear view mirror and windshield. As a result of the forehead contact, the mirror glass was cracked and the laminated windshield was cracked 2.5 cm (1.0") left of center and 17.8 cm (7.0") above the upper instrument panel. Surrounding the windshield crack was a tissue transfer with an oily smudge which extended 8.3-13.3 cm (3.25-5.25") left of center and 14.0-17.1 cm (5.5-6.75") above the upper panel. The driver's right hand and/or arm contacted and separated the pull-out cup holder from the center mid instrument panel. No damage occurred to the plastic cup holder or the slide mechanism.

21. Trajectory and contact points of the unrestrained driver of the pickup truck.

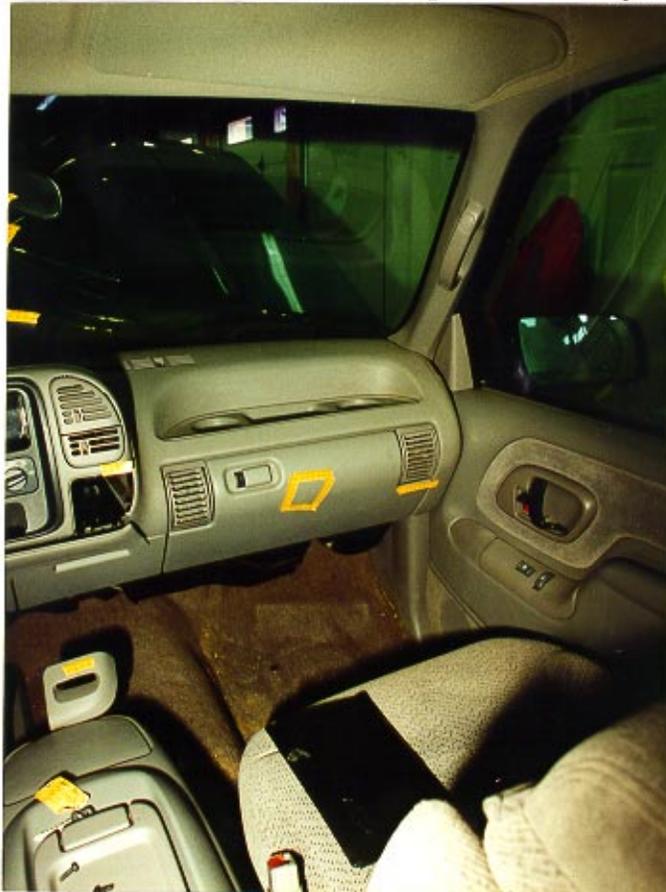
The right front passenger of the vehicle was not restrained by the manual 3-point lap and shoulder belt system. His left knee contacted and scuffed the mid aspect of the glove box door 43.2-47.0 cm (17.0-18.5") right of center and 10.8-14.0 cm (4.25-5.5") below the upper instrument panel. The passenger's right knee contacted the right side of the glove box door at the right air vent louver. This contact did not result in damage, however, the louver cover had separated from the mid panel. His right shoulder subsequently contacted the right upper A-pillar and passenger assist handle. The latter contact sequence did not produce interior damage.

30. Right front occupant's trajectory and subsequent contact points.

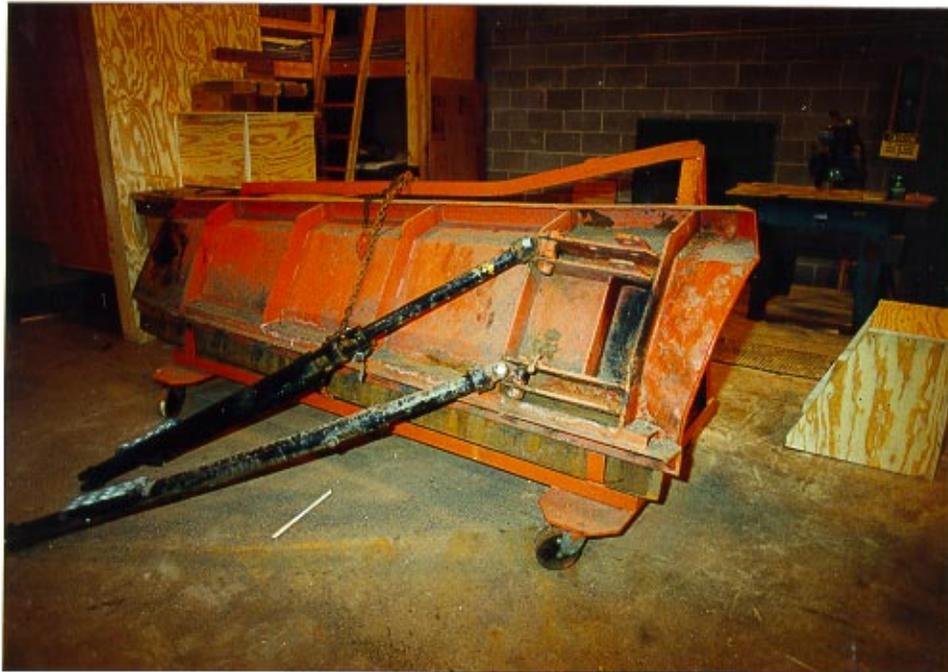
Although the plow was removed from the vehicle and repaired prior to our inspection, the driver stated that the upper arm was deformed by the impact sequence and that the dampening spring was fractured.

34. View of the struck right side mounted wing plow.

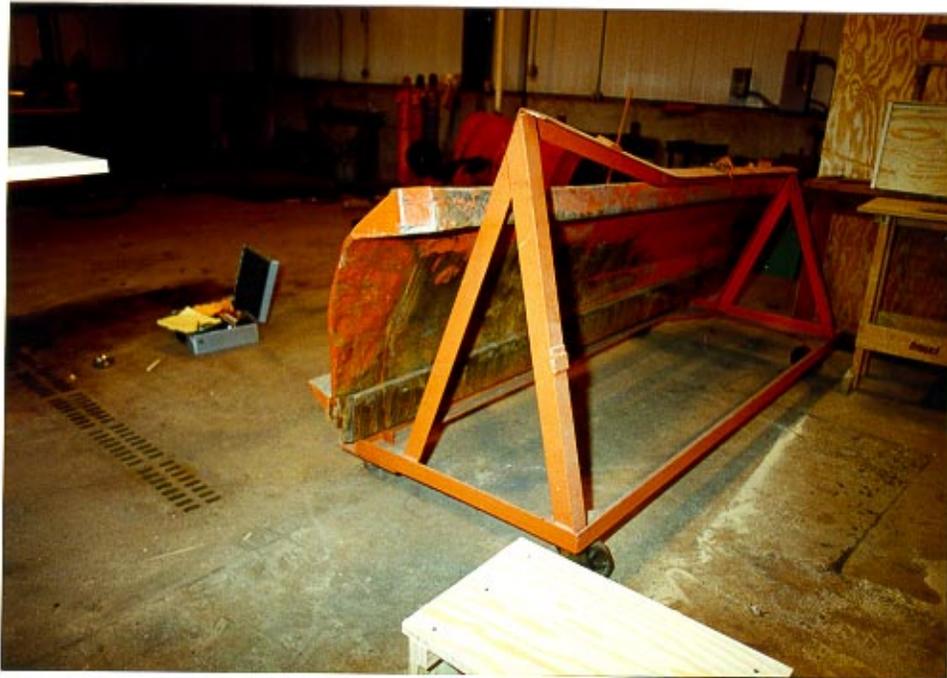
36. Frontal view of the repaired wing plow.
