REPORT NUMBER: 221-MGA-2007-004

**SAFETY COMPLIANCE TESTING FOR
FMVSS NO. 221
SCHOOL BUS BODY JOINT STRENGTH**

**US BUS CORPORATION
2006 US BUS STURDIBUS SCHOOL BUS
NHTSA NO.: C60900**

**PREPARED BY:
MGA RESEARCH CORPORATION
5000 WARREN ROAD
BURLINGTON, WI 53105**

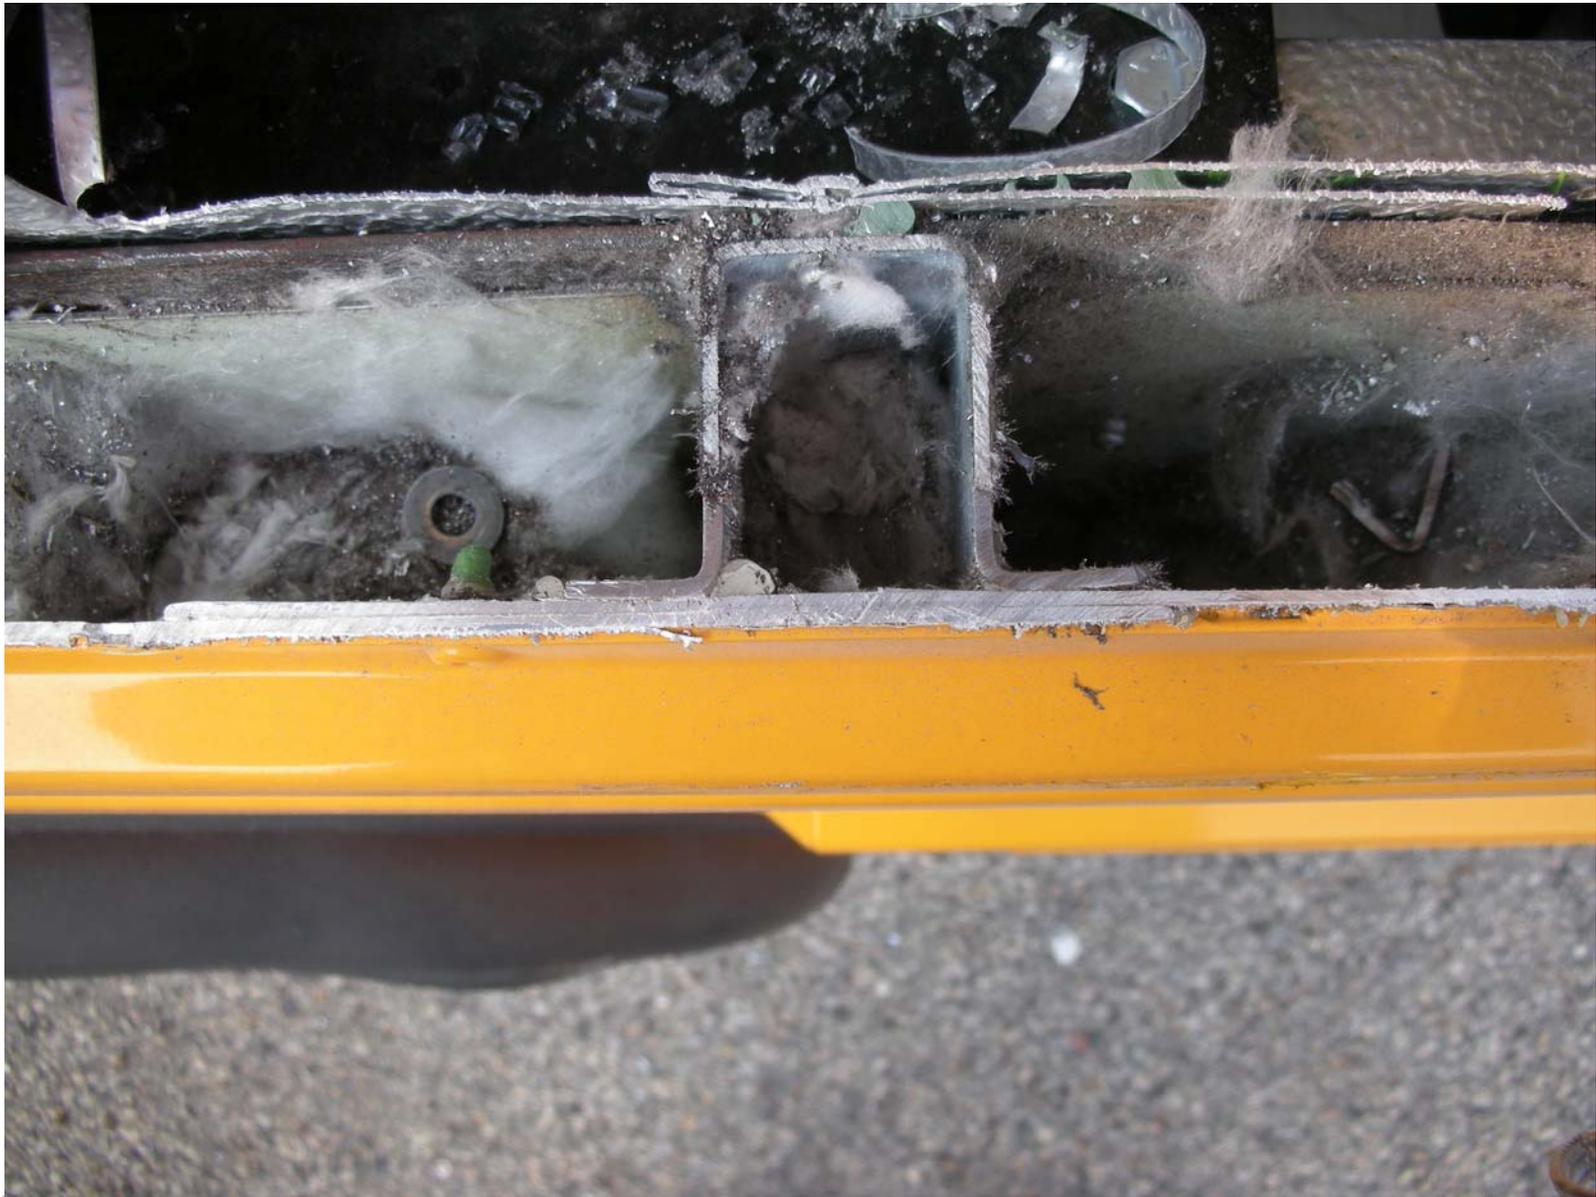
View of Joint #1

Weaker Member	Stronger Member
Material	3003 H-14 Aluminum	N/A
Tensile Strength (MPa)	137.9	N/A
Thickness (mm)	1.270	N/A
Fastener Holes (No./Diameter – mm.)	4 / 5.11	N/A
Net Area (Sq. mm.)	232.1	N/A
Material Strength (N)	32009.4	N/A
60% of Material Strength (N)	19205.6	N/A
Maximum Load From Tensile Test of Joint (N)	35448.7	N/A
PASS/FAIL	PASS	N/A

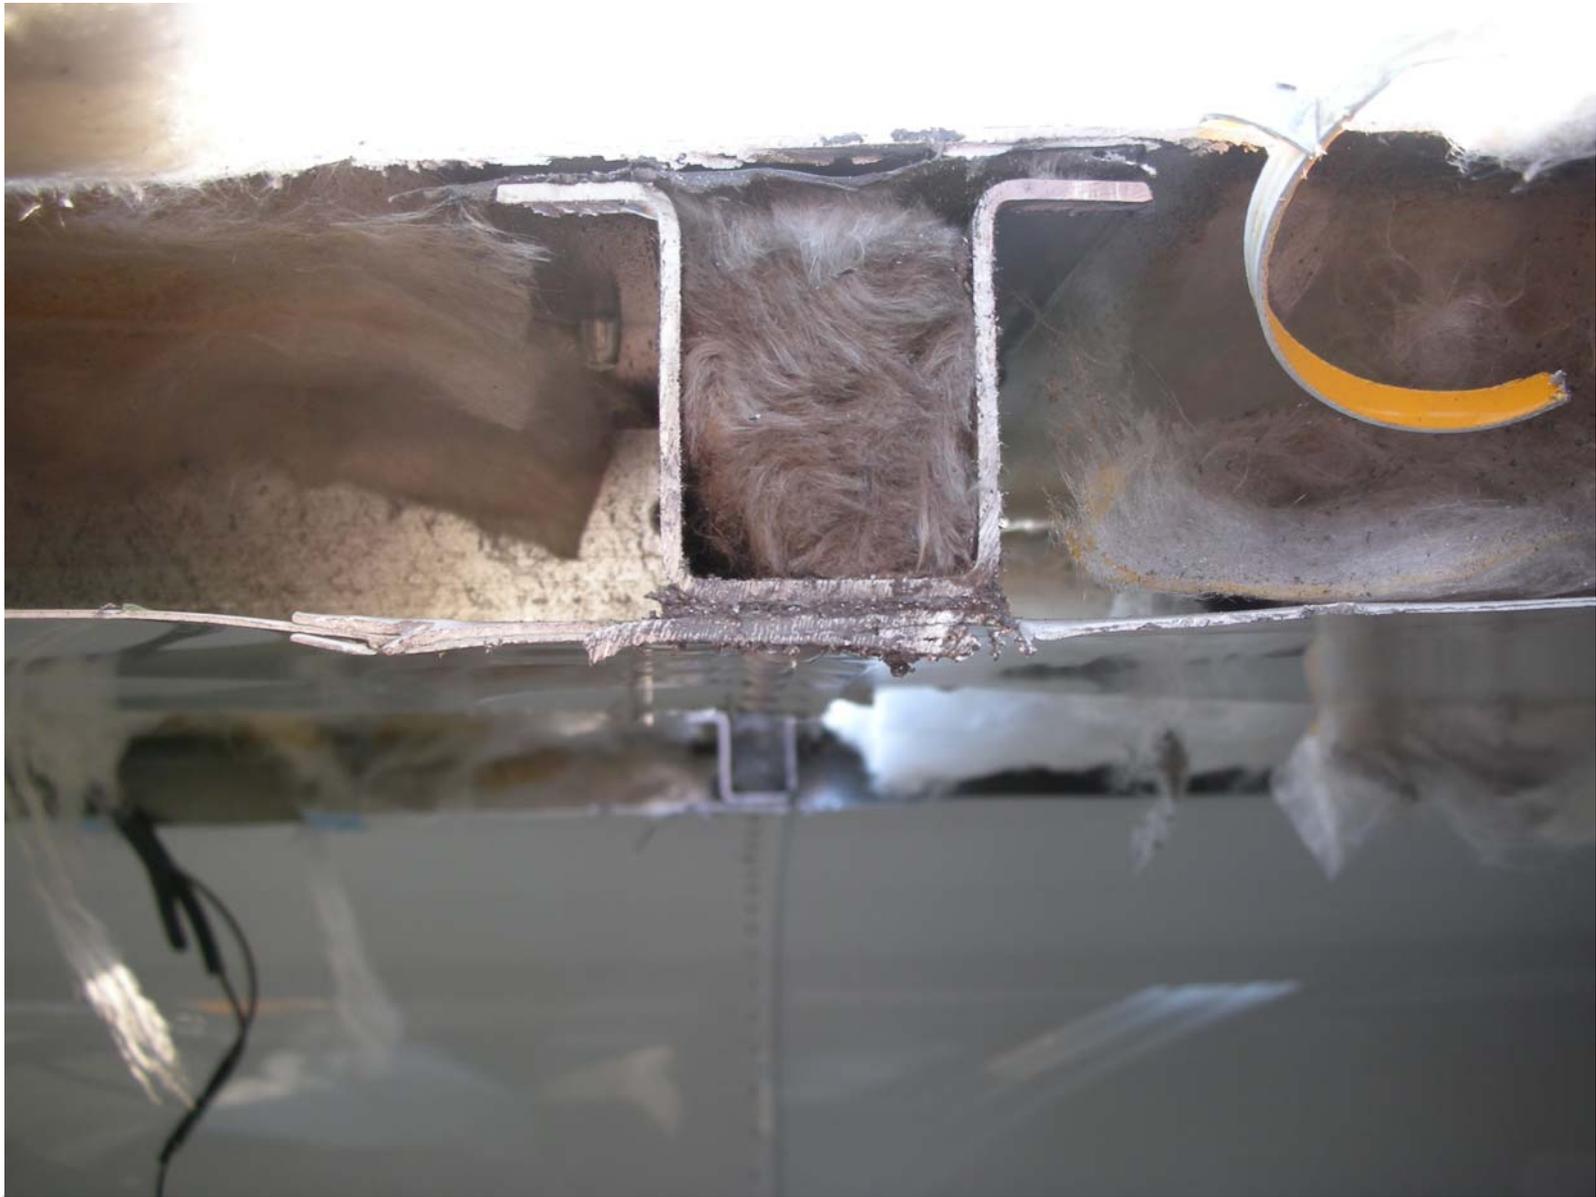
View of Joint #2

Weaker Member	Stronger Member
Material	3003 H-14 Aluminum	N/A
Tensile Strength (MPa)	137.9	N/A
Thickness (mm)	1.016	N/A
Fastener Holes (No./Diameter – mm.)	4 / 5.11	N/A
Net Area (Sq. mm.)	185.7	N/A
Material Strength (N)	25607.5	N/A
60% of Material Strength (N)	15364.5	N/A
Maximum Load From Tensile Test of Joint (N)	27620.3	N/A
PASS/FAIL	PASS	N/A

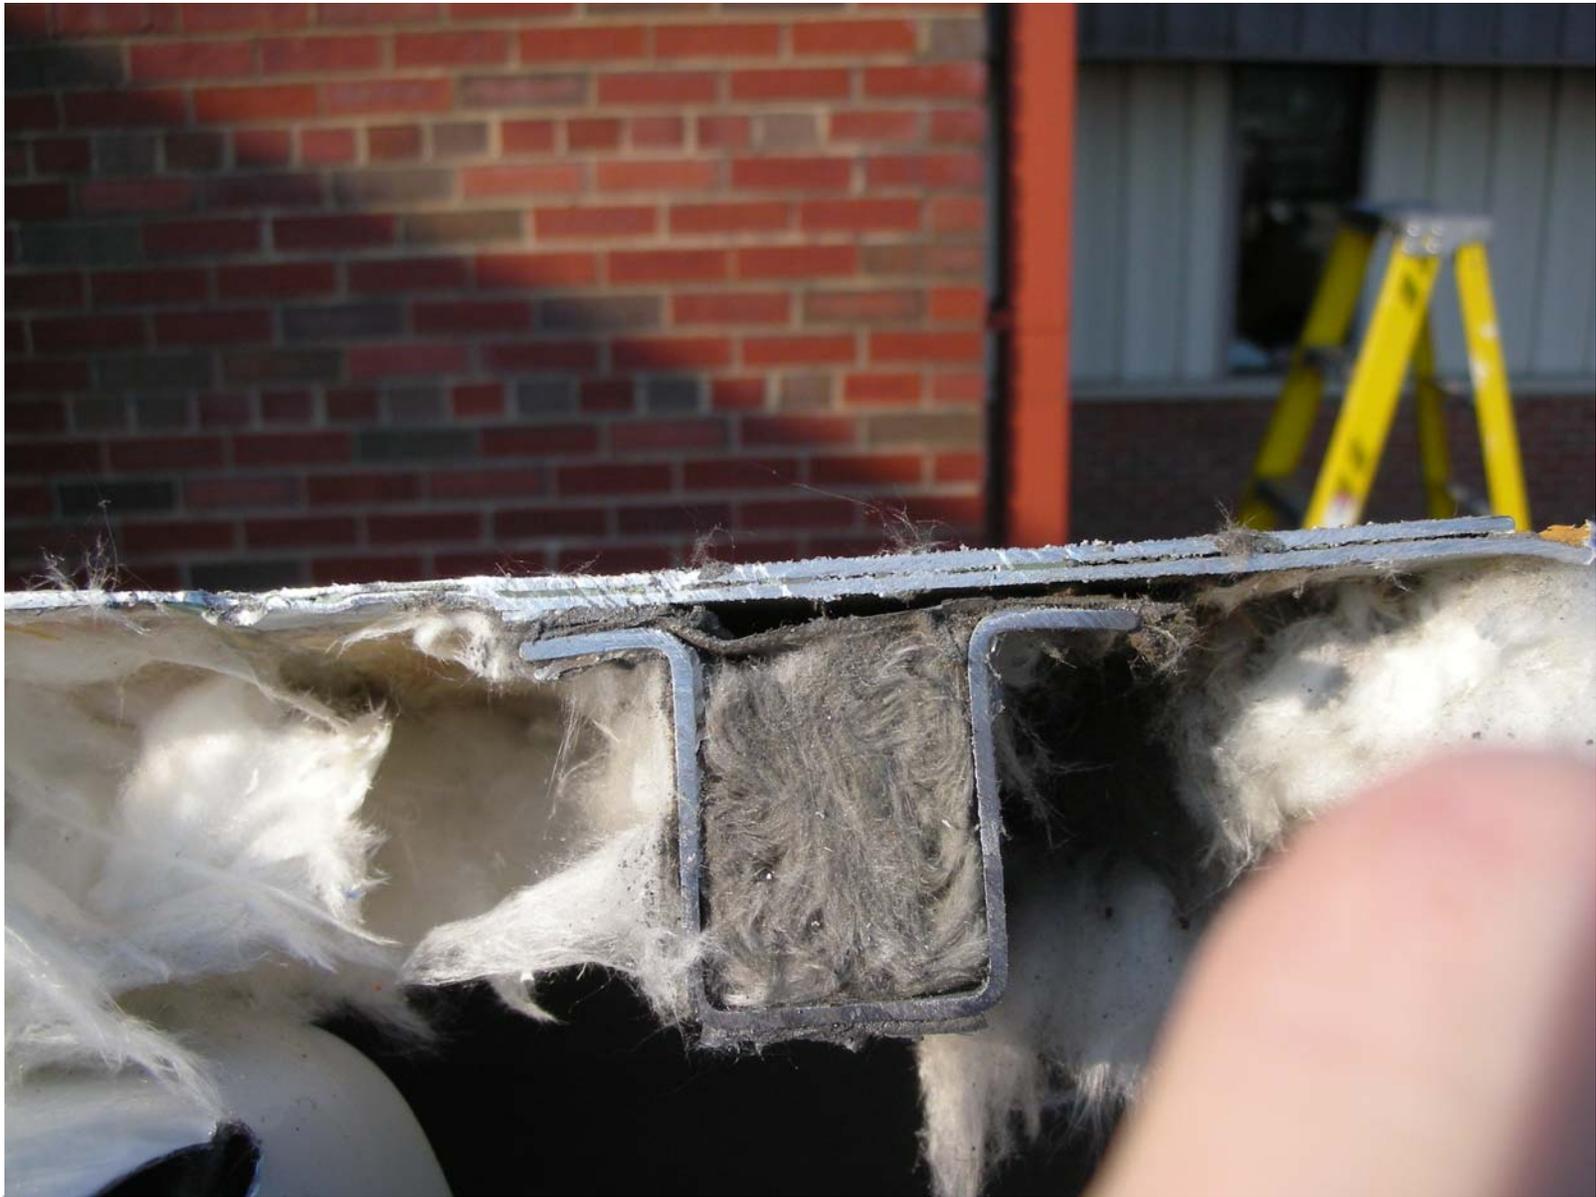
View of Joint #3

Weaker Member	Stronger Member
Material	3003 H-14 Aluminum	N/A
Tensile Strength (MPa)	137.9	N/A
Thickness (mm)	1.270	N/A
Fastener Holes (No./Diameter – mm.)	4 / 5.11	N/A
Net Area (Sq. mm.)	232.1	N/A
Material Strength (N)	32009.4	N/A
60% of Material Strength (N)	19205.6	N/A
Maximum Load From Tensile Test of Joint (N)	26275.9	N/A
PASS/FAIL	PASS	N/A

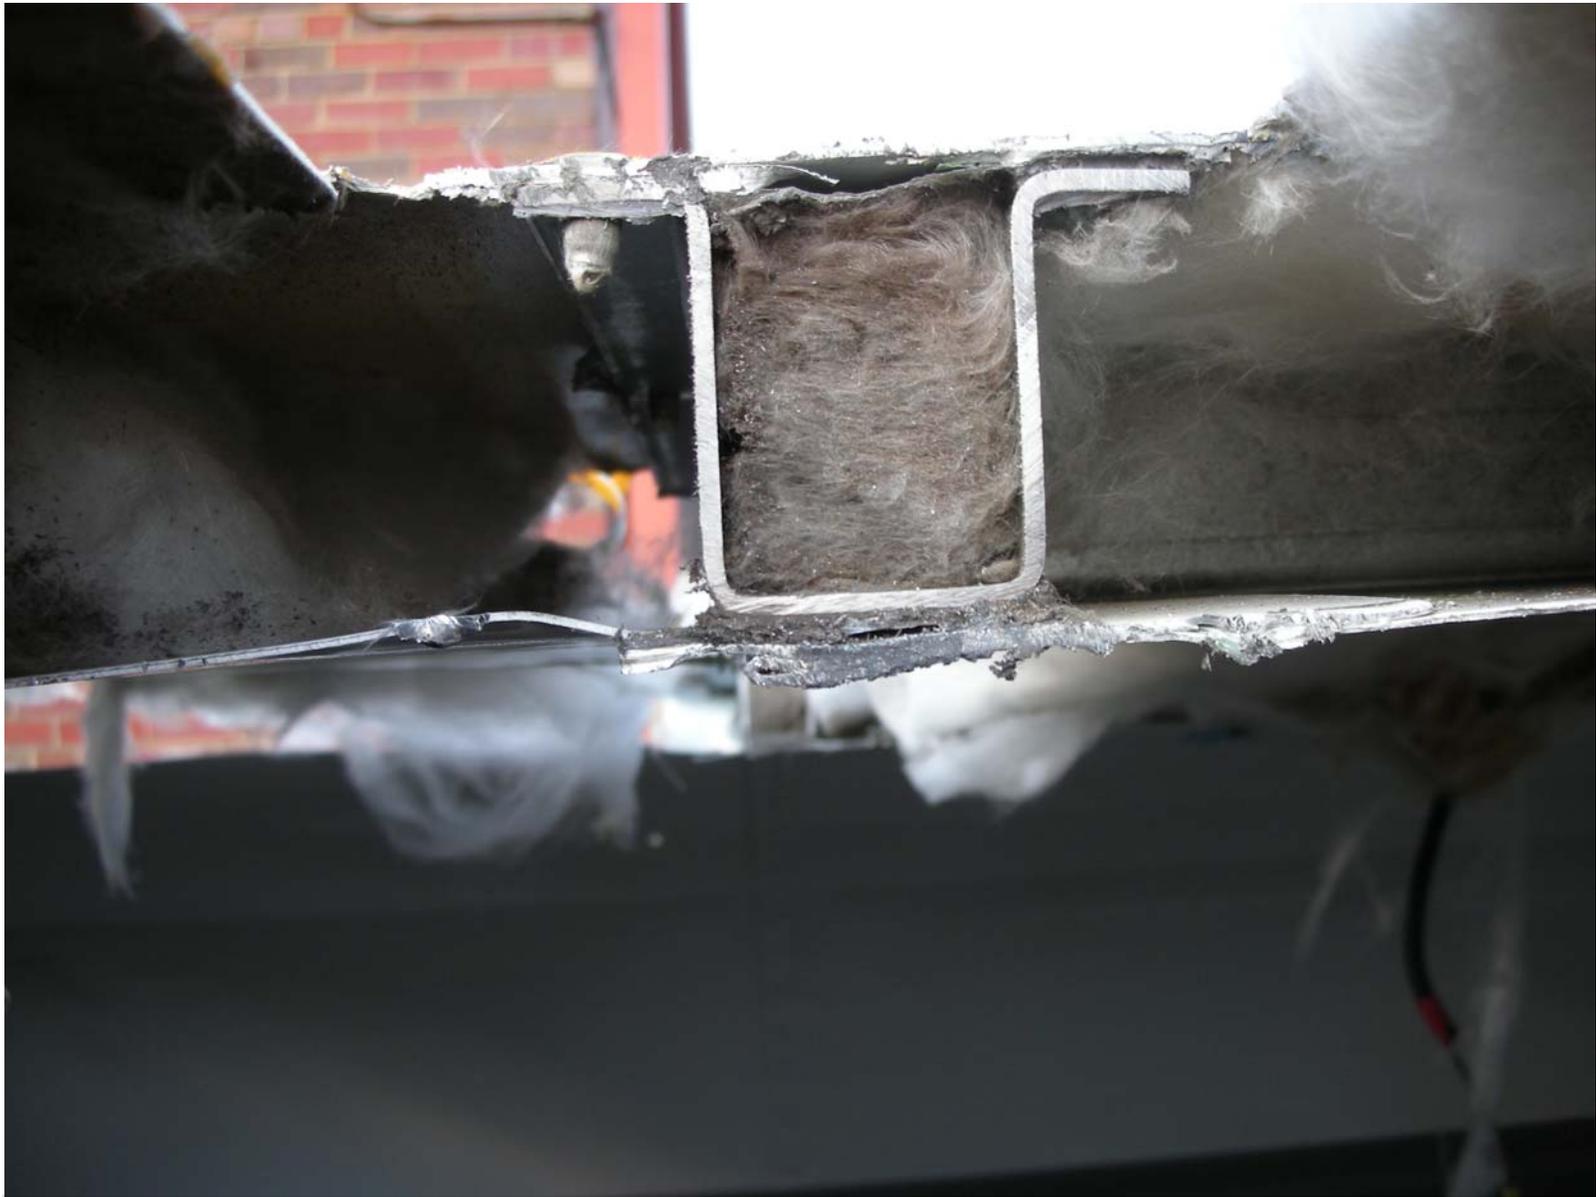
View of Joint #4

Weaker Member	Stronger Member
Material	3003 H-14 Aluminum	N/A
Tensile Strength (MPa)	137.9	N/A
Thickness (mm)	1.016	N/A
Fastener Holes (No./Diameter – mm.)	5 / 5.11	N/A
Net Area (Sq. mm.)	180.5	N/A
Material Strength (N)	24892.2	N/A
60% of Material Strength (N)	14935.3	N/A
Maximum Load From Tensile Test of Joint (N)	25843.8	N/A
PASS/FAIL	PASS	N/A
