DOT HS 812 552

**Special Crash Investigations  
On-Site Air Bag  
Non-Deployment  
Crash Investigation  
Vehicle: 2006 Toyota Scion tC  
Location: Florida  
Crash Date: May 2017**

**SPECIAL CRASH INVESTIGATIONS**  
**CASE NO: CR17015**  
**OFFICE OF DEFECTS INVESTIGATION**  
**ON-SITE ALLEGED AIR BAG NON-DEPLOYMENT CRASH INVESTIGATION**  
**VEHICLE: 2006 TOYOTA SCION tC**  
**LOCATION: FLORIDA**  
**CRASH DATE: MAY 2017**

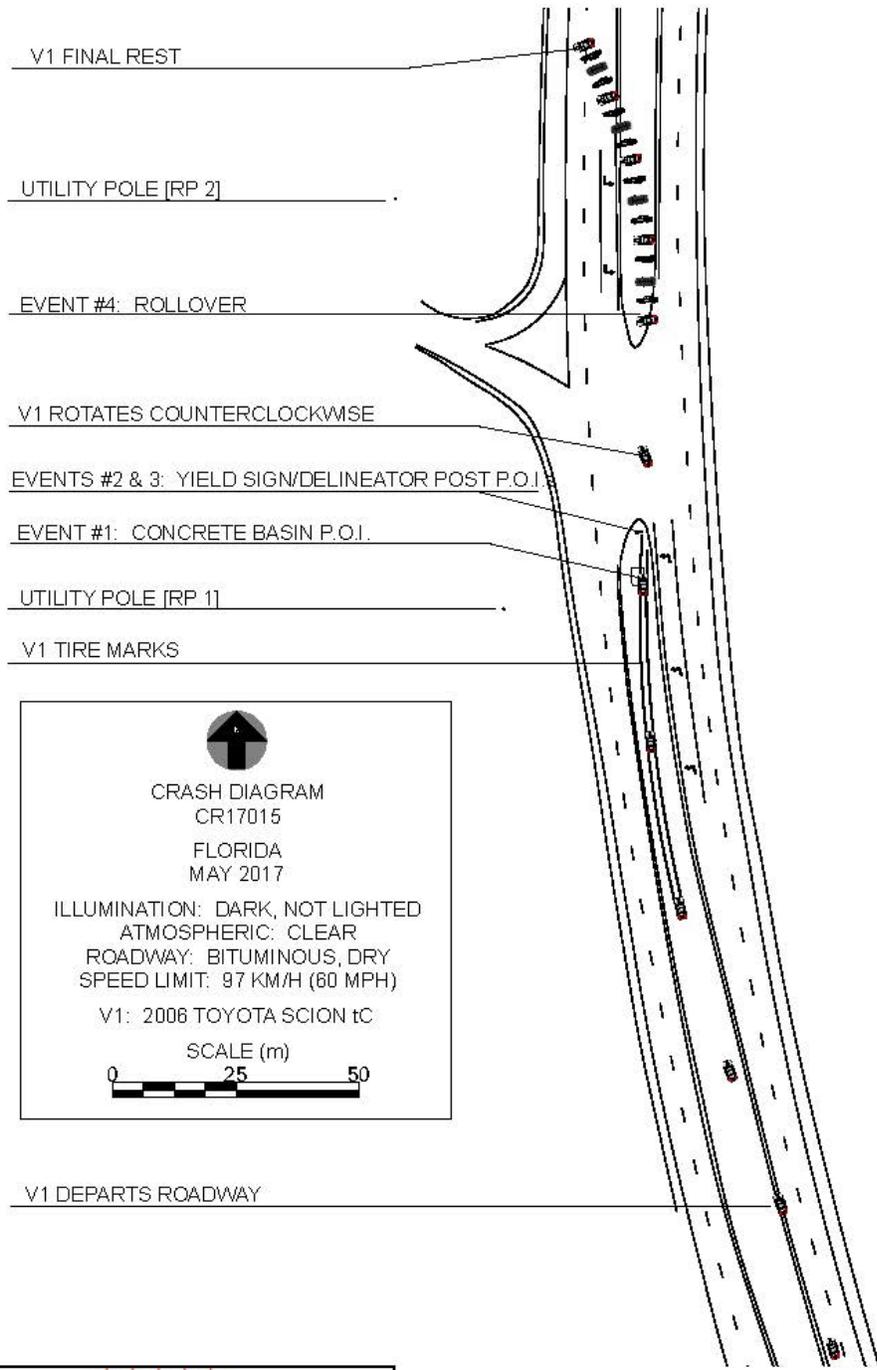
CRASH DIAGRAM  
CR17015  
FLORIDA  
MAY 2017

The driver operated the Scion northbound in the left lane. While her route of travel should have caused her to slow the vehicle and prepare to turn left at the intersection, the driver maintained her travel speed on a straight trajectory. She remained belted in the driver's seat as the Scion entered the median. Tire marks indicated that the driver became alerted to the Scion's off-road trajectory and attempted to regain the roadway by steering right. She likely held the steering wheel firmly as the Scion tracked along the arching median.
