DOT HS 812 609

**Special Crash Investigation
On-Site SKT Guardrail End
Terminal Crash Investigation
Vehicle: 1991 GMC Sonoma
Location: Missouri
Crash Date: April 2016**

SPECIAL CRASH INVESTIGATIONS
CASE NO.: CR16012
ON-SITE SKT GUARDRAIL END TERMINAL CRASH INVESTIGATION
LOCATION: MISSOURI
VEHICLE: 1991 GMC SONOMA
CRASH DATE: APRIL 2016

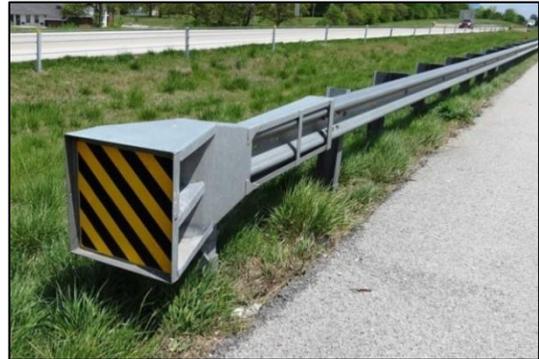
The SKT End Terminal was an energy absorbing end treatment (**Figure 7**). It was manufactured by Road Systems, Inc. and met the requirements for NCHRP 350 Test Level 3. The manufacturer's literature and installation manuals can be found at: <http://roadsystems.com/skt.html>. This SKT installation was 15 m (50 ft) long and consisted of the SKT end terminal, two hinged posts at post locations 1 and 2, an anchor cable, and seven standard steel posts that supported the W-beam with a composite block-out and carriage bolt at post locations 3 to 9. The struck guardrail was a tangent system with a measured W-beam height of 69 cm (27.3 in). This height was measured at an undamaged section of the beam between Post 9 and 10. The impact face measured 51 x 51 cm (20.0 x 20.0 in), width x height.

Figure 7: East-looking image depicting an exemplar SKT guardrail end treatment located on the left side of the interstate highway across from the crash site.

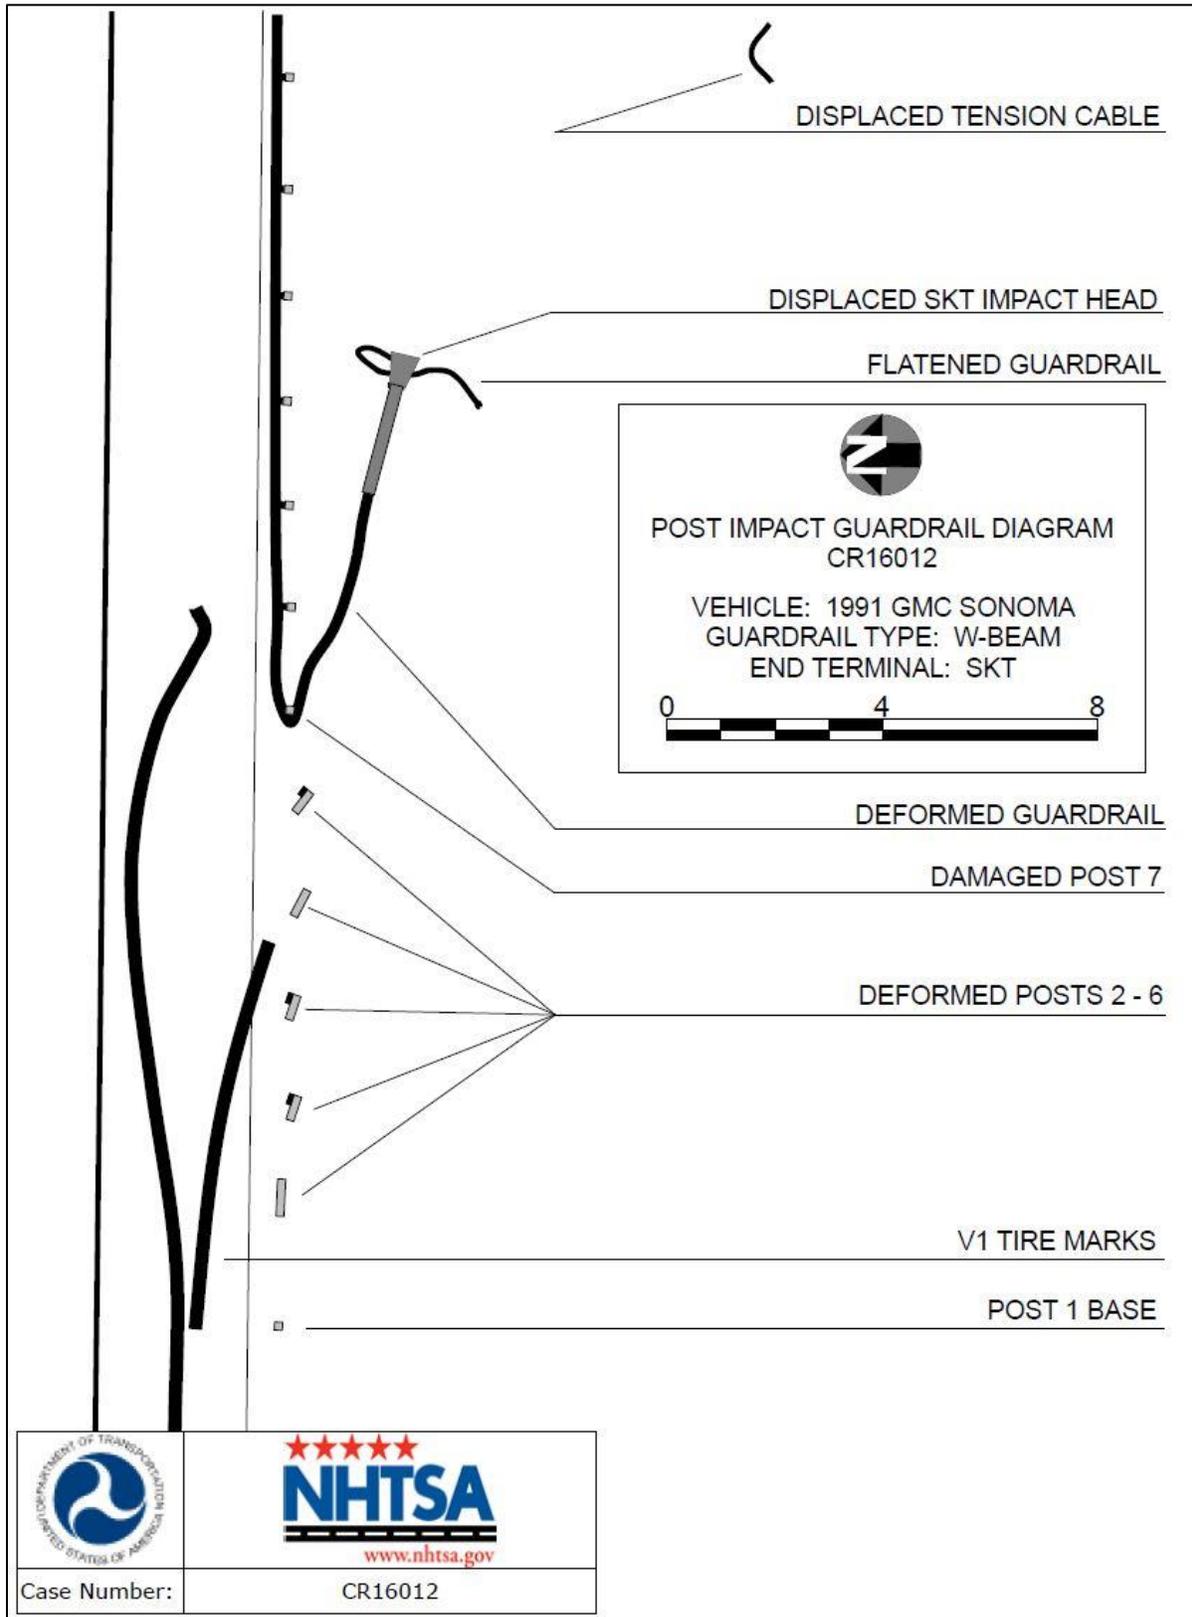
POST-IMPACT GUARDRAIL DIAGRAM

Post 1 consisted of a 15 x 15 cm (6.0 x 6.0 in) box-beam that was attached via a hinge bolt to a lower post section, which was embedded into the ground. The end terminal was attached to the box-beam by two shear bolts. The force of the impact overloaded the two shear bolts, allowing for the displacement of the end terminal and separation from Post 1. The impact force also caused the lower aspect of the box-beam to shear at the hinged connection, which separated the box-beam and displaced it 44.7 m (146.7 ft) to the east from the original location. The cable anchor, originally attached between Post 1 and the W-beam, was displaced 25.0 m (82.0 ft) to the east by the impact.

Posts 3 to 9 of the installation were standard 15 x 10 cm (6 x 4 in) I-beams that supported the W-beam with a composite block-out and carriage bolt. During the crash, the heads of these bolts pulled through the W-beam by deforming the slot in the rail. The composite block-outs remained attached to all the posts except Post 5. This block-out was separated from Post 5 by contact with the vehicle, and was found on the ground adjacent to the cable anchor. Posts 3 to 6 deformed by bending at ground level in the travel direction of the GMC. Post 3 and Post 4 were deformed nearly 90 degrees, with evidence of direct contact on the field side of the flanges of these I-beams. This evidence consisted of flange of deformation with overlying black transfers from the GMC's right front tire/suspension. Similar direct contact evidence was observed to the road-side I-beam flanges of Post 5 and Post 6, which were bent approximately 60 degrees east.

struck the face of the guardrail between Post 7 and 9. Minor deformation was noted at Post 8, and the guardrail damage ended at the Post 9 splice.
