DOT HS 813 587

**Special Crash Investigations:  
Remote Move-Over-Law Crash  
Investigation;  
Vehicle: 1996 International 4000/  
Nonmotorist;  
Location: Washington State;  
Crash Date: April 2021**

**Special Crash Investigations**  
**Remote Move-Over-Law Investigation**  
**Case No. DS21011**  
**Vehicle: 1996 International 4000/Nonmotorist**  
**Location: Washington State**  
**Crash Date: April 2021**

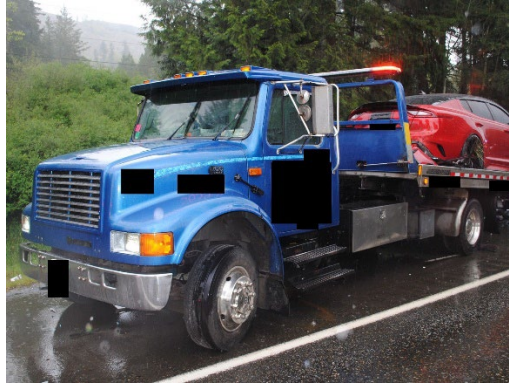
*Figure 1. 1996 International 4000 (police photo)*

The struck vehicle was a 1996 International 4000 medium-duty commercial tow truck with a rollback-style flatbed (Figure 1). The striking vehicle was a 2011 BMW 335d 4-door sedan. The other vehicle was a 2013 Kia Sorento compact SUV. A non-contact 2018 Kia Stinger was loaded on the International. The driver of the International tow truck had responded to a prior single-vehicle crash at this site involving the Stinger and 25-year-old male driver. Police left the scene prior to the second crash. At the time of the second crash, only the International, Sorento, and Stinger were stopped on the right shoulder.

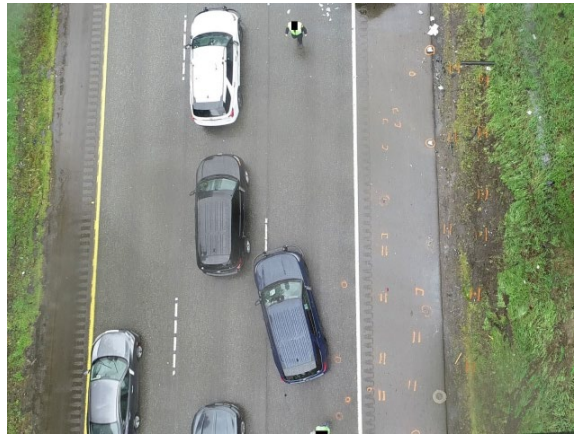
*Figure 2. Crash site overhead view (police video)*

The police report, photos, video, and satellite imagery were used to obtain crash site data. The crash site was in the northbound lanes of the divided north/south interstate highway (Figure 2). The roadway had three northbound asphalt lanes each measuring approximately 3.6 m (12 ft) wide. The lanes were separated by dashed white painted stripes and raised reflective markers located on the dashes and within the spaces between the dashes. The left roadway edge had a solid yellow painted fog line and an asphalt shoulder with a milled-in type rumble strip. The right roadway edge had a solid white painted fog line and an asphalt shoulder with a milled-in type rumble strip. The right shoulder was approximately 3.6 m (12 ft) wide. The roadway was straight, level, and crowned to allow for runoff. Based on police photos and the police report narrative, the pavement and pavement markings were in good condition. The right roadside was a descending grass embankment and a line of trees oriented parallel to the roadway. The posted speed limit was 113 kmh (70 mph). Conditions at the time were daylight and wet with light rain. Police noted water standing in the rumble strip depressions on the right shoulder. The ambient temperature was 8.3°C (47°F). No supplemental warning devices were in use at the site prior to the crash and according to the police report no unusual conditions were present.

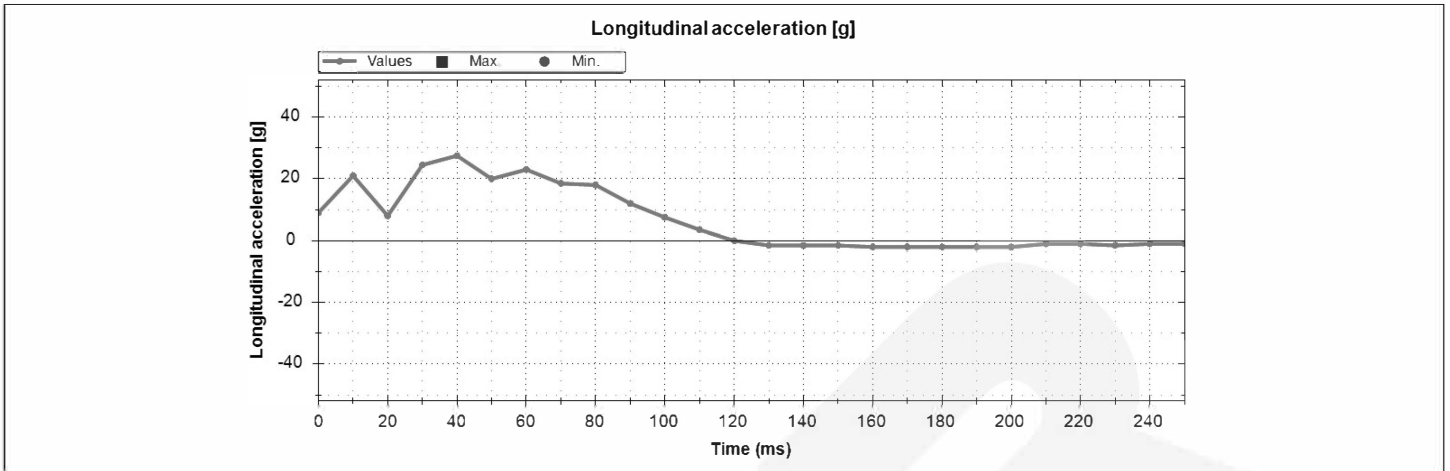
Longitudinal crash pulse\_acceleration (g, 0 ~ 250msec)

The BMW's front plane struck the back plane of the Sorento (Event 1). Police identified a group of gouge marks in the pavement as the point of maximum engagement for this impact. The BMW driver's frontal air bag deployed. The Sorento's EDR captured a deployment level event with a maximum longitudinal delta V of 66 kmh (41 mph) at 115 ms and a maximum lateral delta V of -5 kmh (-3 mph) at 65 ms. The vehicle's seat-mounted side impact and inflatable curtain (IC) air bags deployed and the front-row seat belt pretensioners actuated at 51 ms. For the BMW, a police reconstruction calculated an impact speed of 126 to 129 kmh (78 to 80 mph) with no braking applied, and a longitudinal delta V of -75.8 kmh (-47.1 mph).

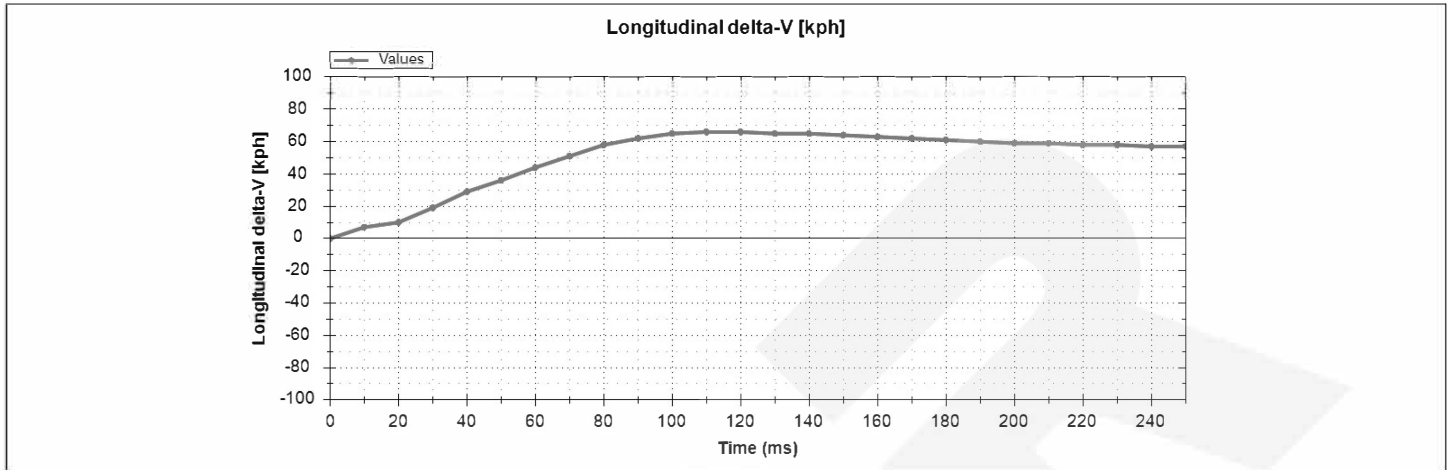
Longitudinal crash pulse\_delta-v (kph, 0 ~ 250msec)

Max. delta-V [kph]	66
Time, Max. delta-V [msec]	115.0
