# Safety Recall

# Code: 69i9

# Subject: 2012 – 2013 MY Beetle with Leather Sport Seats Passenger Occupant Detection System Control Module (J706)

#### REVISED January 9, 2013

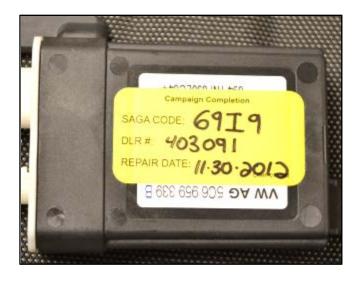
## Section B - Module Inspection

- Adjust the passenger front seat to the fully • raised position
- ⇐ Inspect the PODS module for the campaign completion label (left)
- If the campaign label is installed on the module - Work Complete.
- If no sticker is found, continue to Section C.

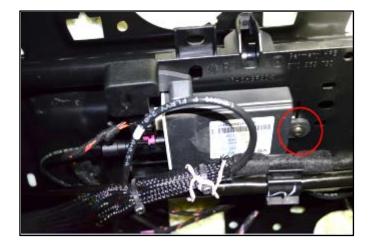
Note: It is not necessary to fully remove the seat from the vehicle.

• Tilt the seat rearward and rest it on the rear seat. This will provide access to the PODS module.

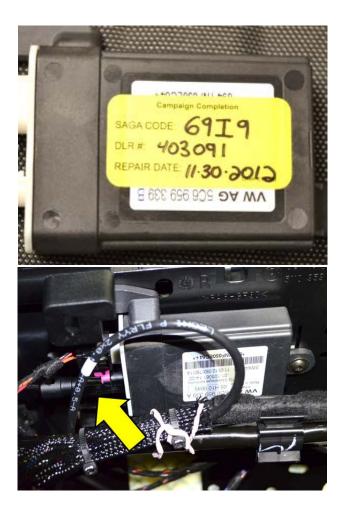
# **PODS Module Replacement**

- $\leftarrow$  Remove mounting bolt <circle>.
- Remove the PODS module from the bottom of the seat.

Fill out and affix Campaign Completion Label part number CAMP 010 000 to the PODS module prior to installation.

> Note: Position the label so the part number on the module itself is not covered.
