ON-SITE CERTIFIED ADVANCED 208-COMPLIANT VEHICLE INVESTIGATION

CASE NUMBER - IN08006 LOCATION - MICHIGAN VEHICLE - 2007 PONTIAC G6 SE CRASH DATE - December 2007

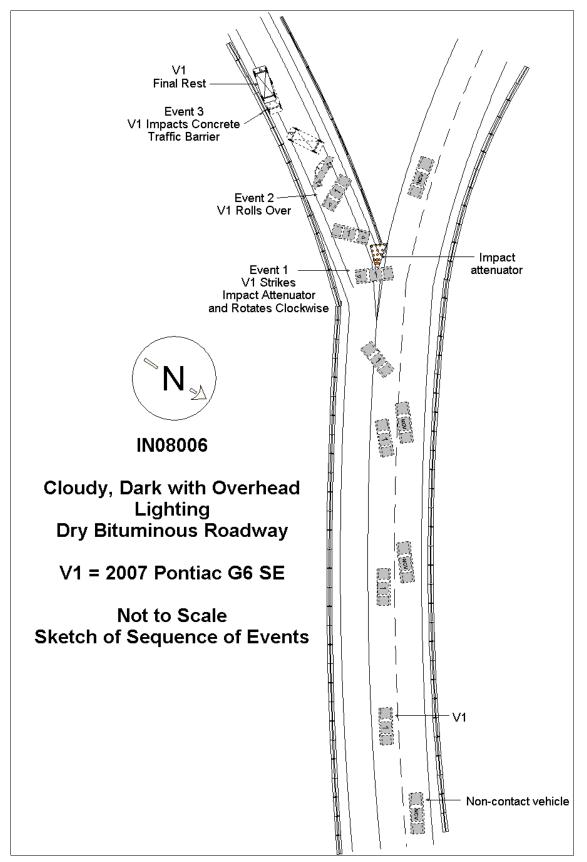
IN08006

CRASH DIAGRAM

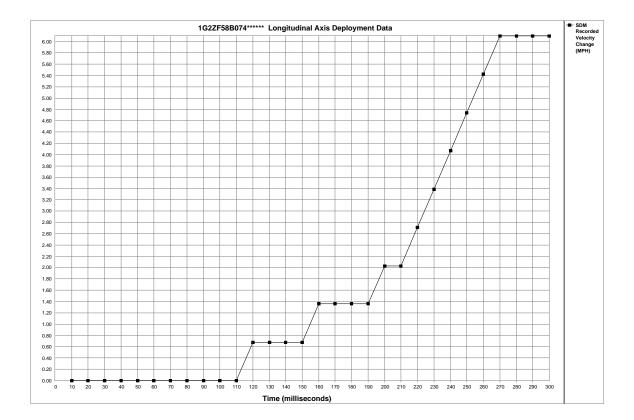
Time (milliseconds)	10	20	30	40	50	60	70	80	90	100	110	120	130	140	150
Longitudinal Axis Recorded Velocity	0.00	0.00	0.00	0.00	0.00	0.00	0.00	0.00	0.00	0.00	0.00	0.68	0.68	0.68	0.68
Time (milliseconds)	160	170	180	190	200	210	220	230	240	250	260	270	280	290	300
Longitudinal Axis Recorded Velocity	1.36	1.36	1.36	1.36	2.03	2.03	2.71	3.39	4.07	4.74	5.42	6.10	6.10	6.10	6.10

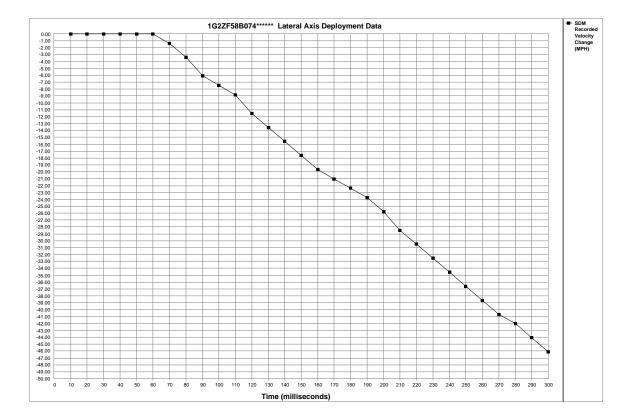
Time (milliseconds)	10	20	30	40	50	60	70	80	90	100	110	120	130	140	150
Lateral Axis Recorded Velocity Change (MPH)	0.00	0.00	0.00	0.00	0.00	0.00	-1.36	-3.39	-6.10	-7.46	-8.81	-11.52	-13.56	-15.59	-17.62
Time (milliseconds)	160	170	180	190	200	210	220	230	240	250	260	270	280	290	300
Lateral Axis Recorded Velocity Change (MPH)	-19.66	-21.01	-22.37	-23.72	-25.76	-28.47	-30.50	-32.54	-34.57	-36.60	-38.64	-40.67	-42.03	-44.06	-46.09

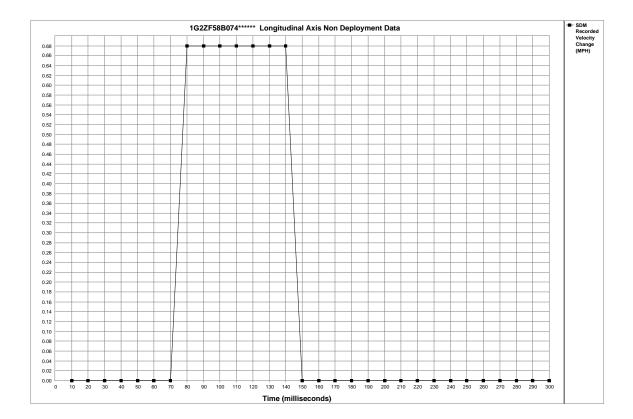
Time (milliseconds)	10	20	30	40	50	60	70	80	90	100	110	120	130	140	150
Longitudinal Axis Recorded Velocity	0.00	0.00	0.00	0.00	0.00	0.00	0.00	0.68	0.68	0.68	0.68	0.68	0.68	0.68	0.00
Time (milliseconds)	160	170	180	190	200	210	220	230	240	250	260	270	280	290	300
Longitudinal Axis Recorded Velocity	0.00	0.00	0.00	0.00	0.00	0.00	0.00	0.00	0.00	0.00	0.00	0.00	0.00	0.00	0.00

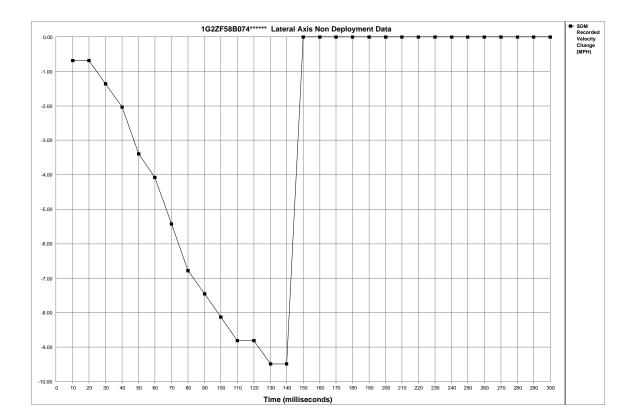
Time (milliseconds)	10	20	30	40	50	60	70	80	90	100	110	120	130	140	150
Lateral Axis Recorded Velocity Change (MPH)	-0.68	-0.68	-1.36	-2.03	-3.39	-4.07	-5.42	-6.78	-7.46	-8.13	-8.81	-8.81	-9.49	-9.49	0.00
Time (milliseconds)	160	170	180	190	200	210	220	230	240	250	260	270	280	290	300
Lateral Axis Recorded Velocity Change (MPH)	0.00	0.00	0.00	0.00	0.00	0.00	0.00	0.00	0.00	0.00	0.00	0.00	0.00	0.00	0.00
